Service Information Bulletin

B64 04 26

COOLANT HOSE CONTACTS STEERING SHAFT B48

E-Series	Model Description	Production Date	Affected Option Code
G60	530i, 530i xDrive Sedan	Vehicles produced from June 30, 2023	With B48 engine

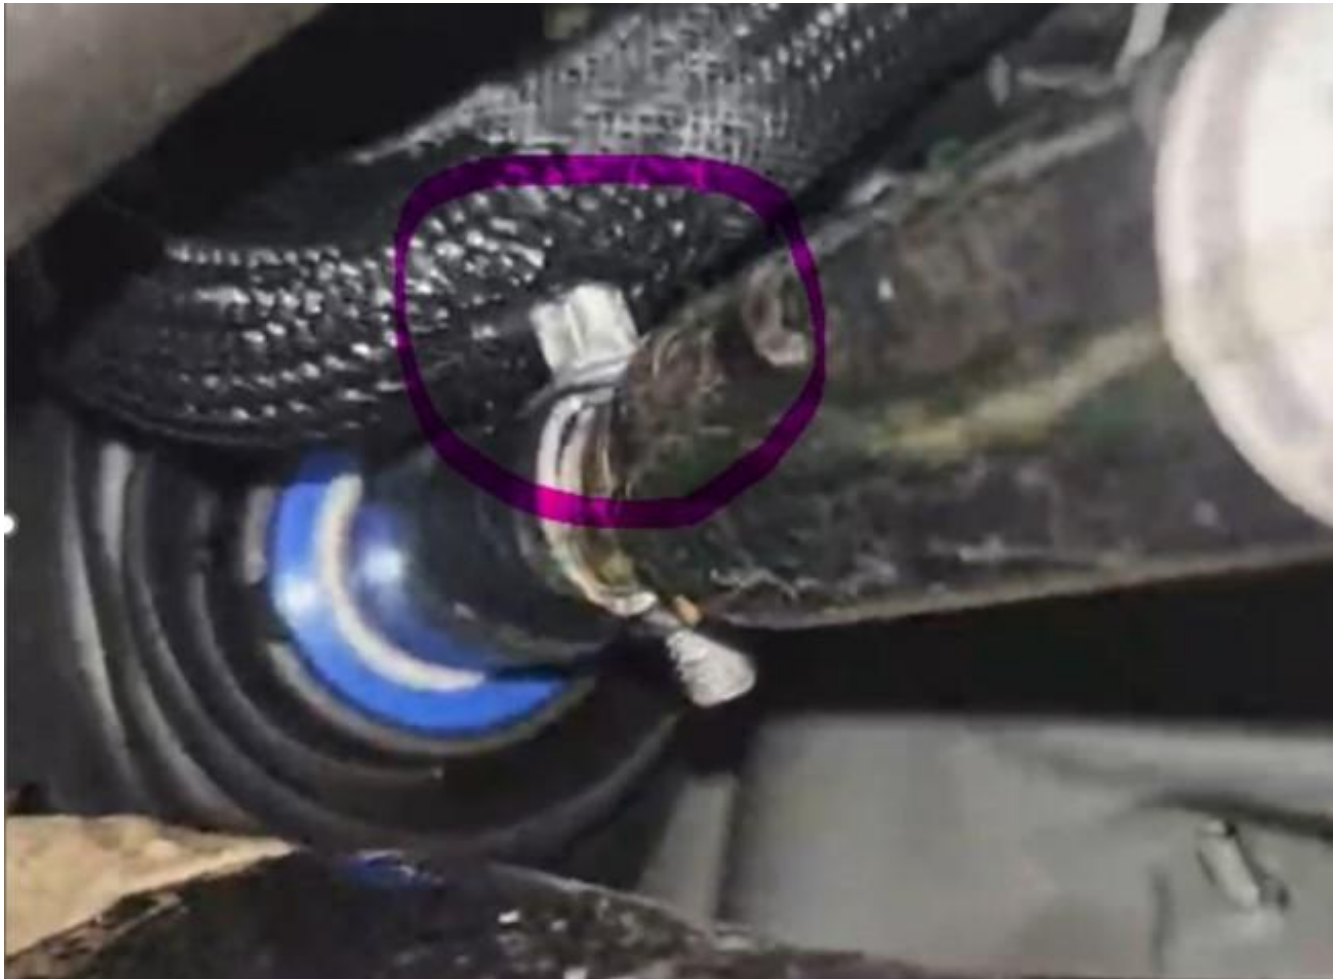
- Customer may feel something transmitted via the steering column while turning the steering wheel.
- There may also be coolant lost accompanied by a check control message: **'Top up coolant'**

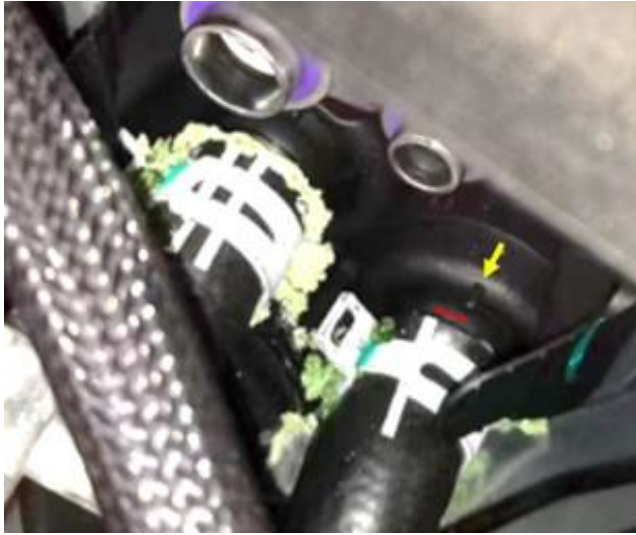
The coolant hose was not properly aligned when installed.

The white marking on the hose should align with the small black plastic mark on the heater core connection shown by the yellow arrow.

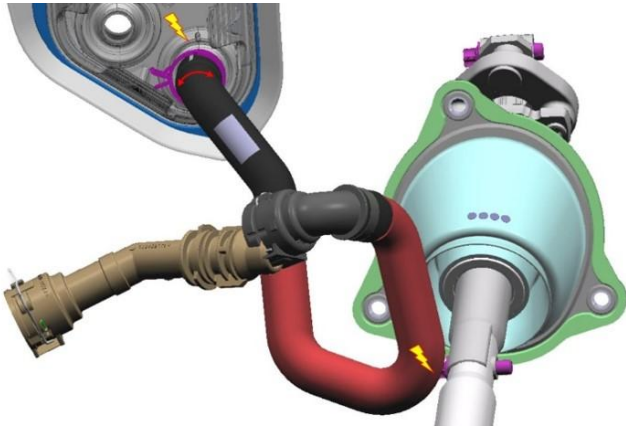
Due to the hose being installed incorrectly, it can now contact the steering shaft. Over time this may cause a hole to be worn through the coolant hose.

- 1) Check whether the identified coolant hose was installed in such a way that the two alignment markings (white line on the coolant feed hose and mark on the heating and air conditioning unit connection) are not lined up.
- 2) Ensure the coolant feed hose is located in front of the coolant return hose. The DMC label must be visible!
- 3) Correct the position installation as needed.

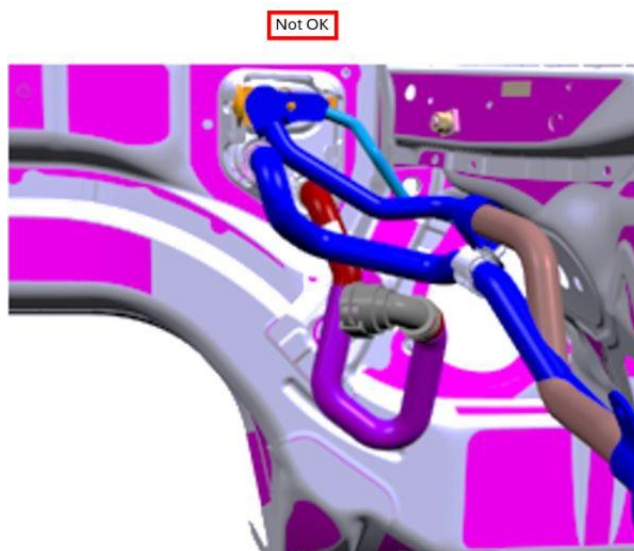
- 2) Check whether the routing of the coolant feed hose is OK. The coolant feed hose must be located in front of the coolant return hose. The DMC label must be visible!
