# GEN5 DD13 Engines with 4364/17

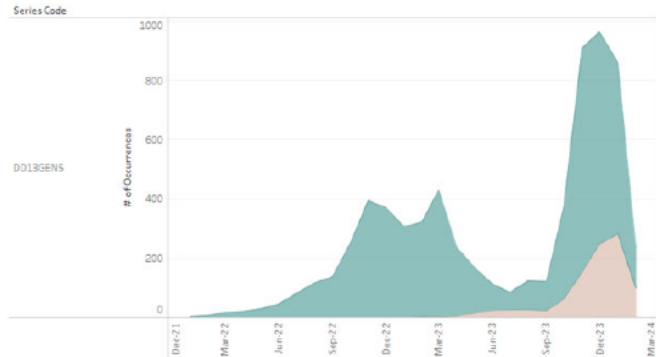
## VISUALIZATION:

- Code 4364/17 – NOx Efficiency Low showing high rates of NTF in troubleshooting on DD13HP engines.
- DD13HP is certified to a lower NOx threshold than DD15.
- Increase seen only in colder weather on DD13.

- Complete published t/s for 4364/17 in the Gen5 Troubleshooting manual – avoid replacing the SCR at this time, where possible, unless damage is found.
- Diagnostics are being updated to reflect software improvements.
- MY22-23 DD13TCO with GATS2.0 - Update ACM to 10.52.1.0 with fuel map ending in ZGS 003. Released 2/10/26.
- MY24-25 DD13HP with GATS2.4 Update to ACM software version 10.56.1.1. Released 2/10/26 (MY26 backwards compat package).
- MY22-26 DD13HP with GATS2.0 Release planned for Q3 2026 running change. TBD.
