# WST X-Series Hood Cracks

- X Series WST

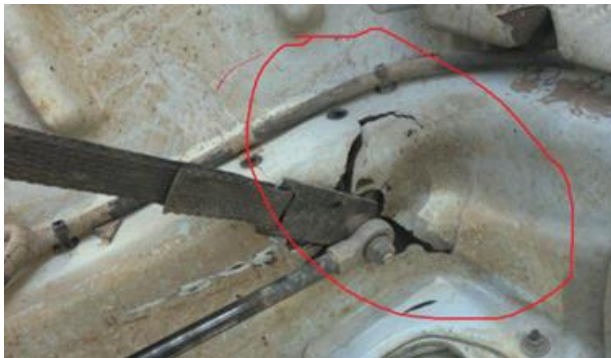
- Customers discover cracks at hood strut mounting point inside the hood at 30000 miles plus, worsening with time.

- Standoffs added to the hood panel to prevent excessive adhesive squeeze-out
- Camera system on order to monitor for proper adhesive application
