# MDEG Exhaust Camshaft

**FIELD SOLUTION:** Fix as failed - replace exhaust camshaft

- DD5 and DD8 engines

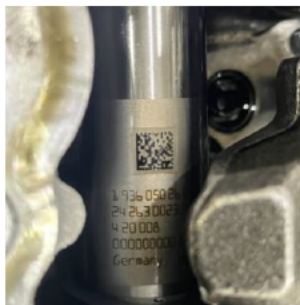
- CEL for 636/2 No Match of Camshaft and Crankshaft Signals
- Trouble shooting will lead to checking camshaft timing which will usually be correct. The tone wheel on the back side of the exhaust cam gear will be shifted and can be seen by comparing the location of the hole on the gear vs the hole on the tone wheel. They will not be lined up.

- Very low failure rate (0.6%) but some repeat occurrences have prompted further investigation into this condition.
- It was determined through conversations with our German colleagues that there was an issue with how the service stock was being assembled in Germany.
  - ☐ The bolt holding the cam gear to the camshaft tube was not being torqued sufficiently.
  - ☐ This was corrected with service stock build dates of 12/15/2024 and newer.
