# P4 Utility Lamp Water Intrusion

- All Cascadias

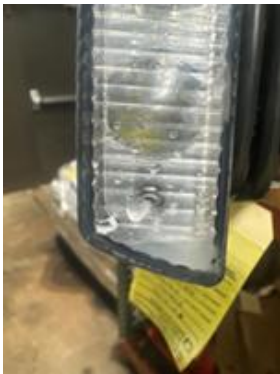
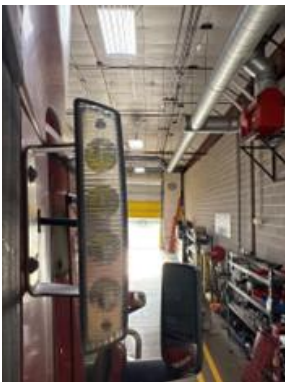
- Customers finding early life water intrusion failures on both LH and RH utility lamps mounted on the outside of the side extenders.

- Engineering and supplier evaluated failed parts to understand root-cause. They determined the moisture was entering the lights through the breather tube membrane.

- Remove breather tube and membrane. 02/2026

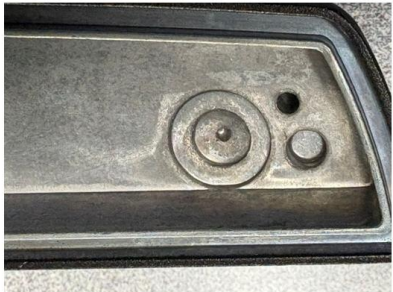
Breather target opening. Secondary drilling operation to create a path into the mounting screw hole so that light can breathe. This hole was filled with silicone to plug until new housings without the drilled hole we available

Close up of target in new housing showing that the secondary drilling is no longer performed so that the light no longer has a path to the atmosphere. Eliminates water vapor from entering and condensing in the light.
