# Transmitter (BST)

## Leaking BST Root Cause:

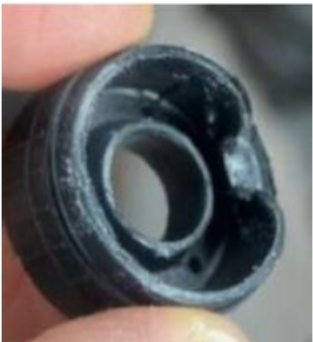
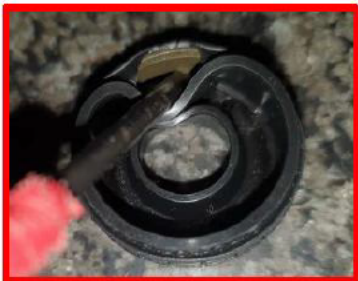
The vulcanization process that applies the rubber to the steel of the DBV seal ring was inconsistent and found to be damaged.

Damaged outer lip, delamination between rubber and metal skeleton

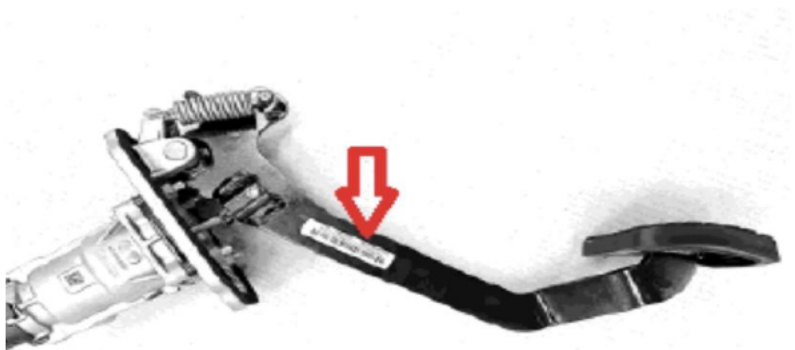
- Clean date from Wabco: 1-1-2026.
- Likely 30 days from Wabco clean date to TMP clean date
- Date code location on pedal assembly:
