# Fifth Gen Cascadia Turn Signal/DRL - Update

Affected Models:  
5<sup>th</sup> Generation Cascadia

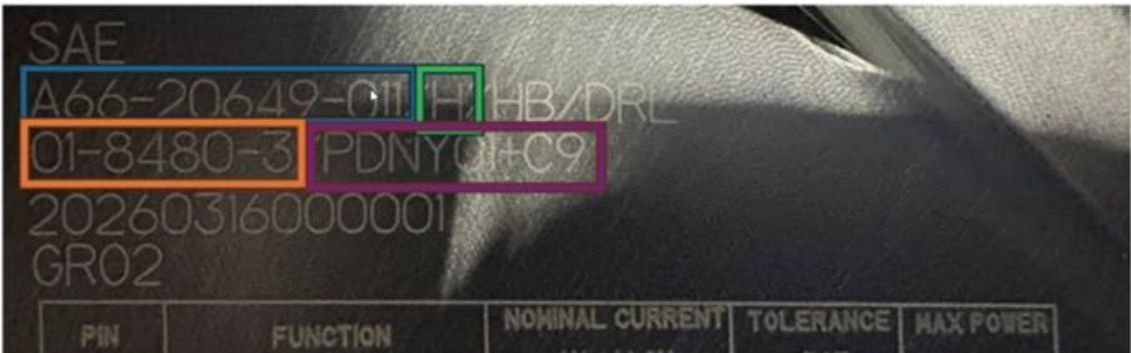
Status Update:  
Solder improvement created a part number change from A66-20649-008/009 to 010/011 (blue)  
New higher efficiency LED was implemented to use less current – June 2026

Headlamp assembly image showing new p/n

**Correction:** Fix as failed; the failed headlamp only. Replace the headlamp assembly.
