# 54-342 Rain/Light Sensor Removal

TSB-54-342-FTL

► New Cascadia

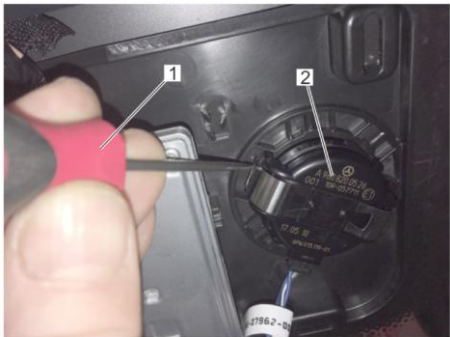
Fig. 1, MPC2 Bracket Cover Removal

1. Bracket Cover

1. ☐ Park the vehicle on a level surface, shut down the engine, and set the parking brakes. Chock the tires. ☒
2. ☐ Disconnect the batteries. ☒
3. ☐ Remove the multipurpose camera (MPC2) bracket cover. See Fig. 1. ☒
