# Chelsea PTO Quality Issue

# TSB-26-059-FTL

Creation Date: 2026-06-22

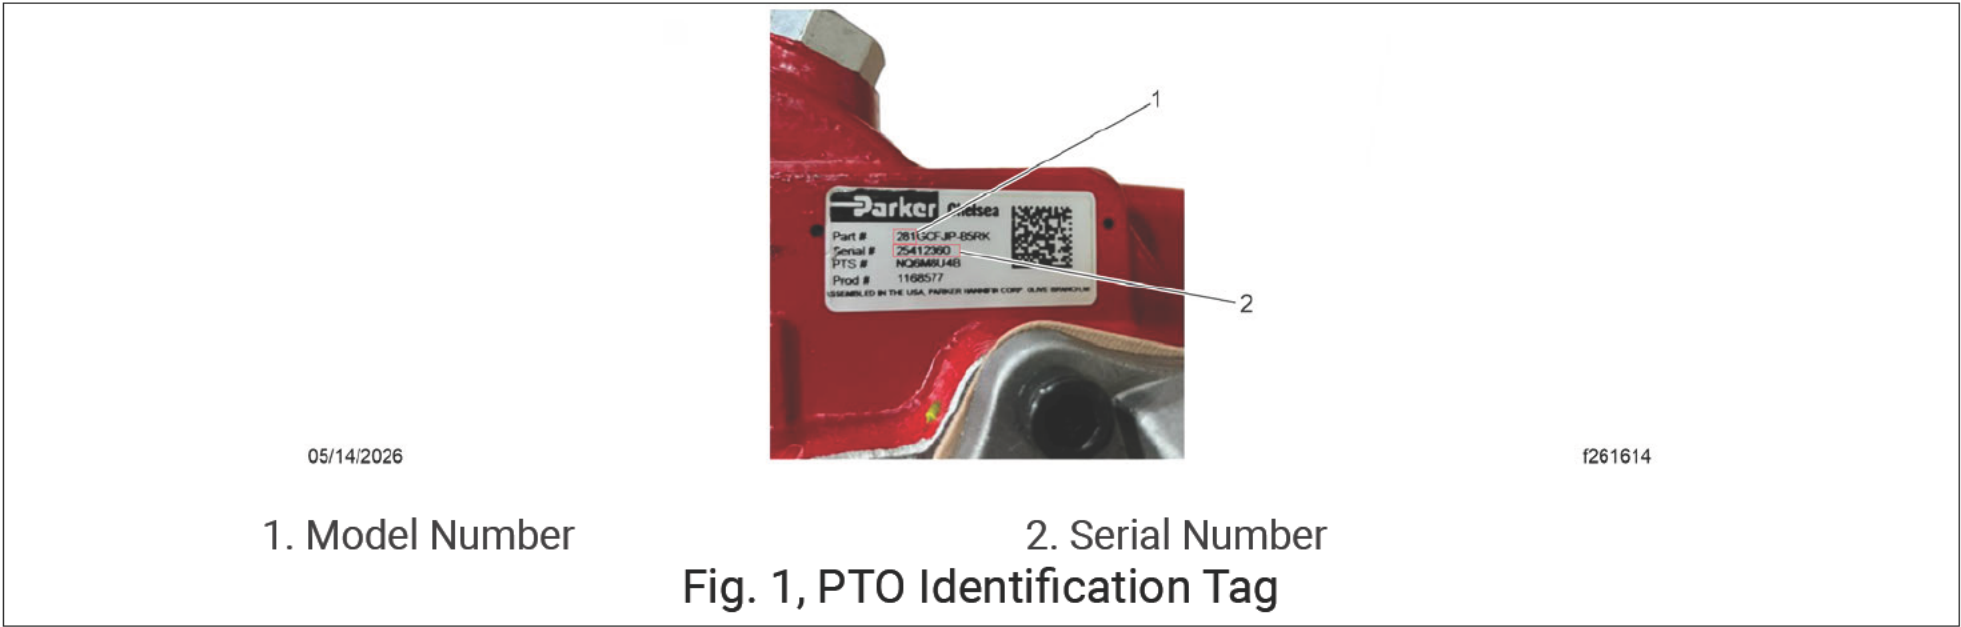
1. ☐ Locate the Chelsea PTO identification tag. See Fig. 1.

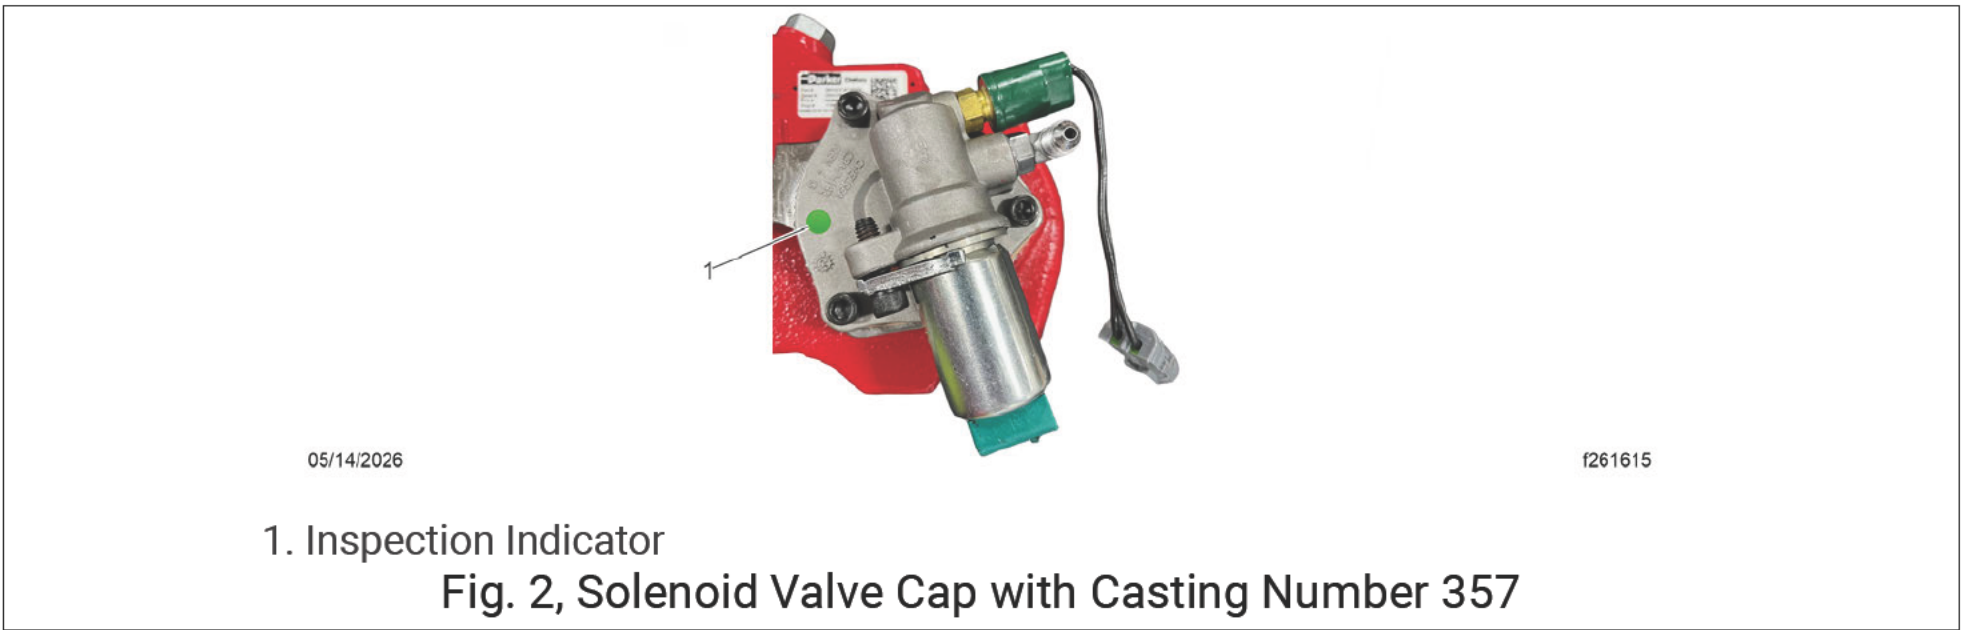
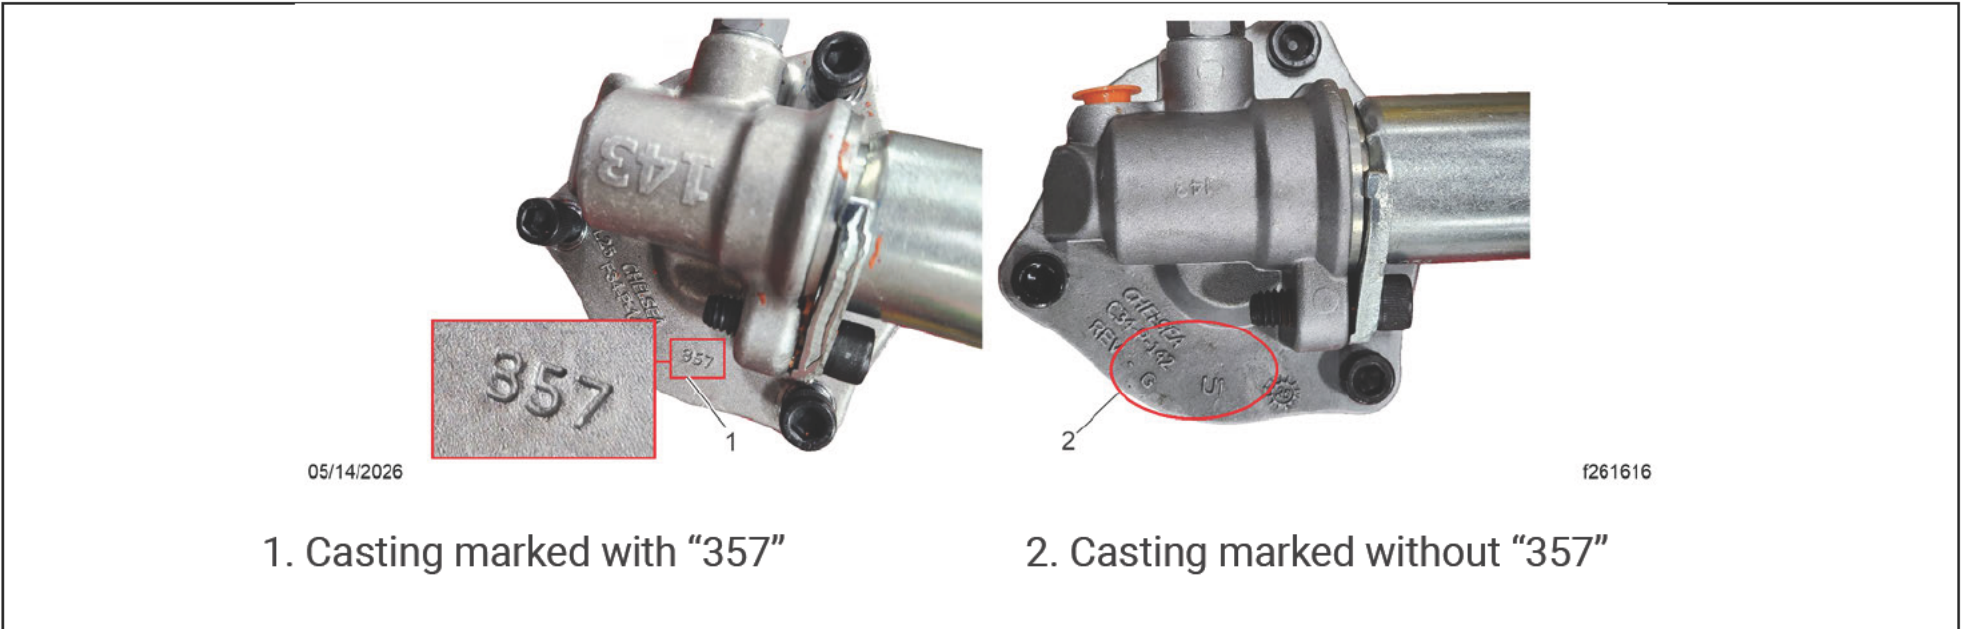
Fig. 3, New Casting with and without “357” Marking

3. ☐ Inspect the solenoid valve cap for a green dot or the casting number 357, which indicate the inspection and other required work has already been completed or is not needed. See Fig. 2. Is there a green dot, or casting number 357 on the bearing cap?

a. ☐ If no, continue with the Repair Steps.

b. ☐ If yes, no additional work is needed.

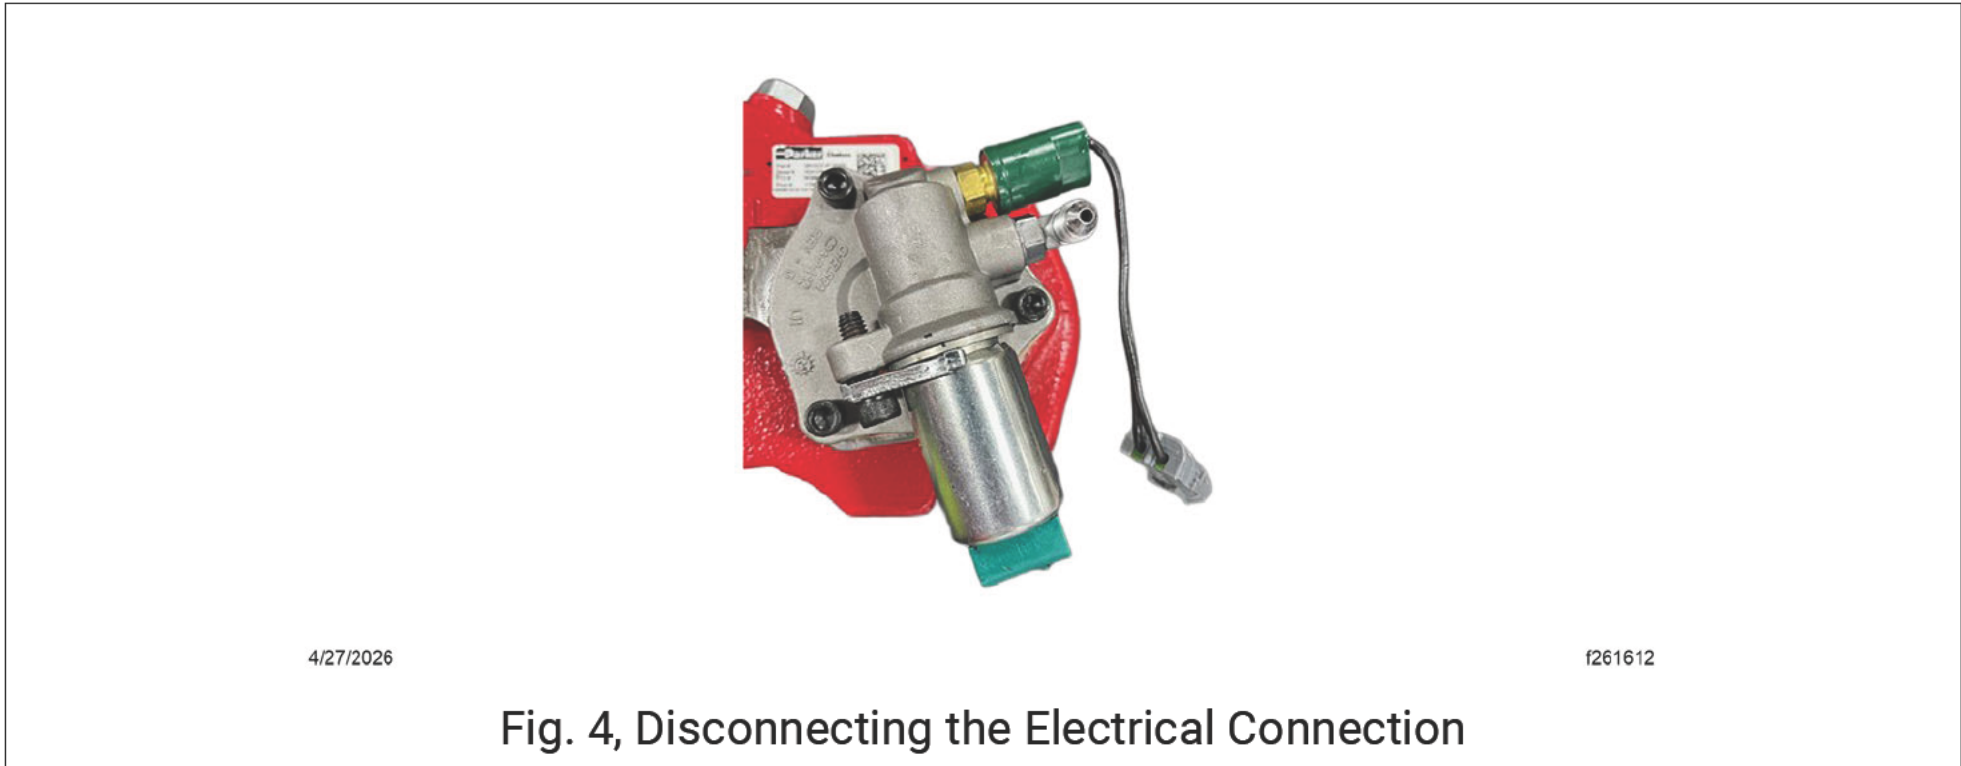
5. ☐ Remove any air or electrical harness connections from the solenoid valve. See Fig. 4.

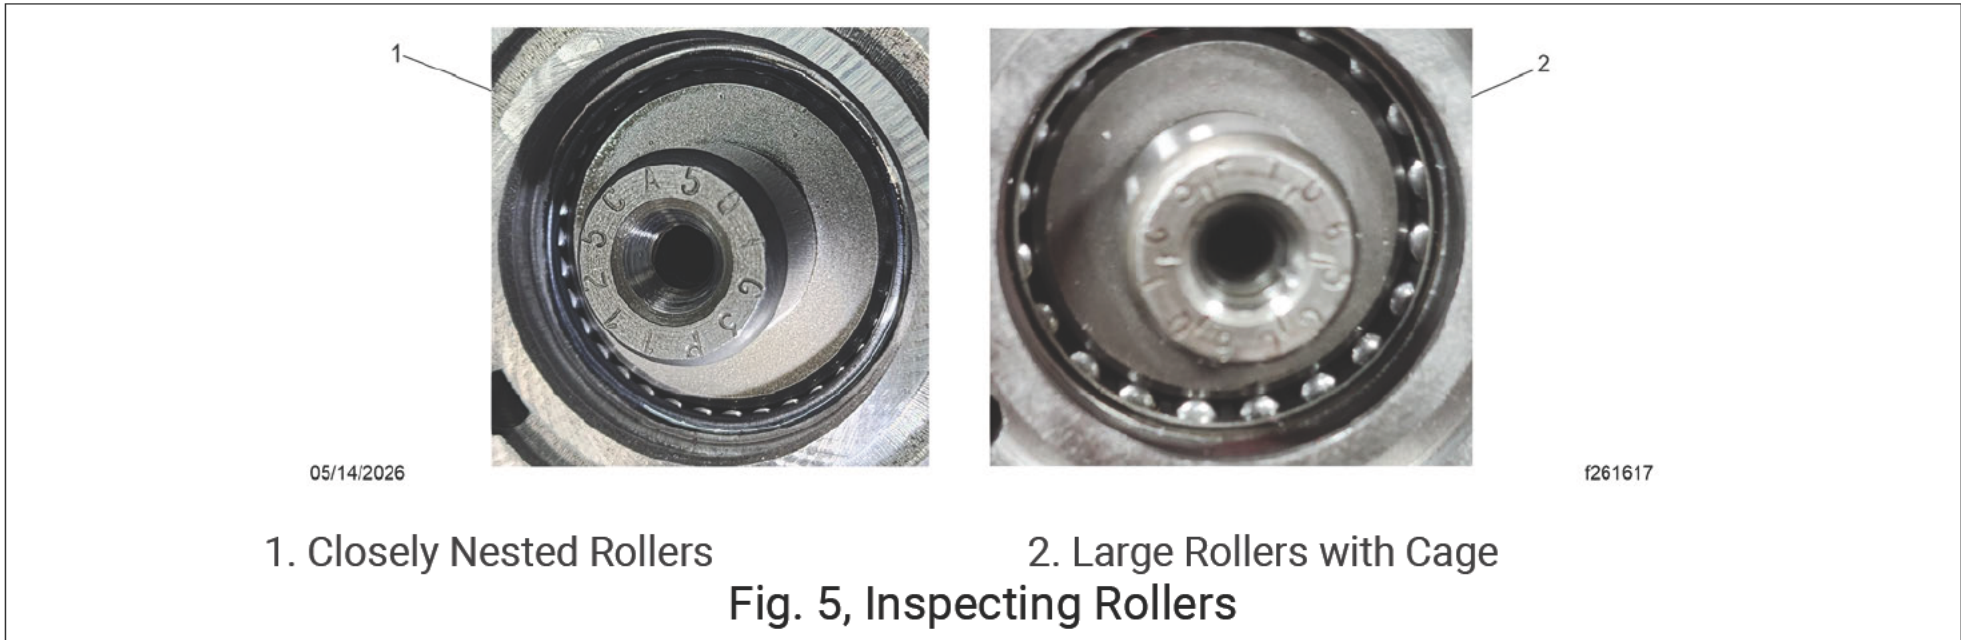
7. ☐ Inspect the needle elements of the bearing. Bearings with larger rollers separated by a cage do not require the new cap. Are the bearing rollers small and nested close together?

a. ☐ If yes, install the new valve cap kit.

b. ☐ If no, use the original valve cap.
