**Date:** 18.06.2026      **Affected Models:** All Emira Model Range      **Affected Regions:** All Regions      **Affected Volume:** N/A      **Number:** 131-26017

Availability of Emira service replacement lower front wishbone ball joint dust covers.

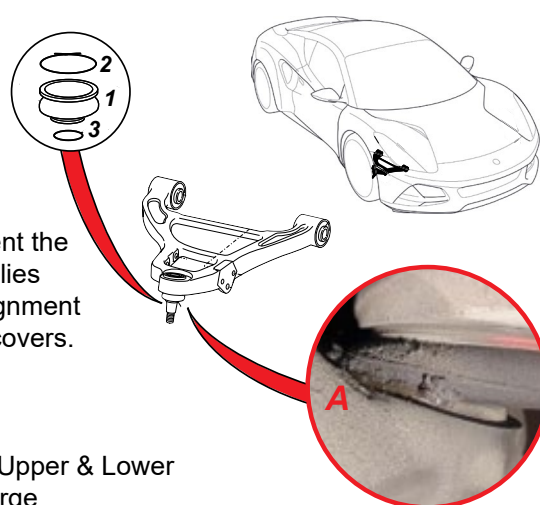
An unfinished rough edge **(A)**, on the steering knuckle assemblies (hub carriers), can, under full suspension/steering movement, contact the lower wishbone ball joint dust cover **(1)**, resulting in premature wear or damage to the dust cover.

If damage to the ball joint dust cover as shown above is seen during an underbody inspection (such as routine servicing etc), but the ball joint is still in a serviceable condition, then the rough edge of the steering knuckle casting should be smoothed and the ball joint dust cover replaced.
