## WTG2 – Update to Software Package VR28.13 SQ5 (Workshop Campaign)

| Model Year: | <b>As of 2024 up to 2026</b> |
| Model Line: | <b>Macan Electric (XAB)</b> |
| Concerns: | <b>Software update (software package VR28.13 SQ5)</b> |

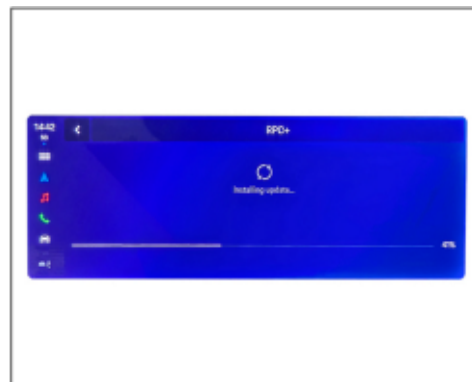
Update progress on central display
