## Y1A, Y1B, Y1C- High-Voltage (HV) Battery Measurements during HV Battery Repair

**Bulletin #: 2518.6**

### Condition

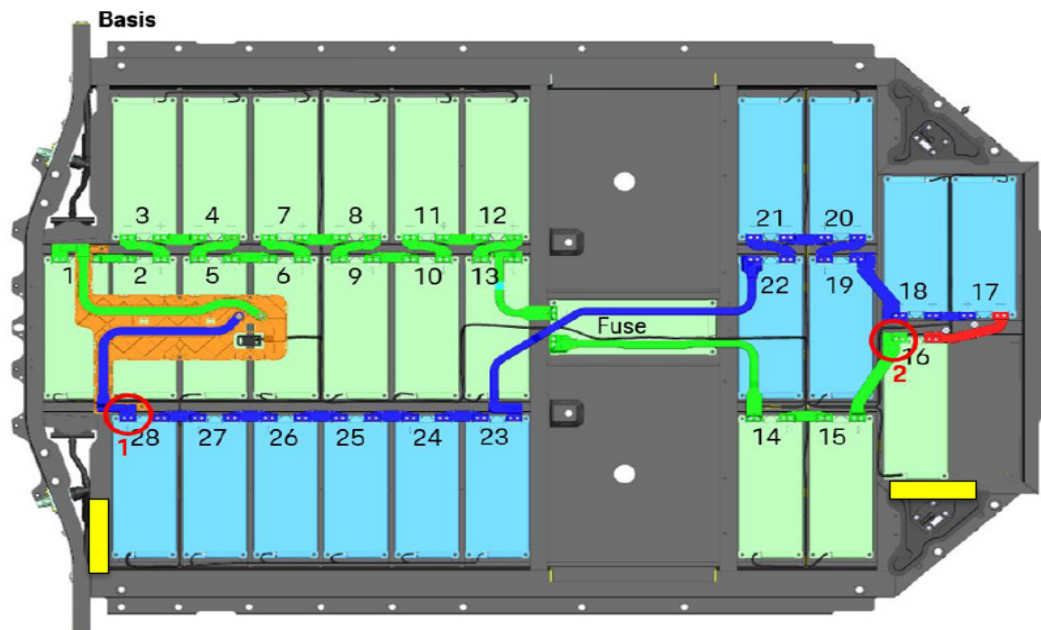
**Figure 1** - 28-module HV Battery measurement points

- Only two DSTs are required on a 28-module battery pack during repair.
- The busbar indicated in red must be removed prior to measurements at either point.

- Perform an IR test at points 1 and 2 before the DST at those points.
- Perform a DST only at points 1 and 2 shown below for each repair scope.
- The yellow boxes in *Figure 1* designate the sections of frame where a lid screw can be hand-started to ground the dielectric strength tester.

- Also perform IR tests at points 1 and 2 after a DST, with the negative probe in contact with a clean spot on the silver frame surface designated by the yellow boxes.

- If the final IR test (IR2) at **measurement point 1** fails, remove busbars and CMC connections from each module shaded in **light blue** for further IR testing as described in the following *Updated IR Measurement Procedure* sections.

- If the final IR test (IR2) at **measurement point 2** fails, remove busbars and CMC connections from each module shaded in **light green** module for further IR testing as described in the following *Updated IR Measurement Procedure* sections.

- EXAMPLE: Point 1 passes DST and IR2 while point 2 passes DST but fails IR2.
  - Perform IR tests on each light green module in the failing section (In this example, section 2). No additional work is required for the passing modules in section 1.

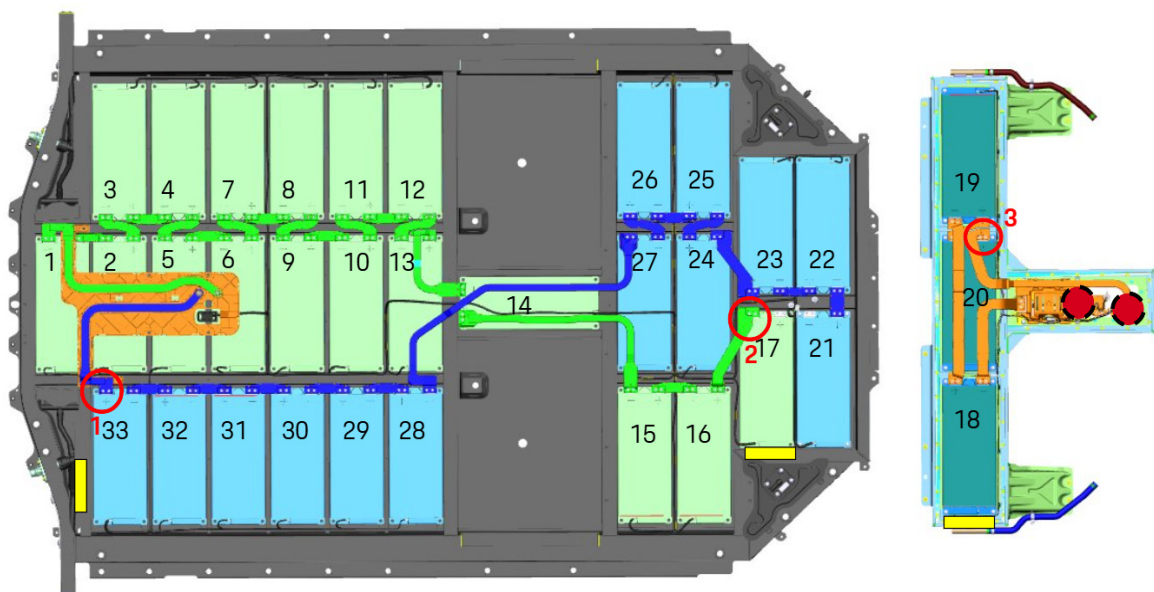
**Figure 3 - 33-module HV Battery measurement points**

- Only three DST's are required on the 33-module battery pack during repair.
  - Perform a DST at points 1, 2, and 3 for any repair scope involving the lower-level modules.

- Repair scopes in only the upper "T" section require an initial DST at the mid-pack fuse as shown in step 3.9.3 of Safety test after assembly work on the high-voltage battery with 33 modules in WM 270803A5 instead of point 3 in *Figure 3*.

- The yellow boxes in *Figure 3* designate the section of frame where a lid screw can be hand-started to ground the dielectric strength tester. If performing a DST on the mid-pack fuse, use the location on the upper "T" section to ground the negative clamp as described in the General DST Procedure Updates section.

- Perform IR tests at points 1, 2, and 3 after a DST, with the negative probe in contact with a clean spot on the silver frame surface designated by the yellow boxes.

- If the final IR test at **measurement point 1** fails, remove busbars and CMC connections from each module shaded in **light blue** for further IR testing as described in the following *Updated IR Measurement Procedure* sections.

- If the final IR test at **measurement point 2** fails, remove busbars and CMC connections from each module shaded in **light green** for further IR testing as described in the following *Updated IR Measurement Procedure* sections.

- If the final IR test at **measurement point 3** fails, remove busbars and CMC connections from each module **in the upper "T" section** for further IR testing as described in the following *Updated IR Measurement Procedure* sections.

- **EXAMPLE:** It is possible for battery to have point 1 pass, point 2 pass, and point 3 fail the IR2 measurement. It would then only be required to perform further IR tests on each module in the upper "T" section. No additional work would be required for the passing lower sections.

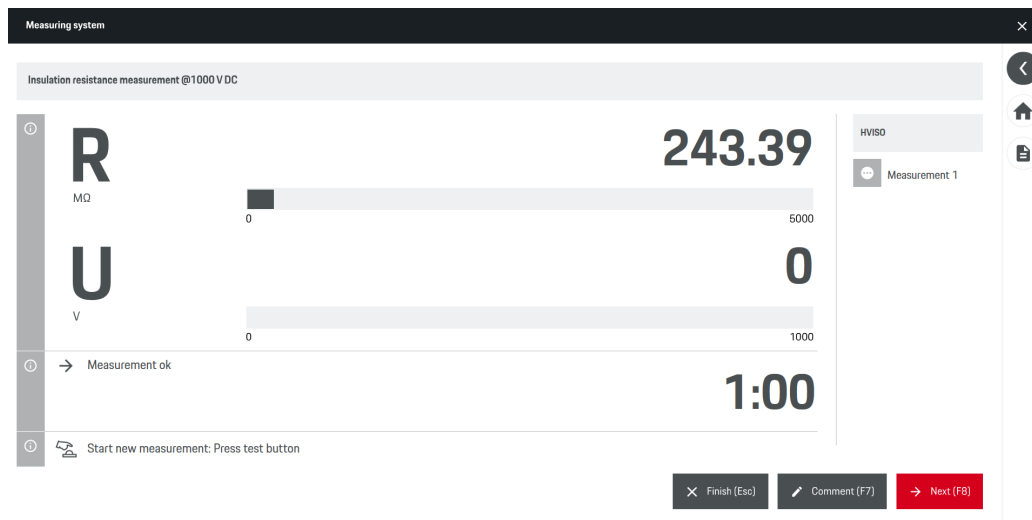
**Figure 7** - Insulation resistance measurement in PIWIS Tester

- Shown below is an example of passing test result for section 1 or 2 after 60 seconds of measuring time. This reading can still be displayed as >5000 MΩ when IR measures above the internal software measuring threshold.
- If any individual module terminal IR test shows a number below 2000 MΩ after 60 seconds of continuous measuring time, this is considered a failure.
  - If more than 5 modules in a failing section measure below 2000 MΩ, submit the completed Taycan HV Battery Insulation Resistance Template to Technical Support via PRMS.
- If IR is below the minimum measurement threshold, the IR test won't complete in the measurement equipment display. If the IR test fails to produce a value after multiple attempts on any module terminal, replace it.
- Document any failures in the "Taycan HV Battery Insulation Resistance Template" Excel file attachment and attach to the repair PCSS entry.
