Technical Service Bulletin: TSB260092

Alternate Viscous Damper Inspection Procedure

- B6.7 CM2450 B155B

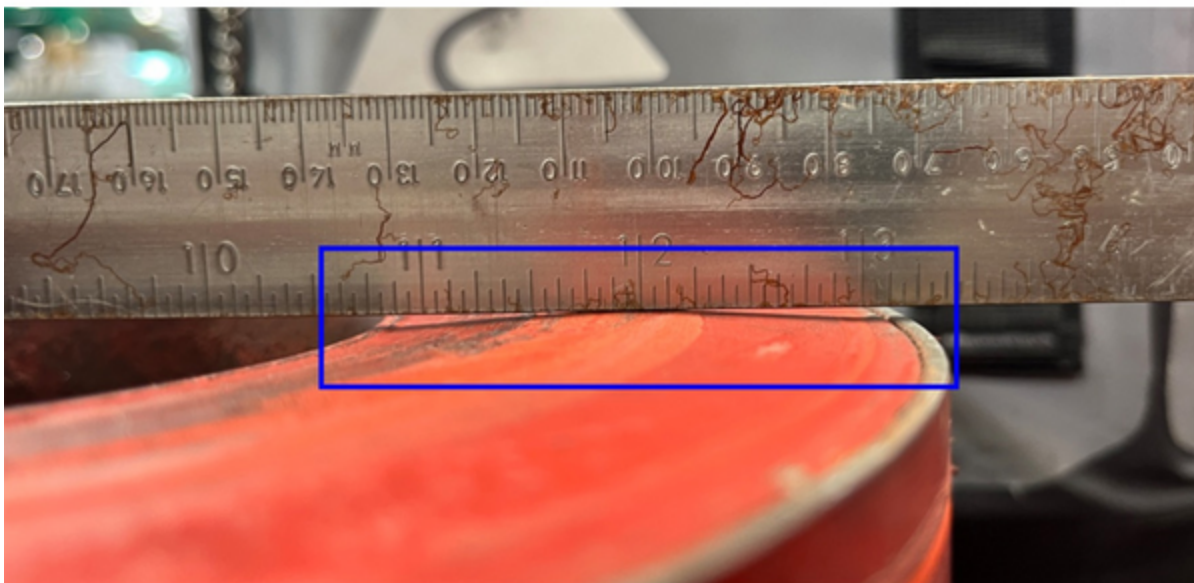
17r02712

The viscous vibration damper is filled with a silicon fluid. In some cases, the fluid can become thicker and expand, bulging the viscous vibration damper.

Figure 1, Example of a malfunctioning viscous vibration damper

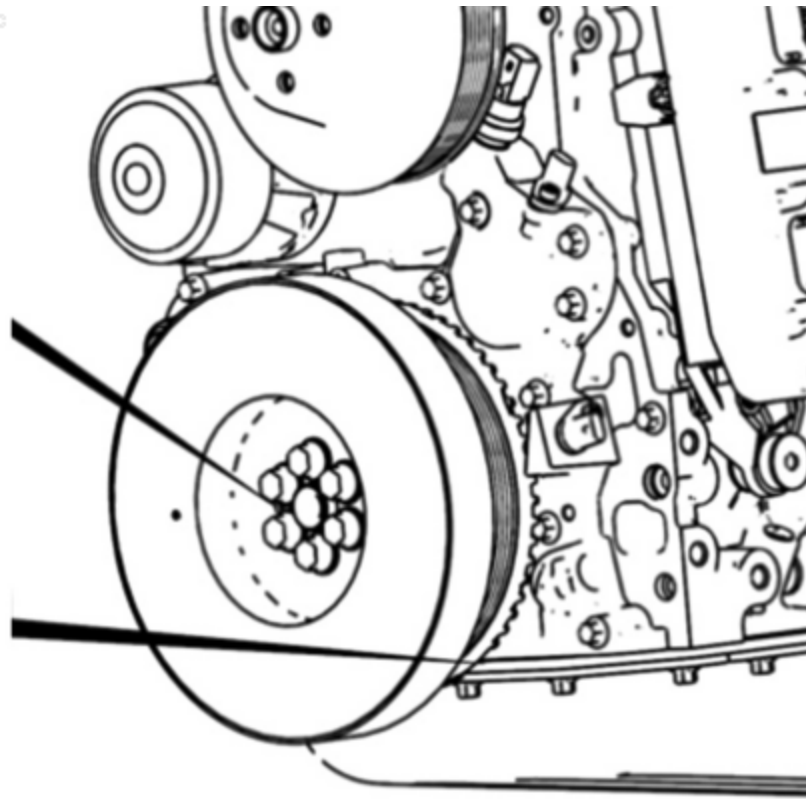
17r02713

Figure 2, Visual mounting hardware check

Visually check for loose or missing mounting hardware. If loose or missing hardware is found, see Technical Service Bulletin, Repeat Viscous Vibration Damper Capscrew Fracture Malfunctions and Viscous Vibration Damper Replacement, TSB210097, to replace the viscous vibration damper and mounting hardware.

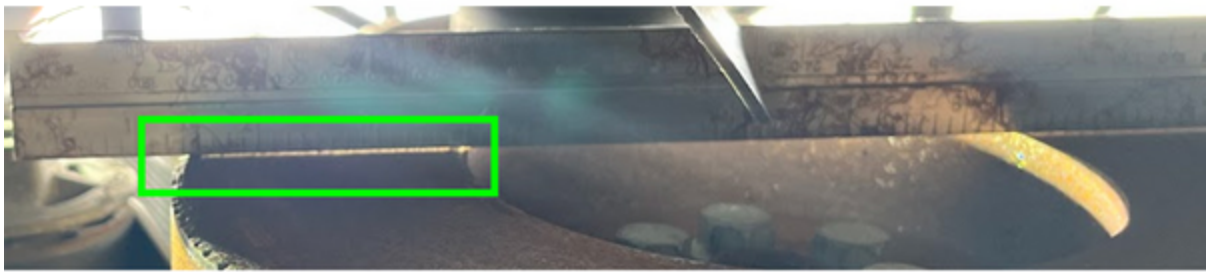
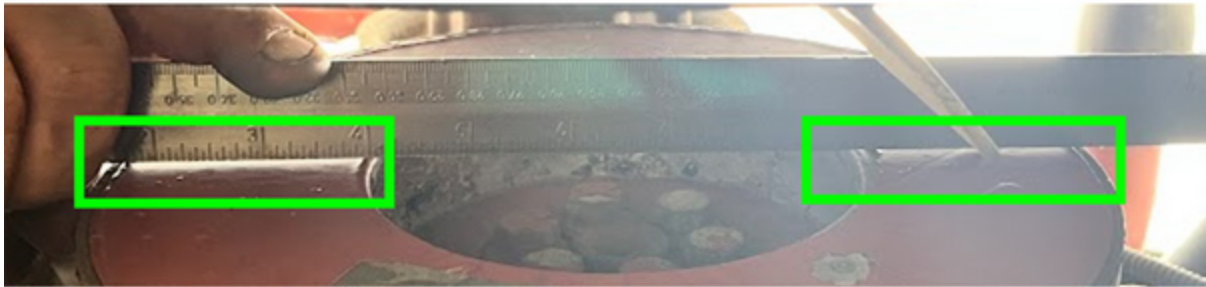
17r02715

Figure 4, Example of good damper - light can be seen across the entire damper face on both sides

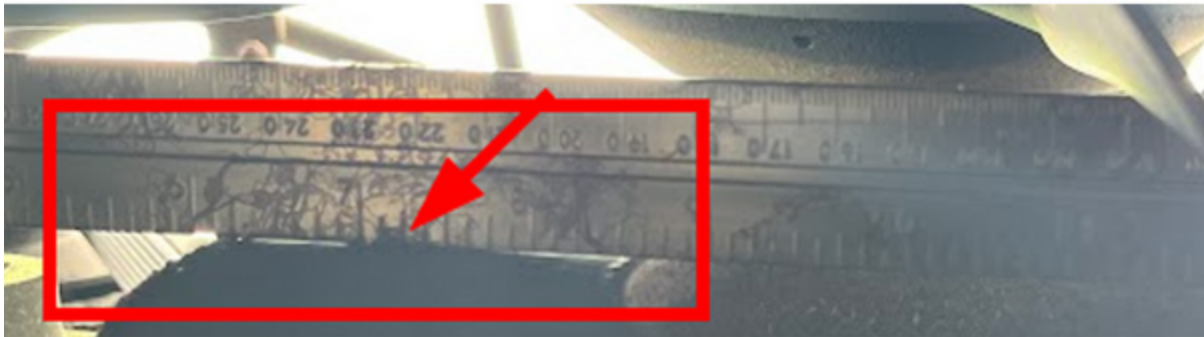
17r02716

Figure 5, Example of damper bulging - replacement is required

If bulging is identified as in Figure 5 or Figure 6, see Technical Service Bulletin, Repeat Viscous Vibration Damper Capscrew Fracture Malfunctions and Viscous Vibration Damper Replacement, TSB210097, to replace the damper and mounting hardware.

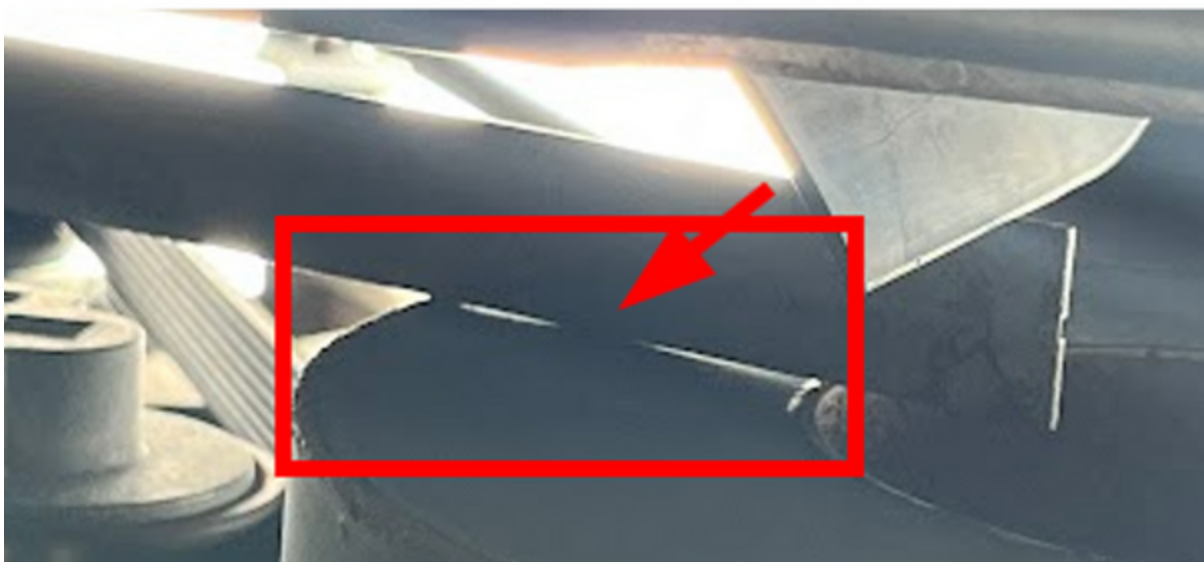
17r02717

Figure 6, Example of damper bulging - replacement is required
