Technical Service Bulletin: TSB260076

Pack Management Unit Fault Codes

- BES CM0904 EV104B
- BES CM2450 EV105B
- BES CM2450 EV107B

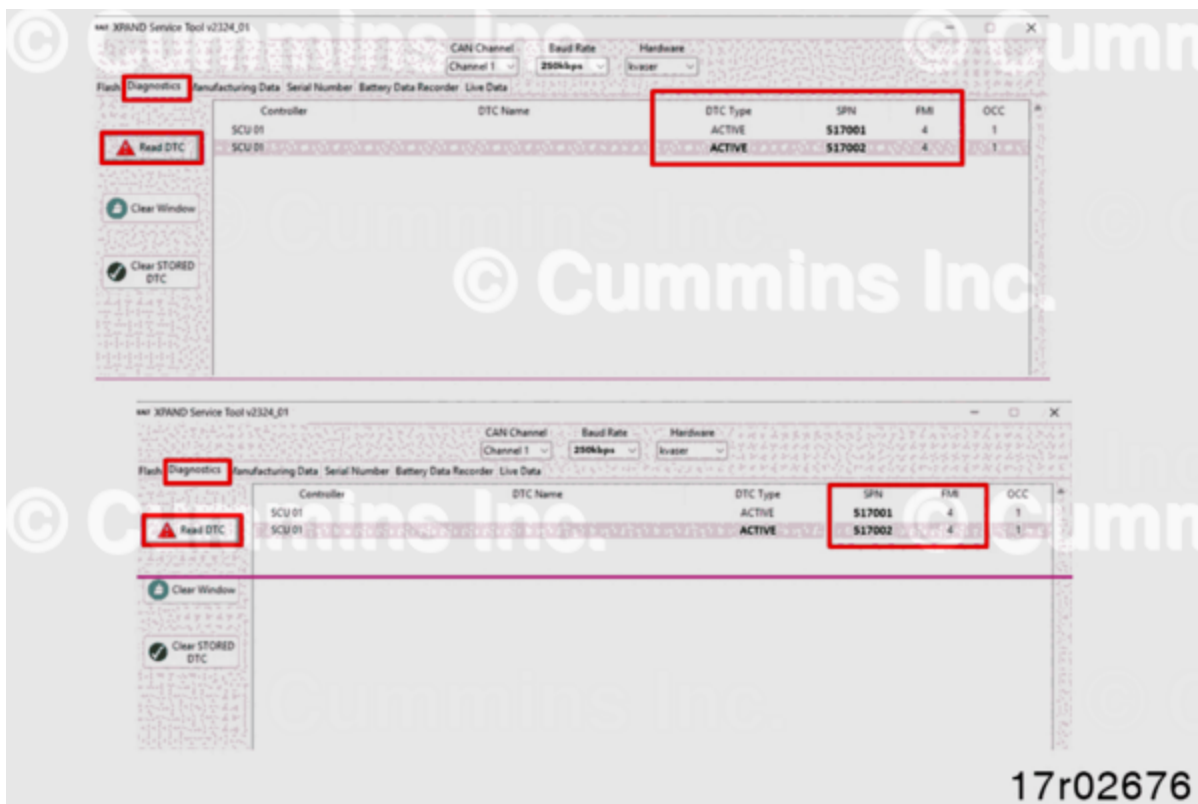
Figure 3, XPAND Service Tool Diagnostics

- Read diagnostic trouble codes from XPAND service tool
  - Select 'Diagnostics' from the top left application bar.
  - Select 'Read DTC' from application bar
  - Check if the following DTCs are ACTIVE or Permanent
    - SPN 517001 FMI 3, 4, 24, or 25
    - SPN 517002 FMI 3, 4, 24, or 25
  - See Figure 3.

- If any of the fault codes listed above are ACTIVE or Permanent, proceed to Resolution section.
- If none of the fault codes listed above are ACTIVE or Permanent, continue with published troubleshooting.

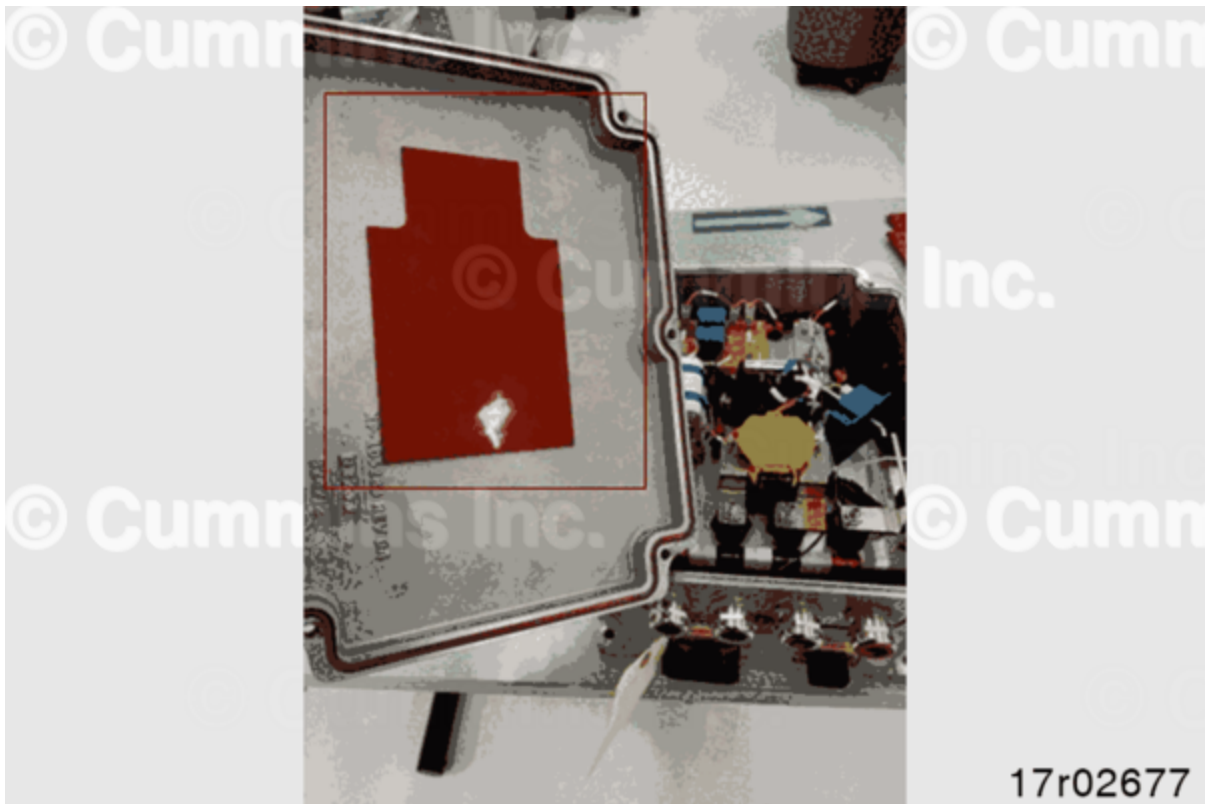
Figure 4, Adhesive pad provided (Part Number ESC 102912) applied on the back of the Pack management unit lid

- Remove pack management unit lid.
  - Refer to published procedure in Service Suite under
    - Energy Storage
    - Electronic Controls
    - Pack Management Unit
      - Disassemble and Assemble
- Inspect contactor low-voltage wiring insulation. If any of the following conditions are found, repair as necessary:
  - Breaks
  - Cuts
  - Damage caused by contact with pack management unit lid
- Email ServiceEngineering.Parts@cummins.com to request repair kit.
  - Repair kit will be provided at no cost .
- Install repair kit.
  - Apply adhesive pad, Part Number ESC102912, to back of pack management unit lid. See Figure 4.

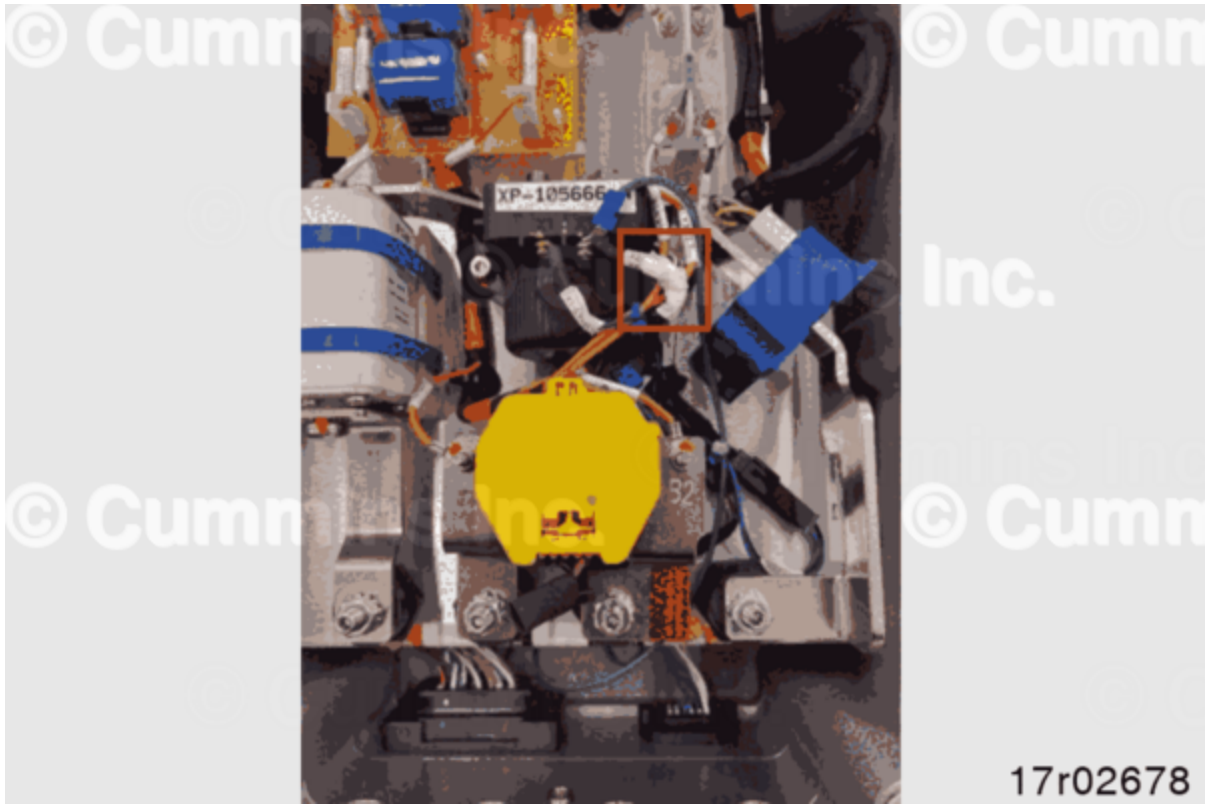
Figure 5, Electrical tape applied on contactor low voltage wiring harness

- Apply electrical tape to contactor low-voltage harness. See Figure 5.
