## Technical Service Bulletin

Transaction No.: 2078397/5

01-25-04 - DTC P0456 Software Update and Hardware Check

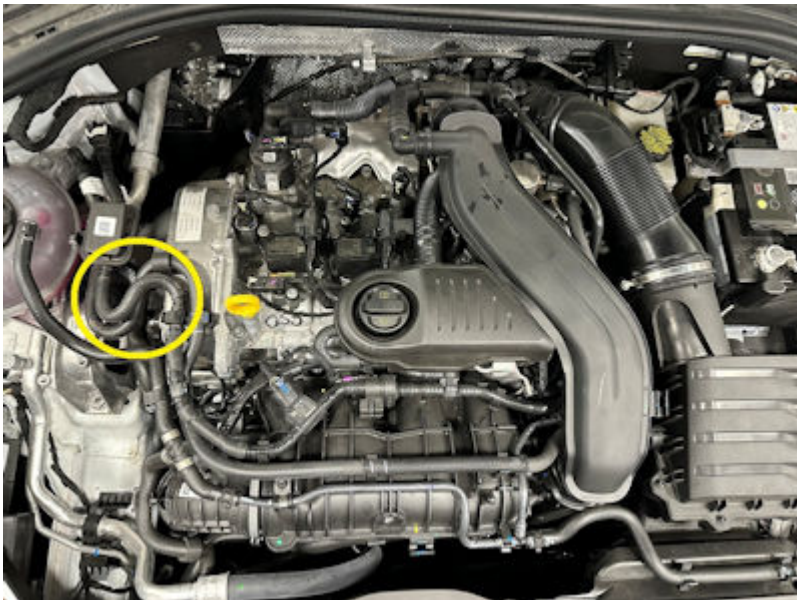
**Figure 1:**

Focus special attention to the area circled in Figure 1.

**STEP 4: Inspect, and if necessary, replace purge line with -N80-**

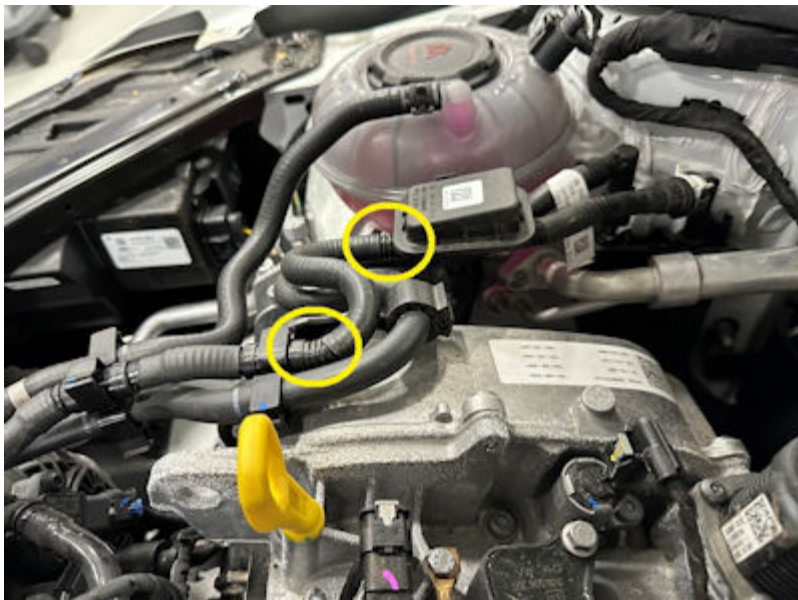
**Figure 2:**

Figure 2 highlights two sections of the purge line from figure 1 that are prone to cracking.

If a leak is found from the corrugated purge line (shown above) remove and replace the component.
