## Technical Service Bulletin

Transaction No.: 2079645/3

01-25-06 - Misfire Due To Excess Intake Flashing

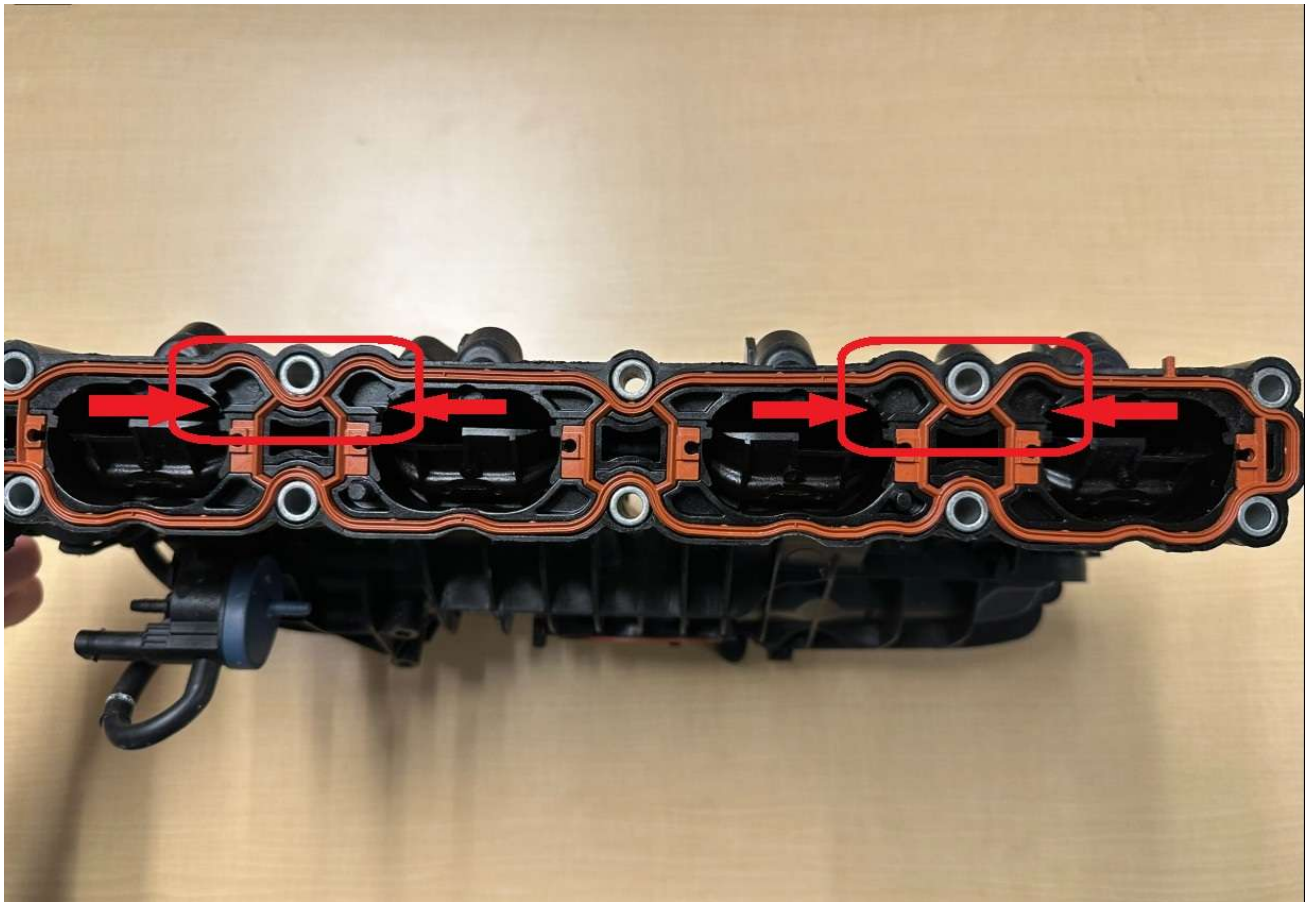
**Figure 1:**

1. Remove the intake manifold per the steps outlined in the repair manual.
2. Inspect the 4 intake ports for excess flashing in the areas circled in red below in figure 1.

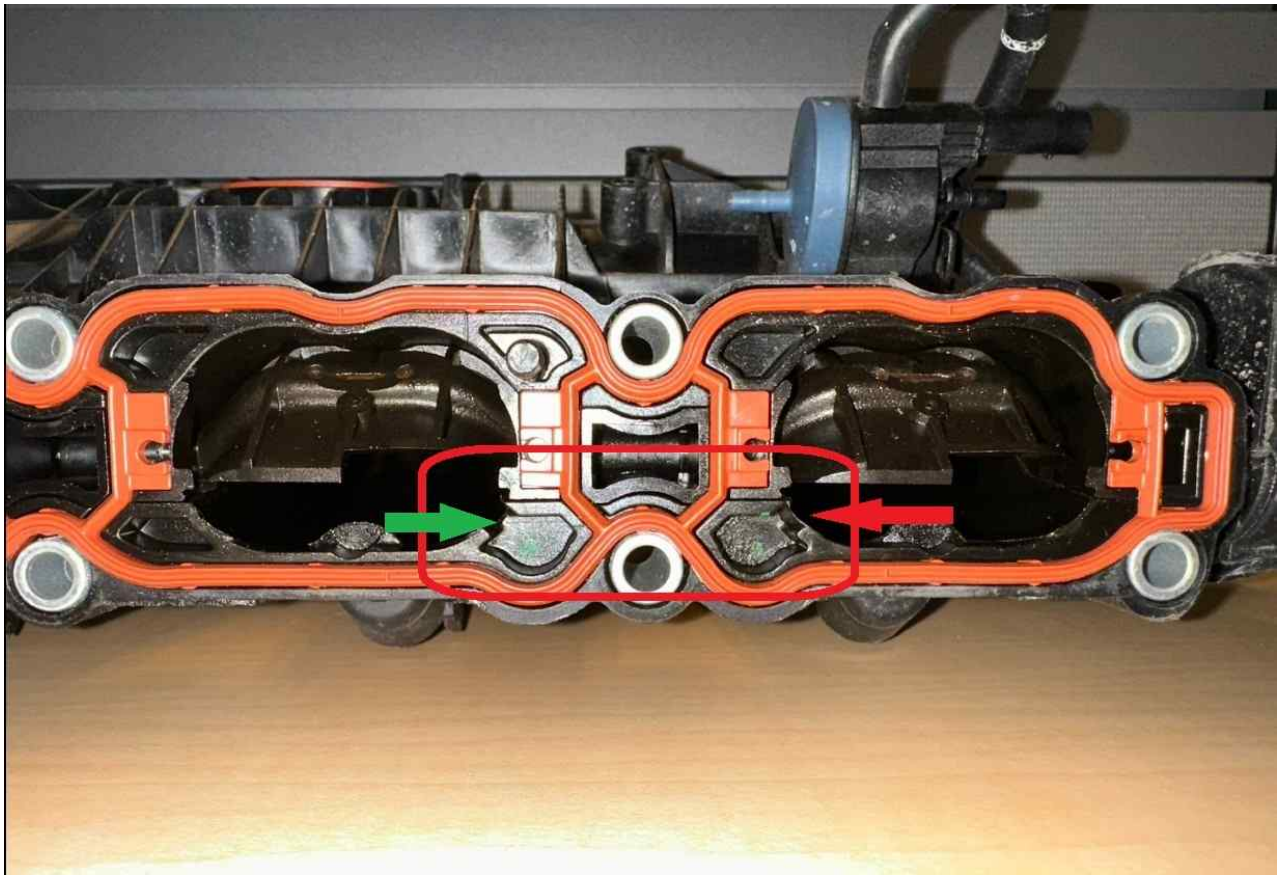
**Figure 2:**

In figure 2 below, the green arrow shows an intake port without excess flashing, and the red arrow shows an intake port with excess flashing.

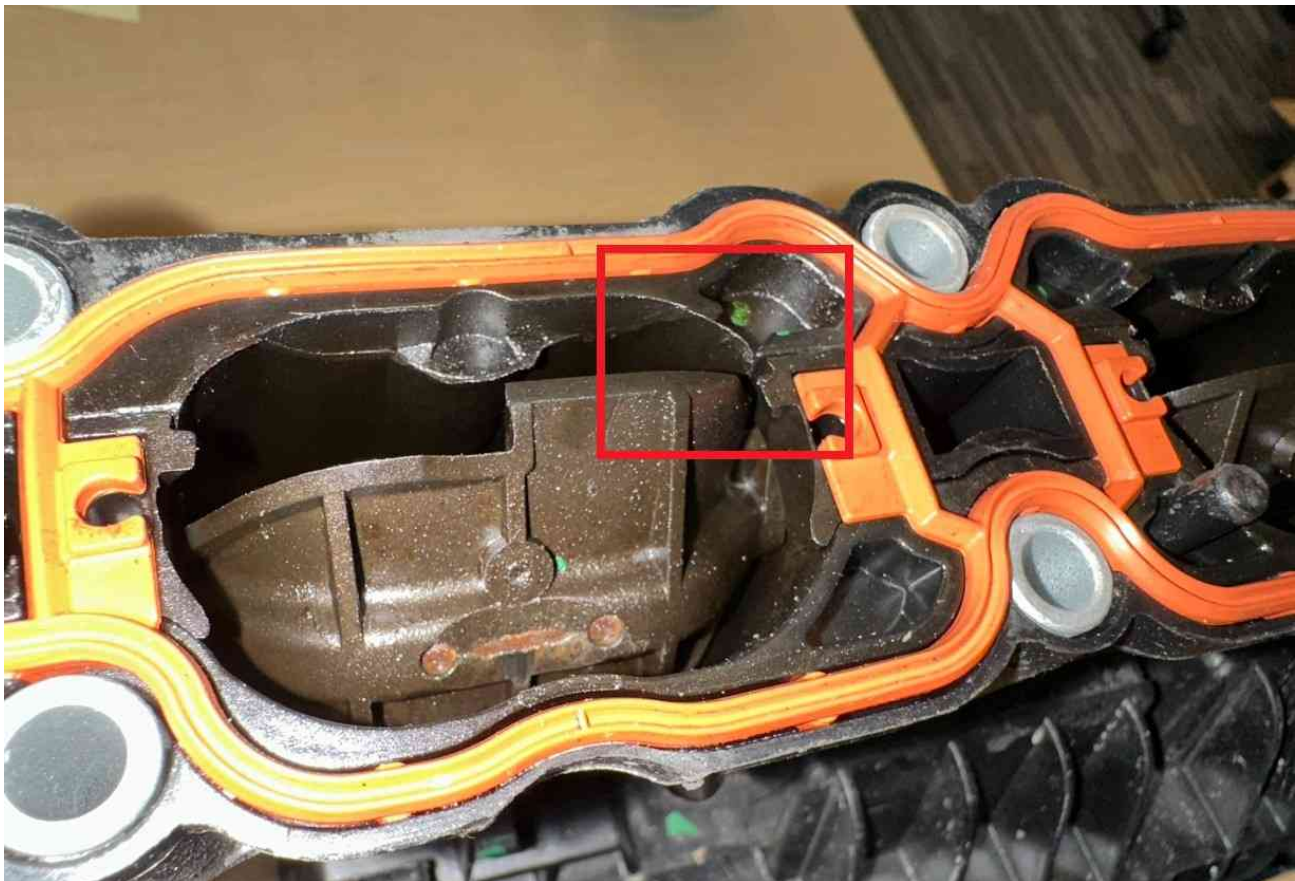
**Figure 3:**

3. If excess flashing is found blocking the intake manifold port, rework of the intake manifold will be required. See figure 3 below for another example.

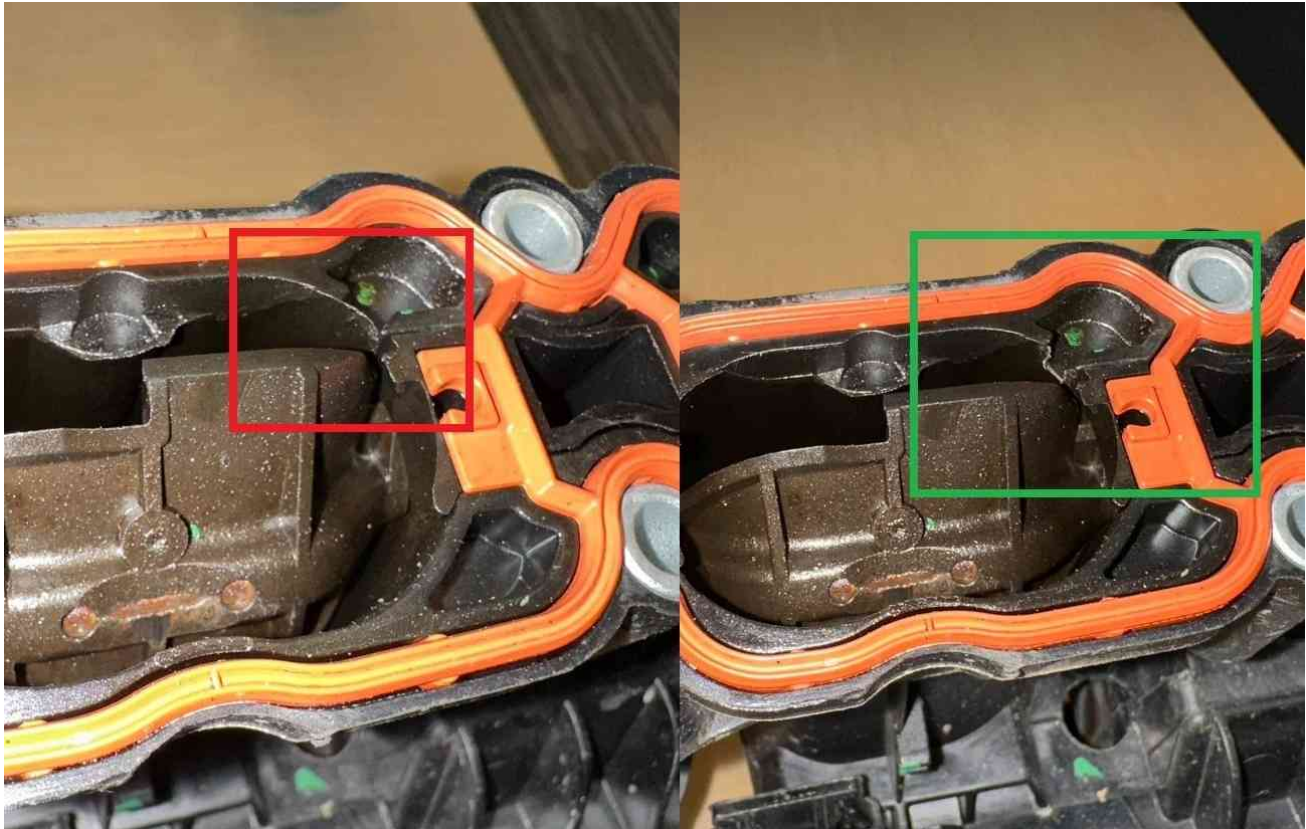
**Figure 7:**

Figure 7 below shows an example of the intake port before and after the rework procedure.
