## Technical Service Bulletin

Transaction No.: 2082009/2

21-26-02 - Oil Leak From Turbocharger Air Inlet Elbow

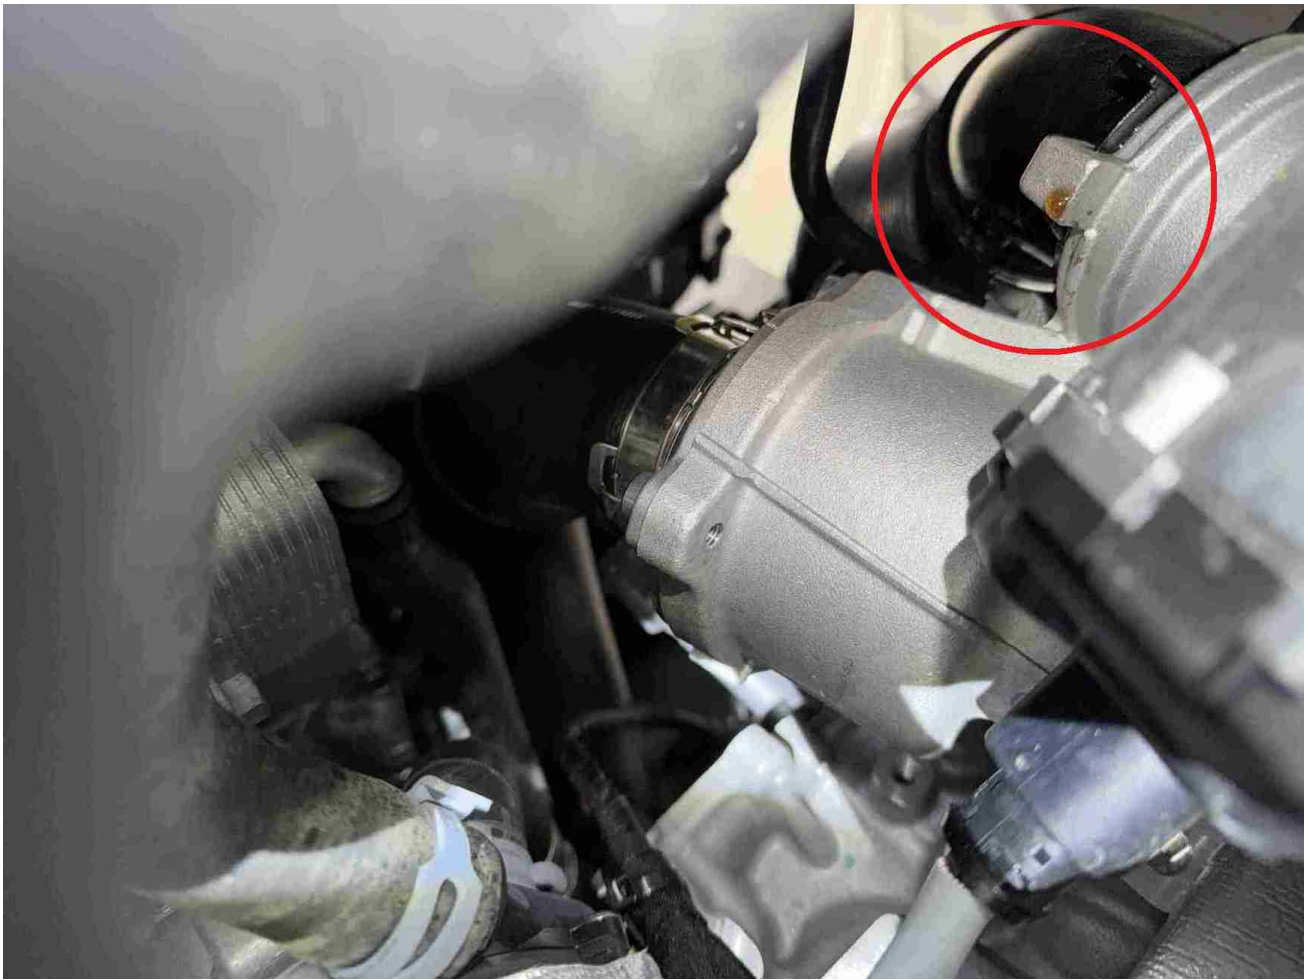
Figure 1

Oil condensate may collect and settle in the turbocharger air inlet tubing, resulting in a possible drip at the inlet air elbow.

Verify the leak is coming from the turbocharger air inlet elbow. If the leak is from another component in the engine bay, this TSB is not applicable. See Figures 1 and 2 for examples.
