## Technical Service Bulletin

Transaction No.: 2079347/2

39-25-01 - Bevel Box Oil Leaks

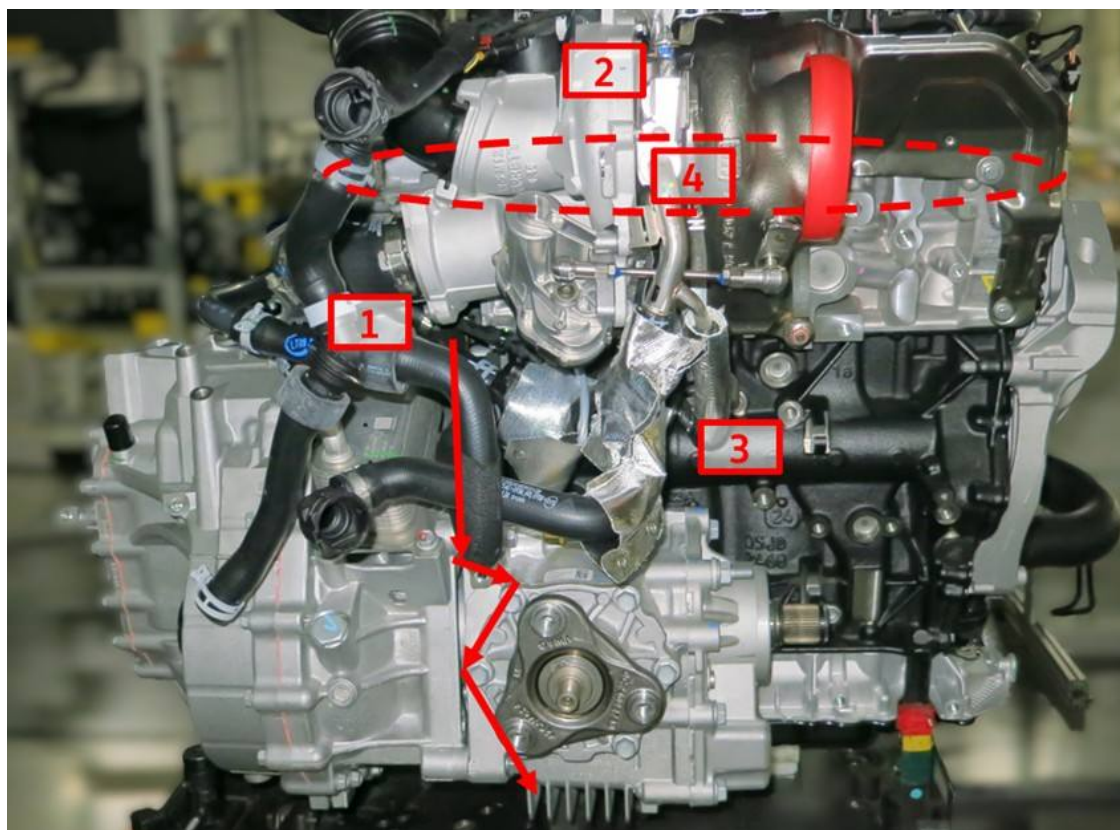
Listed below are known areas of motor oil leakage illustrated on Figure 1:

| # | Location | Possible Cause |
| 1 | Turbocharger Inlet Pipe | Oil condensate build-up |
| 2 | Turbocharger Oil Supply Line | O-ring damaged |
| 3 | Turbocharger Oil Return Line | O-ring damaged |
| 4 | Cylinder Head Cover | Loose fasteners |

If the source of the leak is unclear, cleaning the area and using UV dye in the engine oil may assist in identifying the origin.

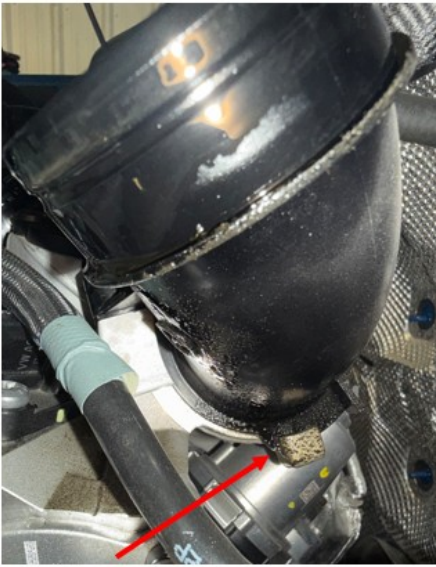
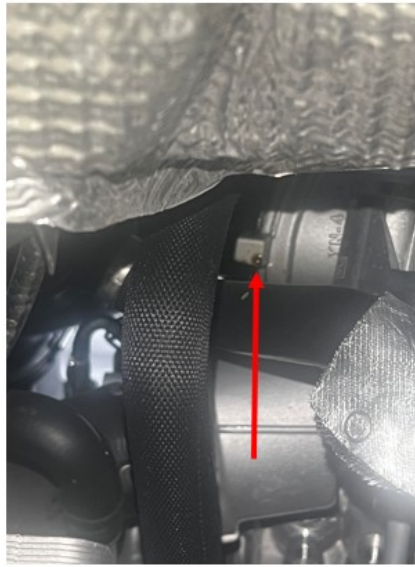
1. Motor Oil Leak/Drip from Turbocharger Inlet Pipe – Oil condensate build-up in inlet tube – See TSB 2082009 for repair information.

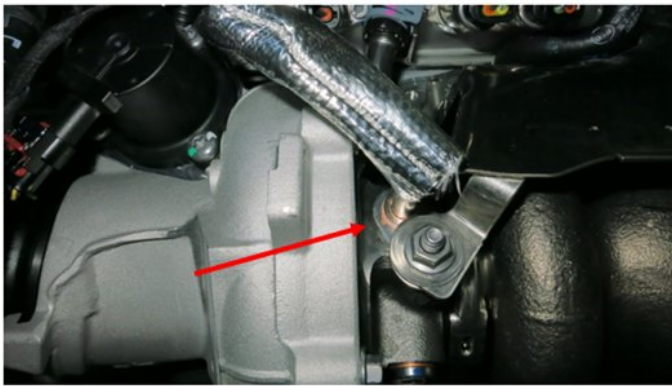
**Supply line**

**2 & 3. Motor Oil Leak/Drip from Turbocharger Oil Supply/Return Lines – Damaged O-rings**

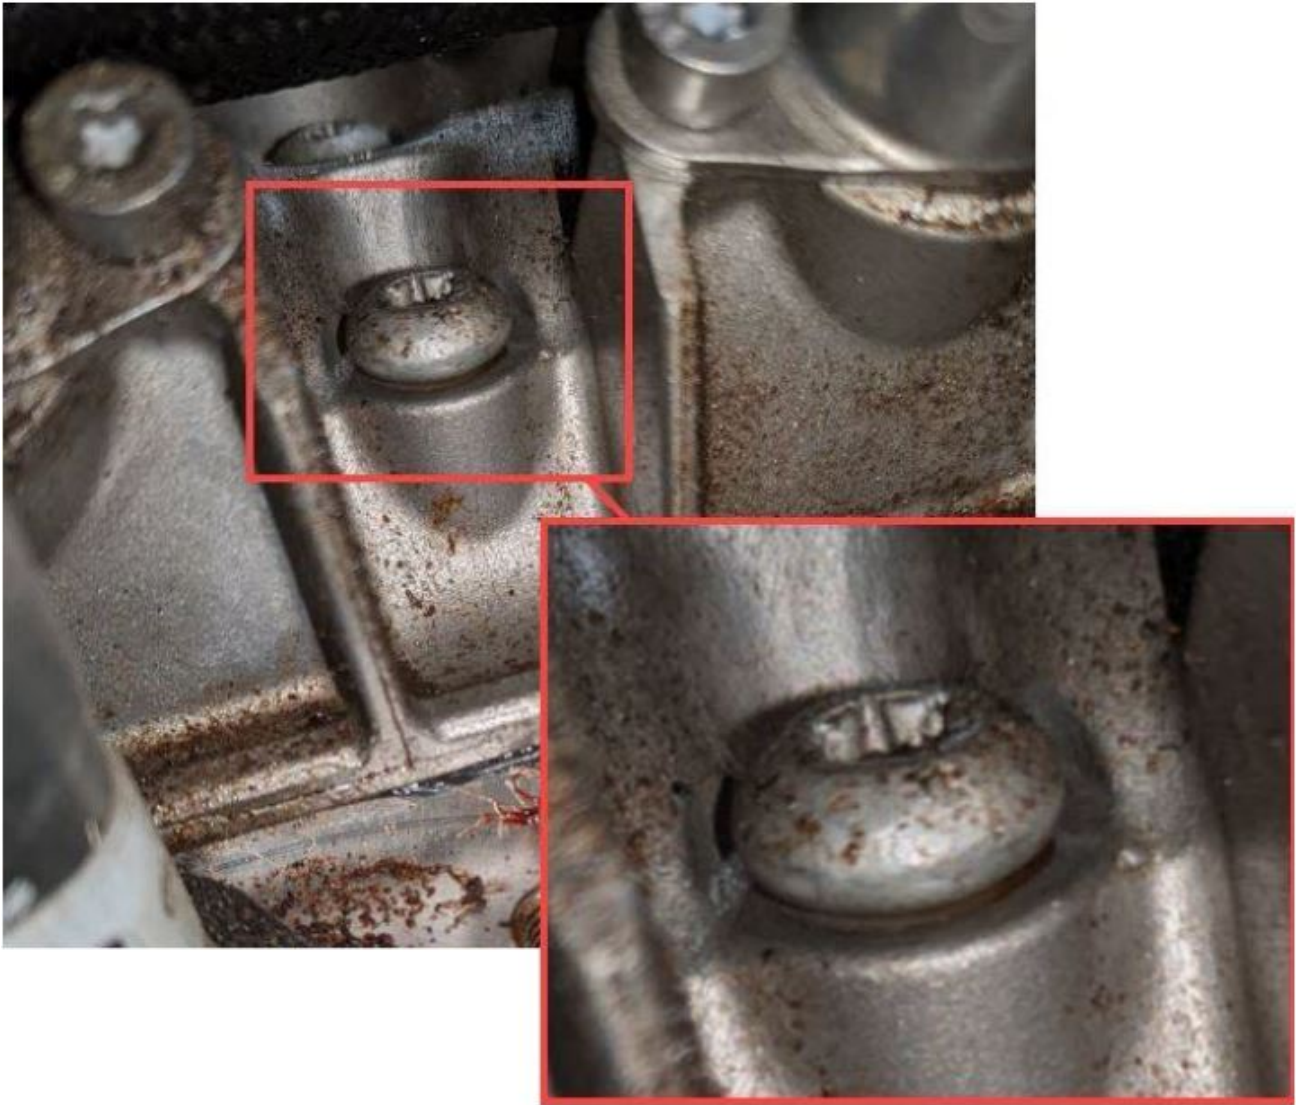
**4. Motor Oil Leak/Drip from Cylinder Head Cover – Loose Fasteners**

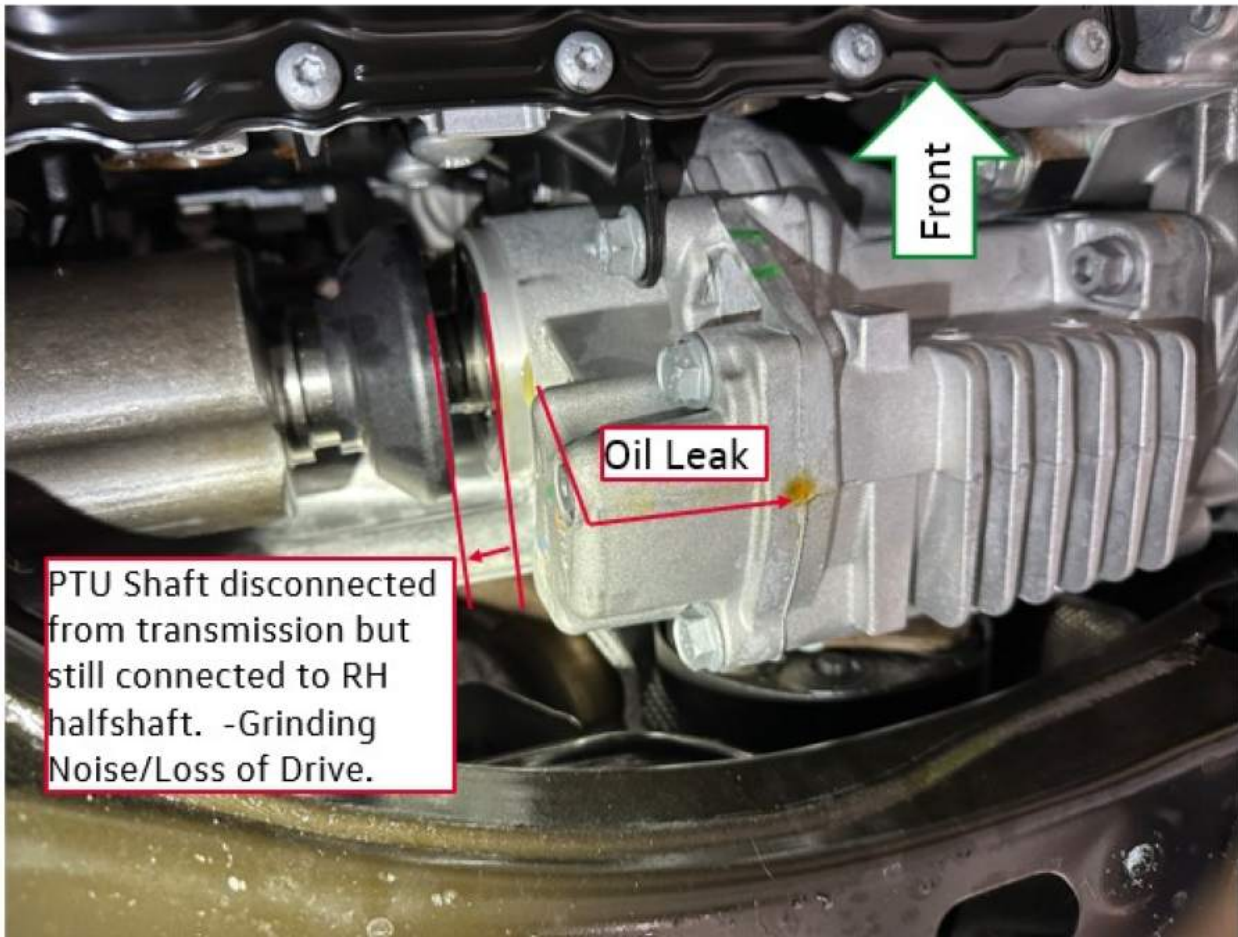
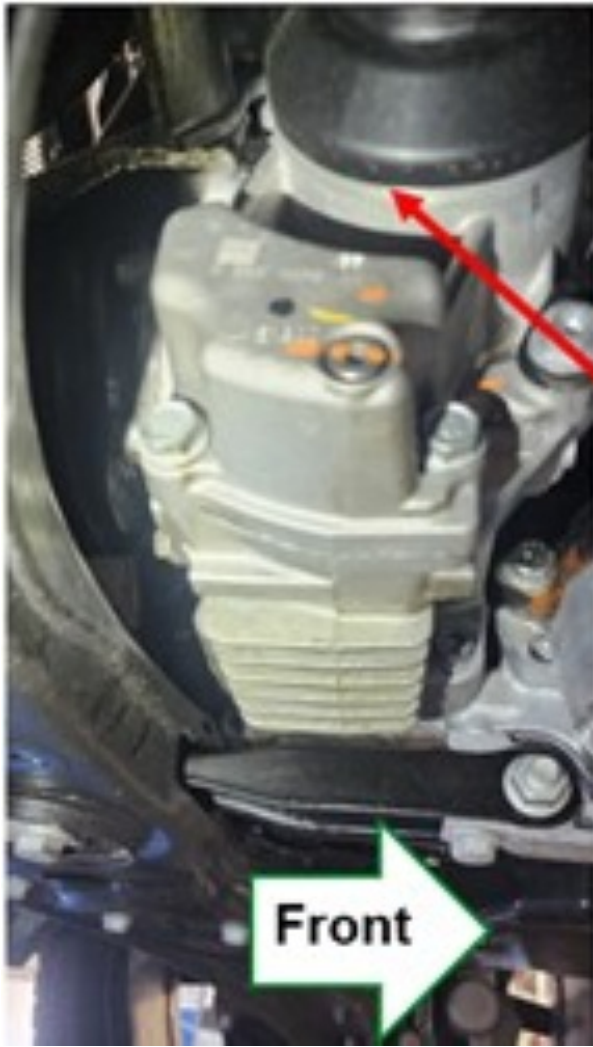
Gear oil may leak from the Bevel Box if the link shaft is not properly clipped or is out of position.

1. Leakage from the passenger side of the Bevel Box can occur when the link shaft circlip is not fully seated in the grooves of the transmission side gear.
2. In some cases, the circlip may be missing entirely.
3. If this condition appears to be present, inspection of the Bevel Box may help confirm whether the circlip is properly seated or missing.
4. If the circlip is missing, verify that it is still not lodged in the transmission side gear. This condition may be documented with photographs. Bevel Box replacement may be considered depending on findings.
5. It may also be useful to inspect the splines on the transmission side gear for signs of damage.

**Note:** Any grease found in this area is not a sign of a leak. Occasionally, grease from the splines can work its way out of the shroud as the shaft turns.
