## Technical Service Bulletin

Transaction No.: **2059528/19**

91 ConBox High: Emergency call (SOS) fault/LED red, with DTC B200000

Release date: Jun 1, 2026

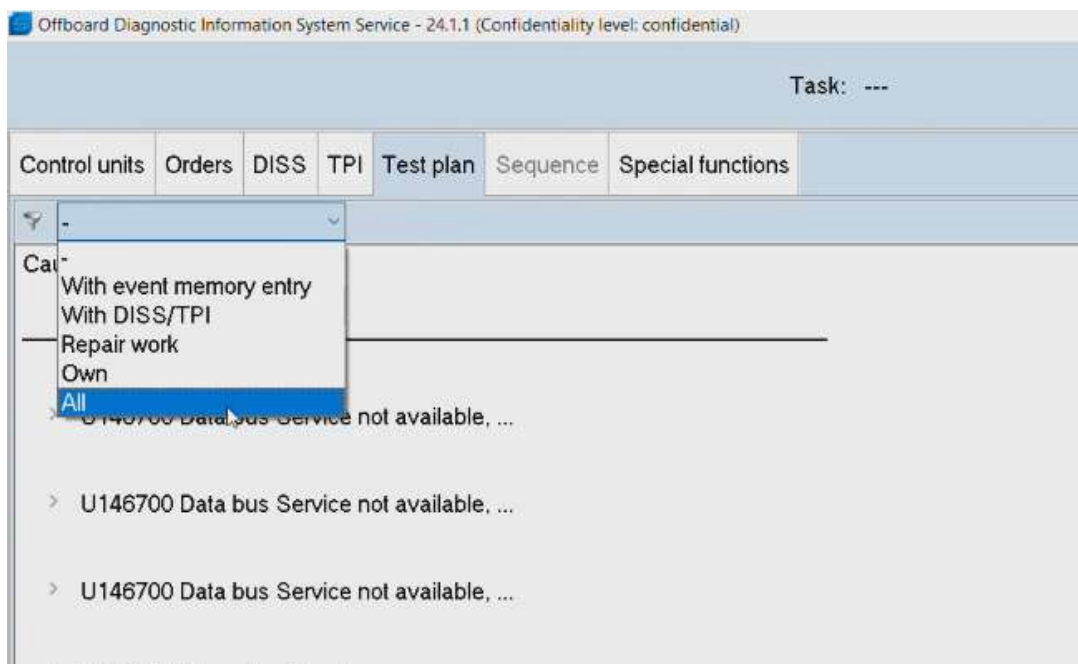
**If the following test program is not automatically entered in the test plan, the test plan filter can be changed from “Standard” to “All”. The test program will then appear and can be used (Figure 2).**

**Figure 2.** ODIS test plan filter.

1. From the test plan, perform program “J949 – Control Module for Emergency Call Module and Communication Unit, check control module”. The program is automatically added as part of the test plan due to DTC “**B200000**: Control module faulty” being logged. You can also find the function under the following path in ODIS: *Self-test >> Diagnostic capable systems >> 0075 – Control Module for Emergency Call Module and Communication Unit -J949- >> 0075 – Electrical components >> Control Module for Emergency Call Module and Communication Unit, check control module*.
2. Then check whether the DTC has been erased, and the message has disappeared from the instrument cluster. If the message is still shown, repeat step 1
