## Condition

| Model(s) | Year(s) | VIN Range | Vehicle Specific Equipment |
|---|---|---|---|
| All Audi vehicles | 2019 – 2026 | All | with Audi virtual cockpit FPK2+ |

| <b>Claim Comment:</b> | As per TSB 2064983/14 | | |

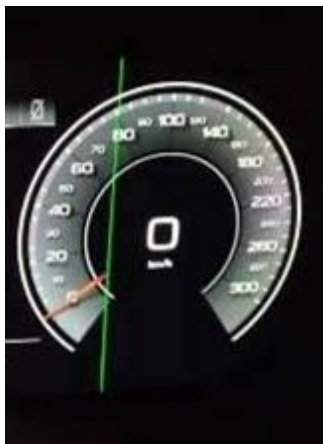
The display of the Audi virtual cockpit shows pixel faults in the form of one or more colored, white, black or grey lines.) (Figures 1-2).

**Figure 1.** The vertical line through the instrument cluster display.

Pixel error in the virtual cockpit.

If the production date read out is **BEFORE** January 01 2026, this TSB applies and the Audi virtual cockpit must be replaced.

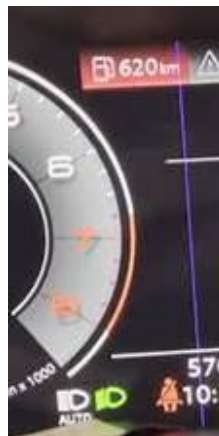
**Figure 2.** The vertical line through the instrument cluster display.
