## Technical Service Bulletin

| Topic | 42 Booming noise from rear area while vehicle is moving (depending on vehicle speed/wheel speed) DTC P18F100 |
| Brand | Audi |
| Transaction No. | 2068250/5 |

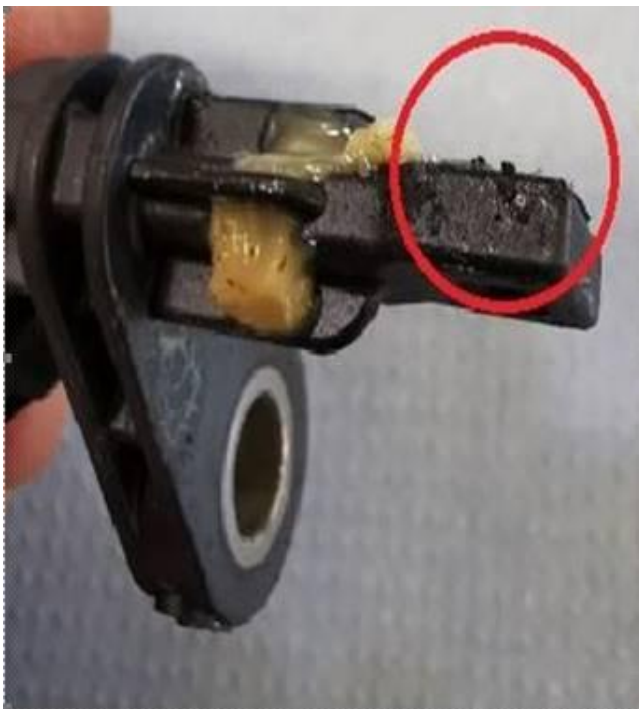
Foreign metallic particles in the area of the wheel speed sensor/wheel hub/wheel bearing/drive shaft (see figure 1, red circle) lead to implausible wheel speed signals.

**Figure 2:** Metallic particles in the speed sensor.

1. Check components for foreign metallic particles.
2. Remove foreign metallic particles, check components for damage, and replace components if necessary.

- **Remove foreign metallic particles:**
- Thoroughly remove foreign metallic particles from the components with workshop materials.

Do **not** use magnetic aids/tools to remove the foreign metallic particles as this could cause secondary damage to the sensor ring in the wheel bearing.

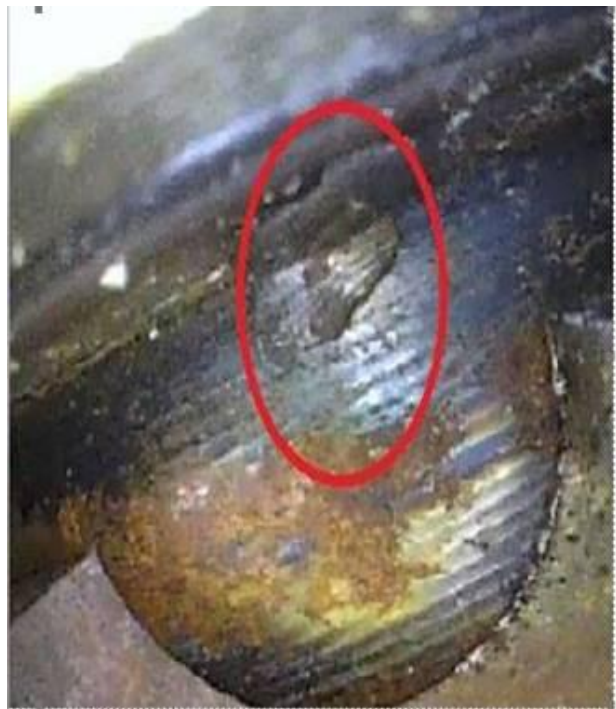
**Figure 3:** Metallic particles in the hub.

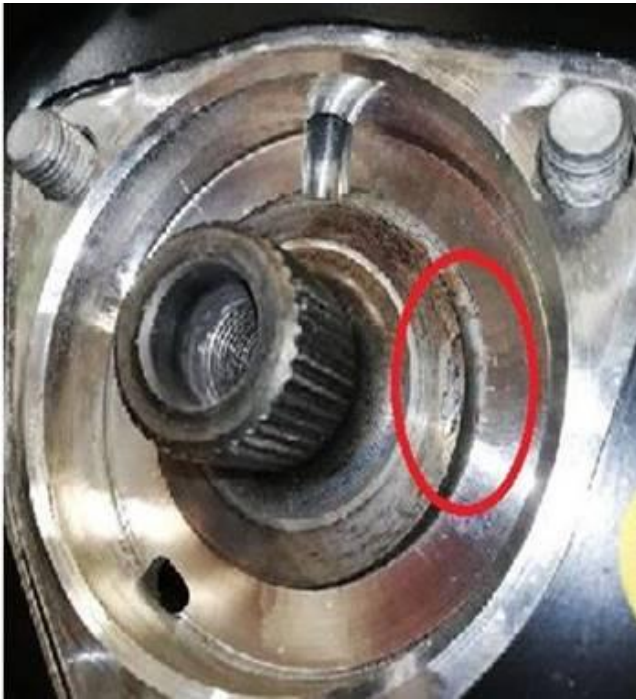
**Figure 4:** Metallic particles/damage in the wheel hub/bearing.

- If there is damage to the components, the corresponding components must be replaced according to ELSA/ETKA.
- Finally, delete the DTCs.

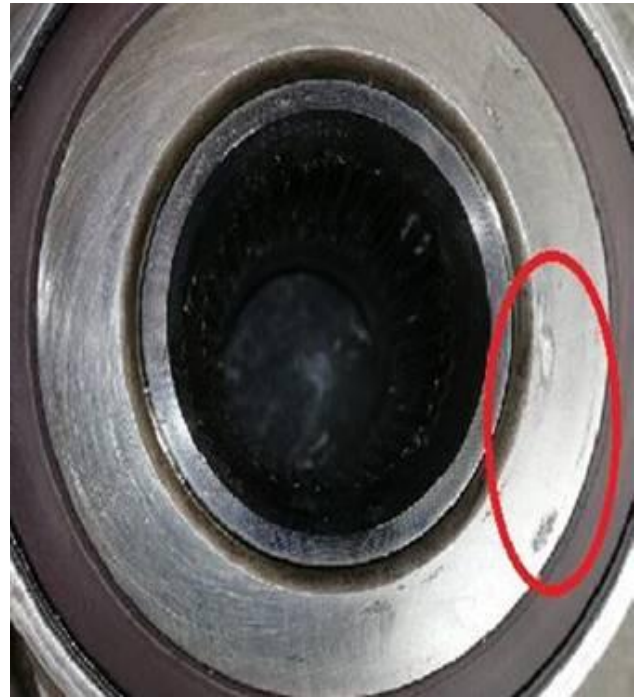
**Figure 5:** Metallic particles/damage in the wheel hub/bearing.
