## Technical Service Bulletin

Transaction No.: **2072473/3**

19 Red Coolant warning lamp comes on; Coolant Leak at Turbocharger

Release date: Jun 11, 2026

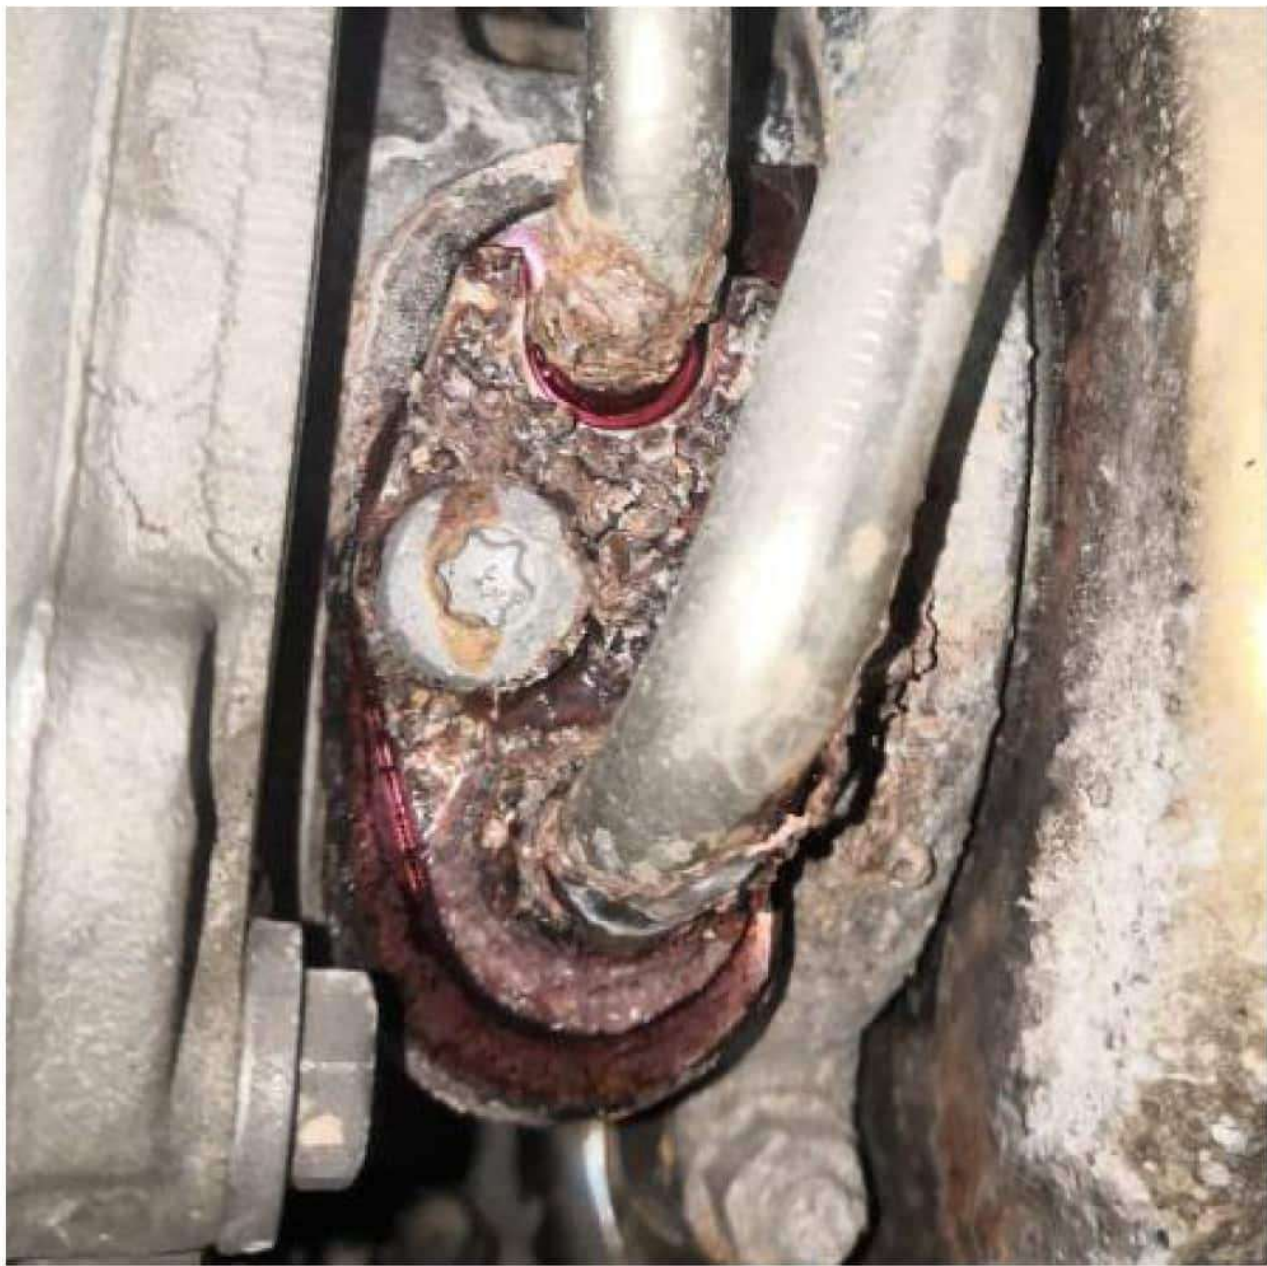
A coolant leak is identified at the return lines to the turbocharger (Figure 1).

**Figure 1.** Coolant leak at the return lines to the turbocharger.

In some model years, After-Run Coolant Pump (V51) start with a slight delay. This can lead to unintended additional heat at O-rings at the return connected to the turbochargers.

- Replace the O-rings at the coolant return lines at the Turbocharger (refer to Figures 2 and 3 or SSP **920493**).
- **Please remove and install the coolant return line according to workshop manual (ELSA) and replace O-rings on the coolant at the crankcase side (Figure 3).**

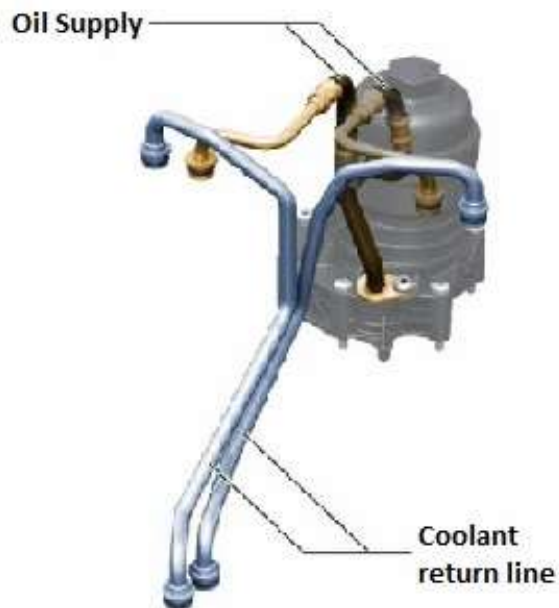
**Figure 2:** Coolant return lines are marked.

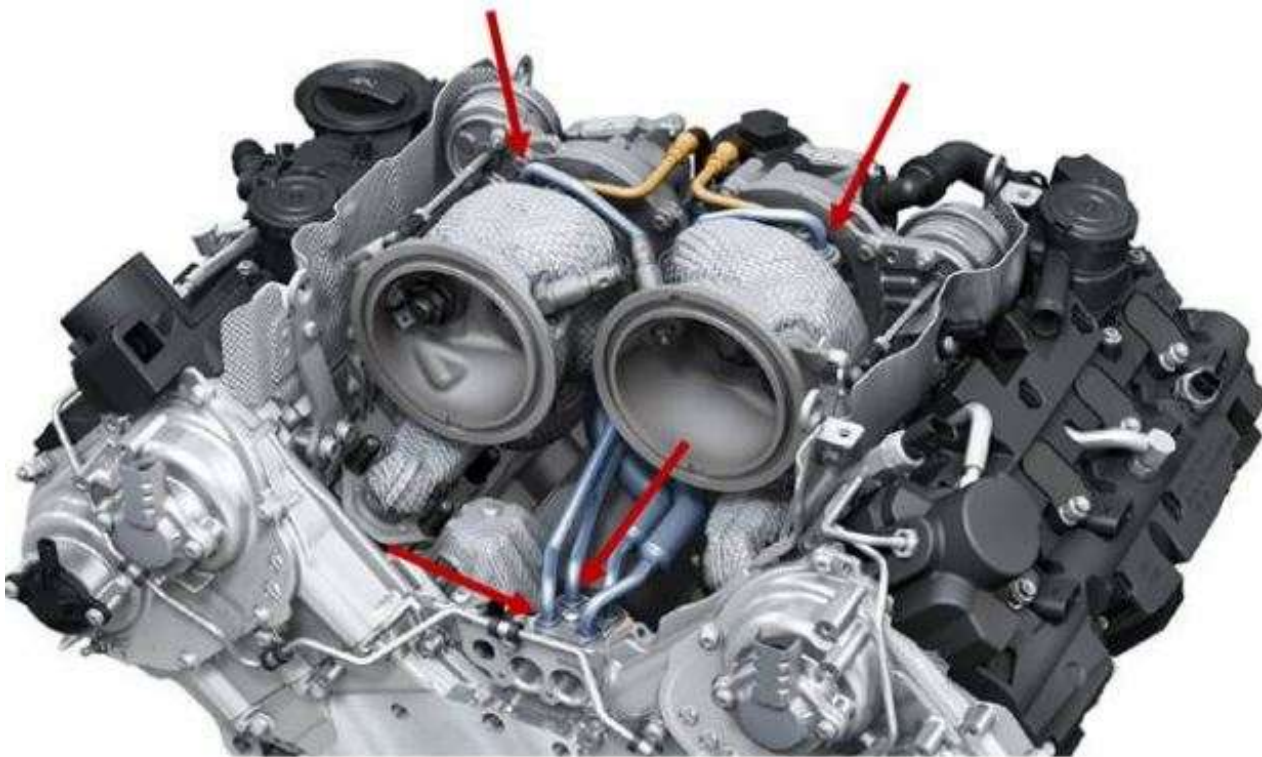
**Figure 3:** Location of the O-rings.
