## Condition

| Model(s) | Year(s) | VIN Range | Vehicle Specific Equipment |
| Q8 e-tron, Q8 Sportback e-tron, SQ8 e-tron, and SQ8 Sportback e-tron | 2024 | | |

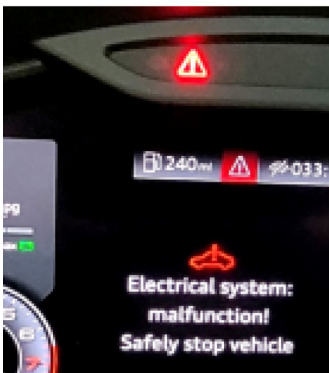
- A Drive System/Electrical System Malfunction message (Figure 1) appears in the instrument cluster.

**Figure 1.** Warning lamp associated with message.

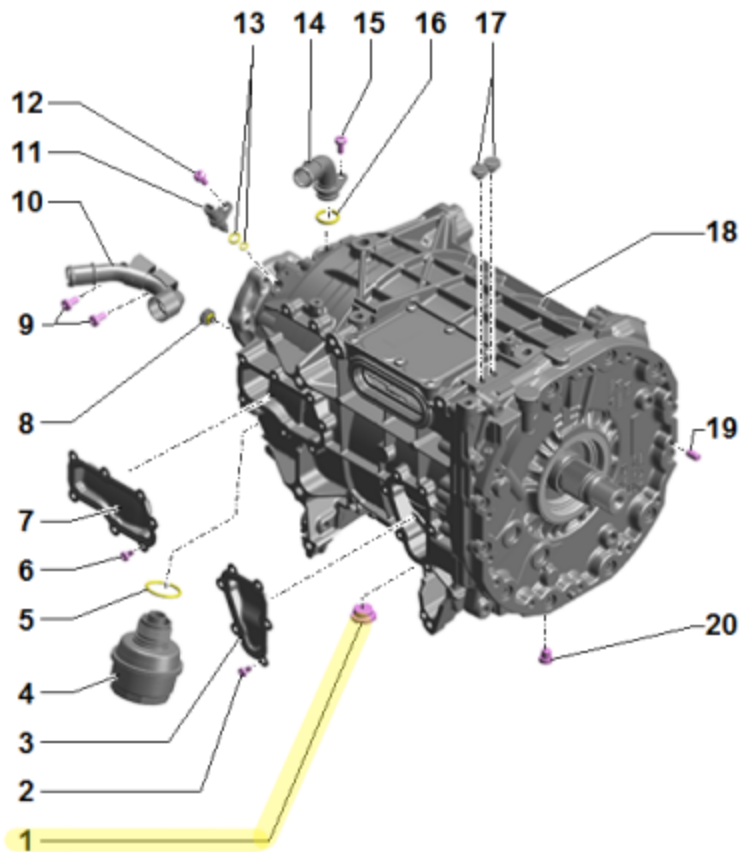
**Rear axle (Figure 2):**

Drip container is overflowing:

- Coolant leaking from active chamber.

Drip container is empty:

- Coolant leaking from active chamber, particularly on vehicles with low mileage.

**Figure 2.** (1) Drain plug.

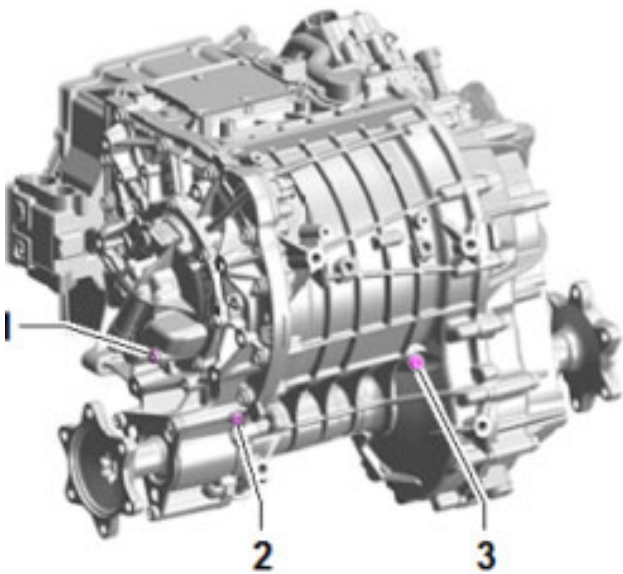
**Front axle (Figure 3):**

- Coolant leaking from active chamber.

**Figure 3.** 1) Resolver cover: A few milliliters of coolant leakage is not an issue from a technical perspective. 2) Active chamber: No coolant may escape from the bores.

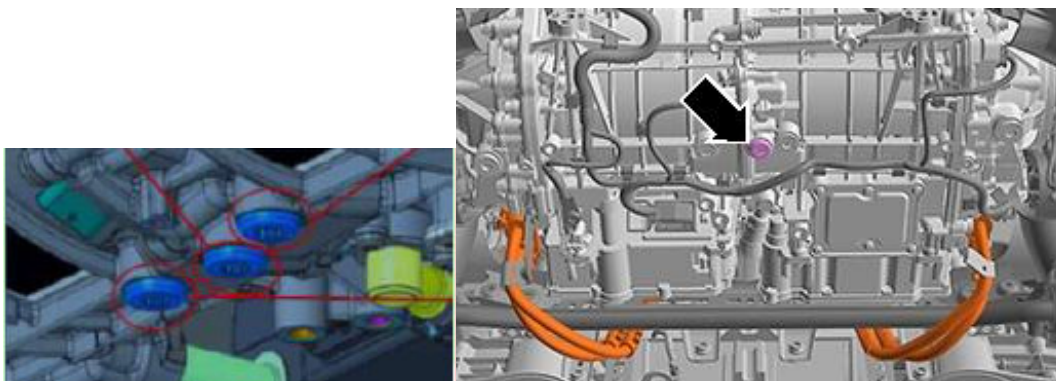
**Dual motor rear axle (refer to Figure 4):**

**Figure 4.** The drain plug is located between the two rear electric motors (Center drain plug)..

A few milliliters of coolant leakage is not an issue from a technical perspective.

The drain plugs for the active chamber are located on the left and right.

No coolant may leak.
