## Technical Service Bulletin

Transaction No.: **2076749/3**

24 Intake Manifold Sensor, MIL on, DTCs U060A00, U060900

Release date: Jun 10, 2026

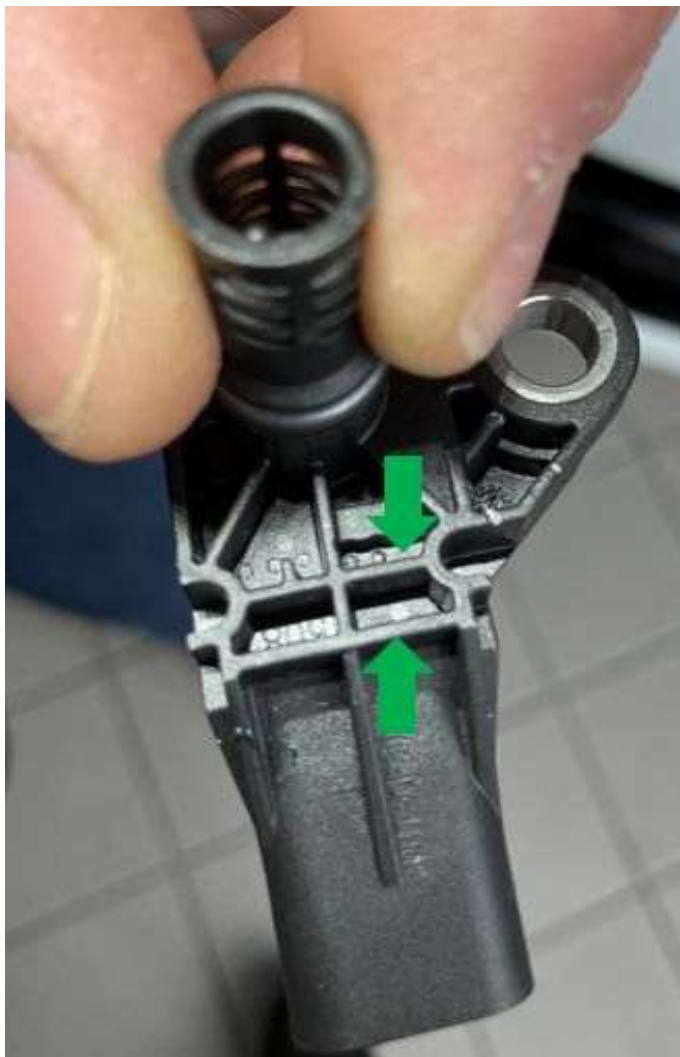
**Figure 1.** Apply the adhesive bead as indicated by the green arrows.

- Apply an adhesive bead on the back of the sensor along the first and second transverse ribs (see Figure 1).

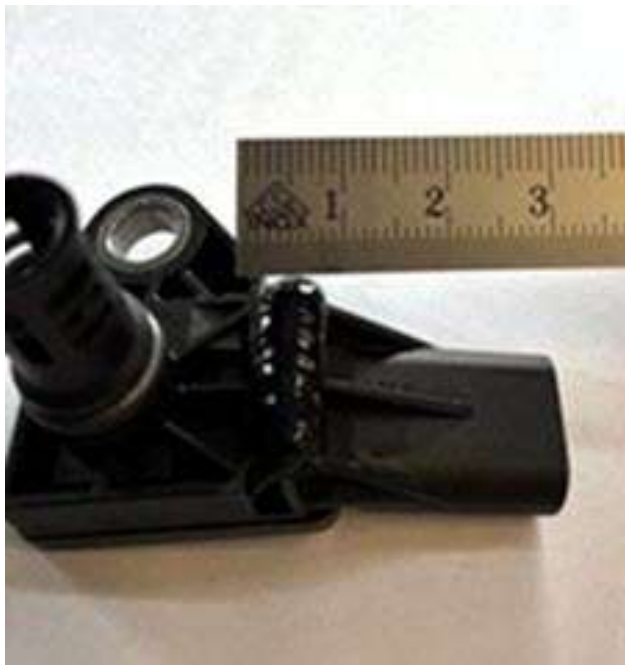
**Figure 2.** The adhesive bead should be approximately 5mm wide.

- Apply an adhesive bead that is approximately 5mm wide and approximately 2mm high (see Figures 2 and 3).

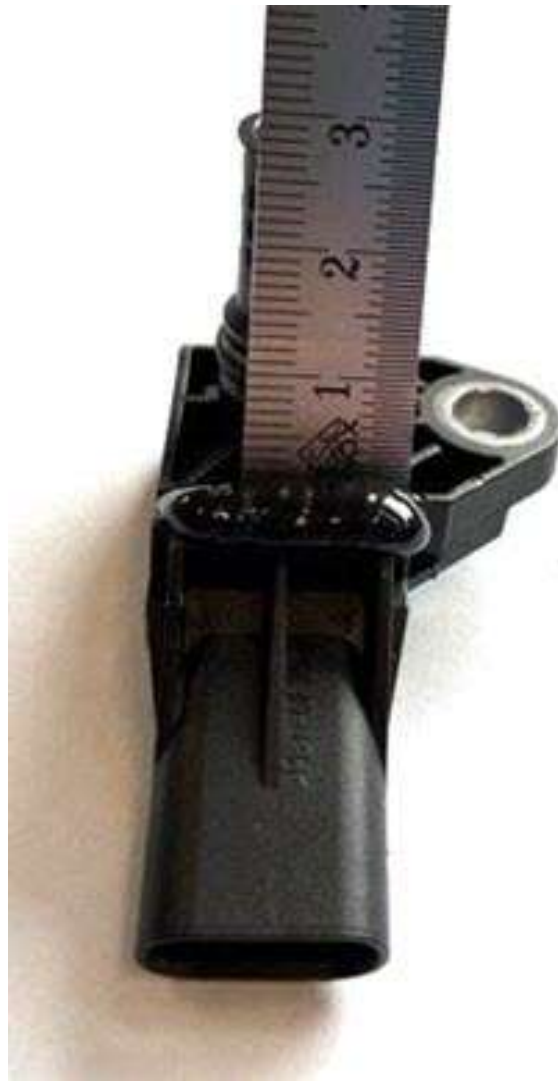
**Figure 3.** The adhesive bead should be approximately 2 mm high.

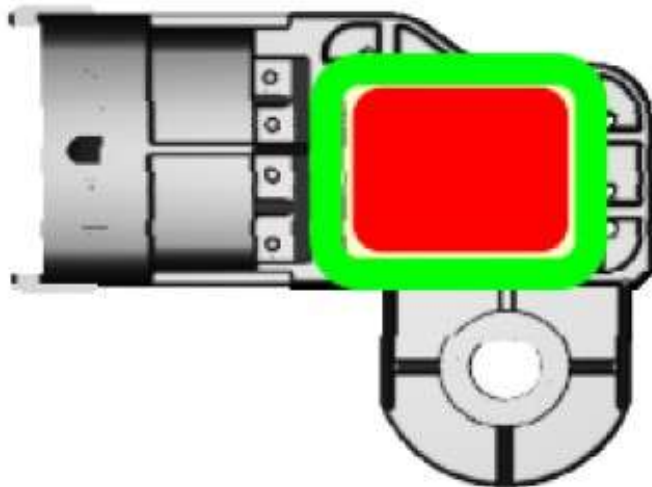
**Figure 4.** Ensure no force is applied to the red area in the above diagram.

When installing the new intake manifold pressure sender, please ensure that no forces are acting on the sender cover (see red surface in Figure 4). Therefore, please do not press on this surface during installation as doing so could damage the sender.
