## Technical Service Bulletin

Transaction No.: **2076776/3**

93 Q6 e-tron Charging flap cannot be opened from outside

Release date: Jun 1, 2026

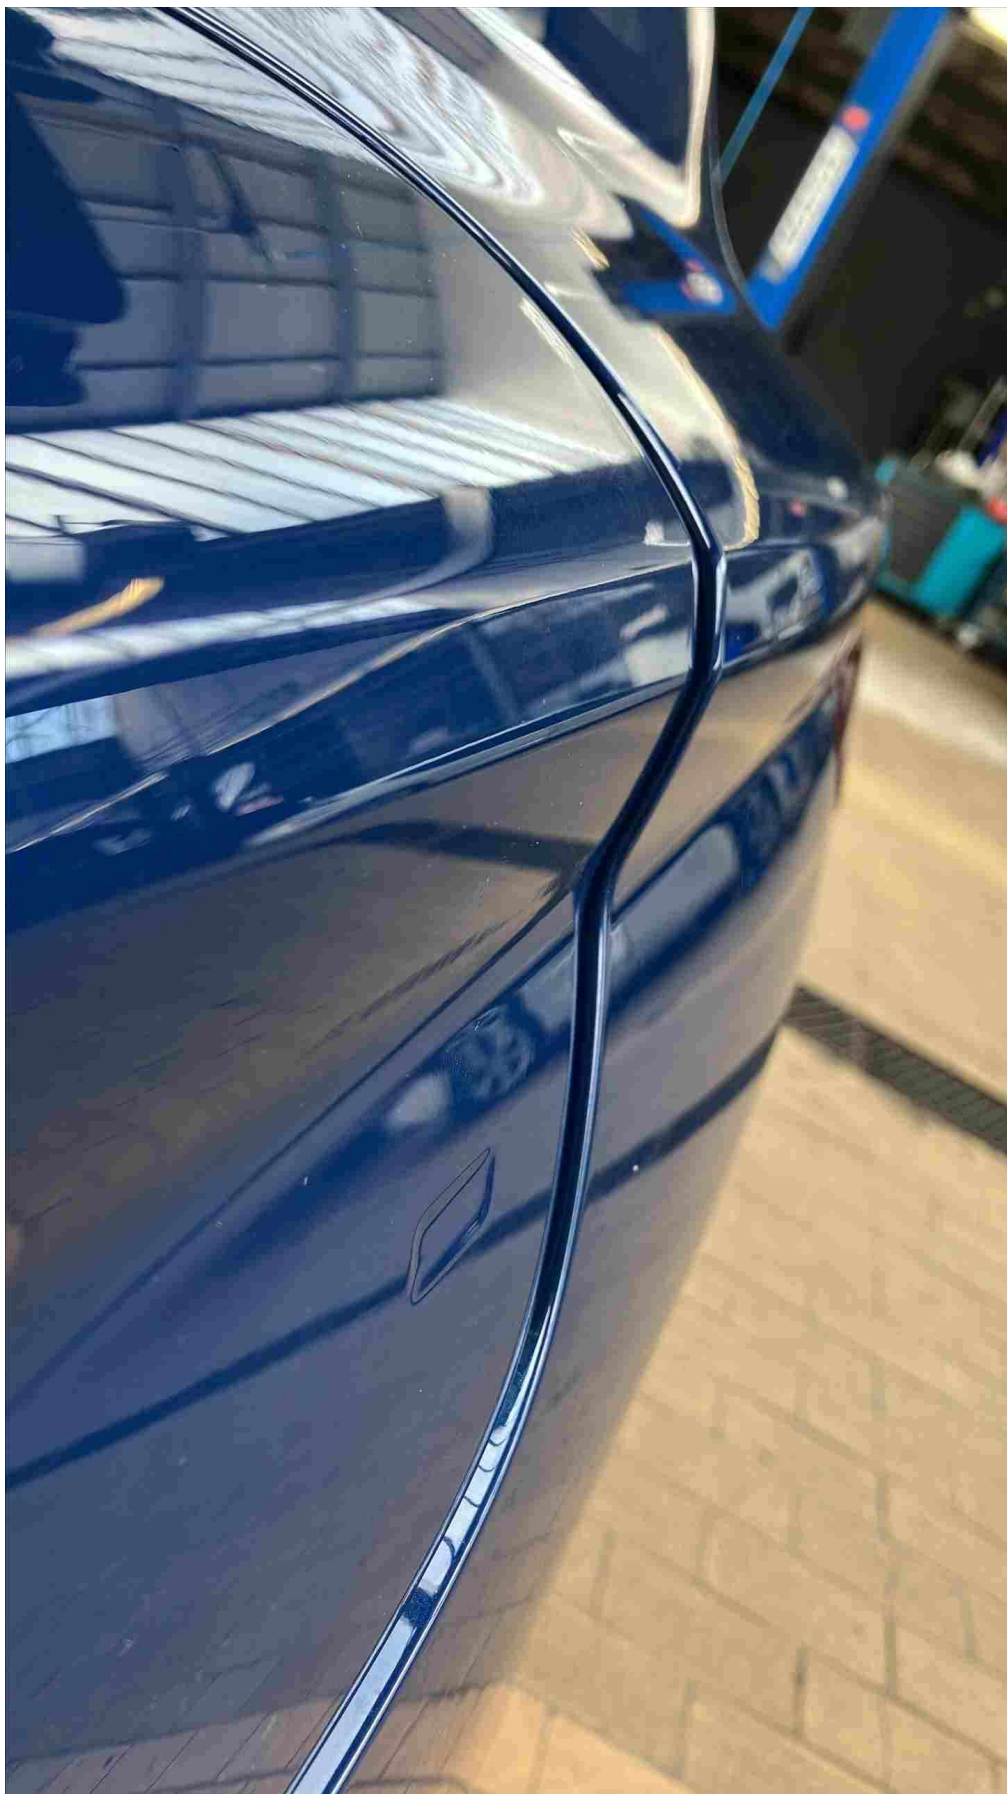
In rare cases, tension in the charging flap module 85H.810.001.A or 85H.810.002.A can lead to plastic deformation of the charging flap. This causes the charging flap to become recessed in the vehicle body and results in the button in the charging flap module being activated permanently. As a result, it is no longer possible to open the charging flap from the outside. It is still possible to open it from inside the vehicle via the MMI/display (charging menu or goodbye screen) (Figure 3).

**Figure 3.** *The charging flap is recessed in the body, resulting in permanent activation of the button.*

Photo above shows the charging flap recessed into the body, resulting in permanent activation of the button.

Replace the deformed charging flap module (left side, or right side) according to the *Workshop Manual*.
