## Technical Service Bulletin

Transaction No.: **2079136/3**

91 Driver assist systems: failure of various driver assist systems, DTC "B201000: No basic setting" in DA 810B

| Model(s) | Year(s) | VIN Range | Vehicle Specific Equipment |
|---|---|---|---|
| Q5, Q5 Sportback, SQ5, and SQ5 Sportback (GU) | 2025 | All | 79H |

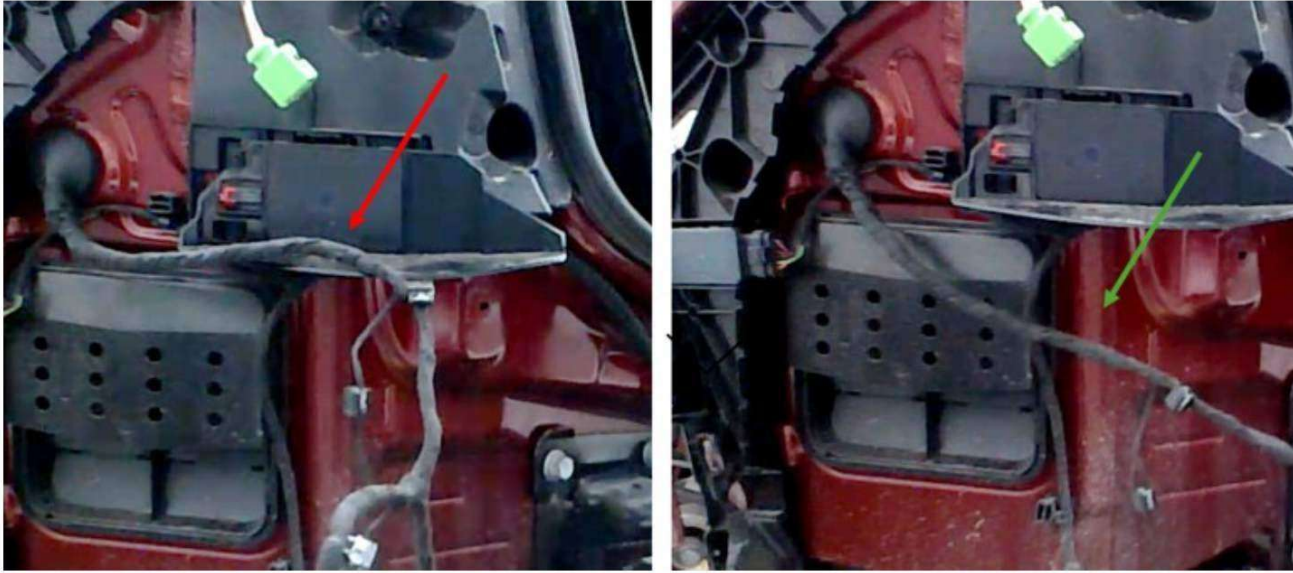
Potential incorrect cable routing of bumper wiring harness – causes harness to obstruct field of view of the sensor of lane change assist control unit -J770-. Please refer to the following images and the video provided in the TSB.

Figure 1 (left) shows incorrect cable routing of bumper wiring harness in field of view of sensor of lane change assist control unit -J770-

Figure 1 (right) shows the correct routing of the bumper wiring harness below the field of view of sensor.

Incorrect cable routing in the field of view of the sensor may be the cause of the event memory entry **"B201000: No basic setting (symptom number 1301)"**.

**Figure 1.** Incorrect cable routing (left in image) and correct cable routing (right in image) of bumper wiring harness

Install the rear bumper cover and make sure that the bumper wiring harness is routed below lane change assist control unit 2 J770 (see Figure 1, right).

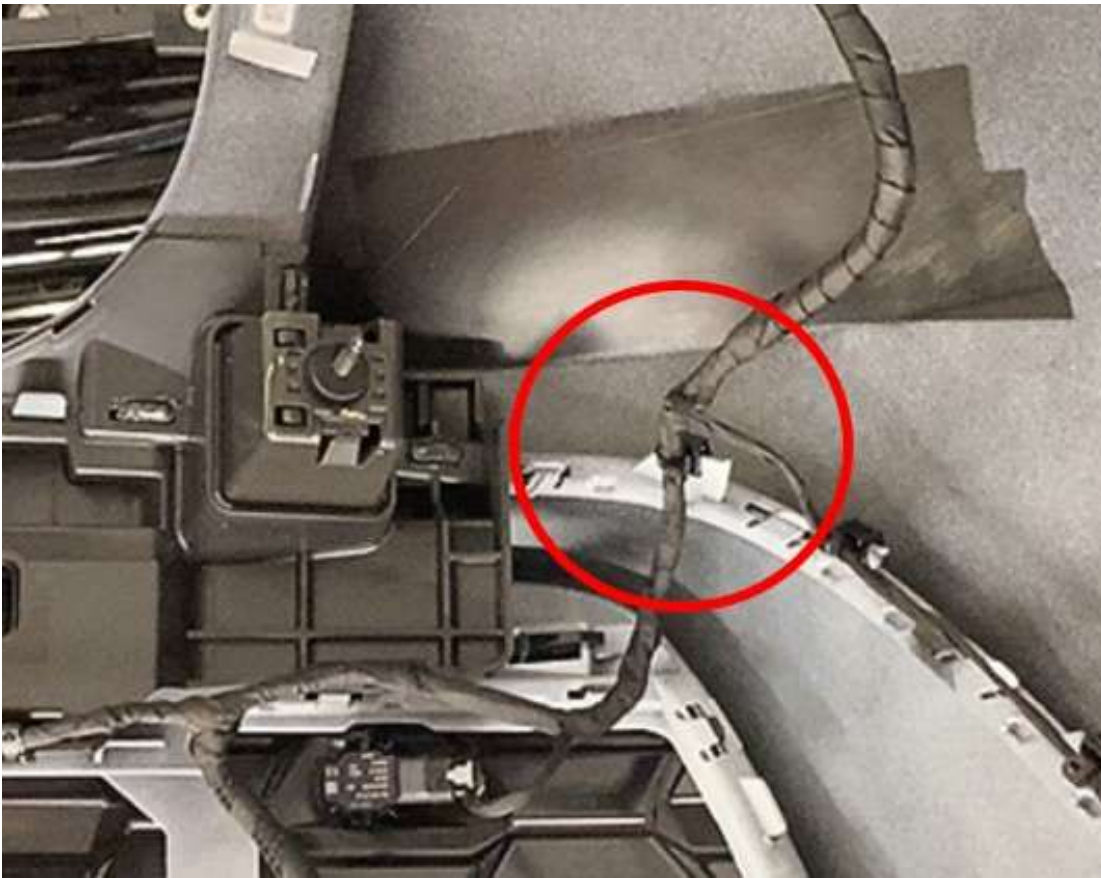
**Figure 2.** Position of cable tie with clamping base

Remove the rear bumper cover. Remove the wrong cable tie with clamping base at the position shown (see Figure 2) and affix cable tie with clamping base 3D0.971.838.L in its place.

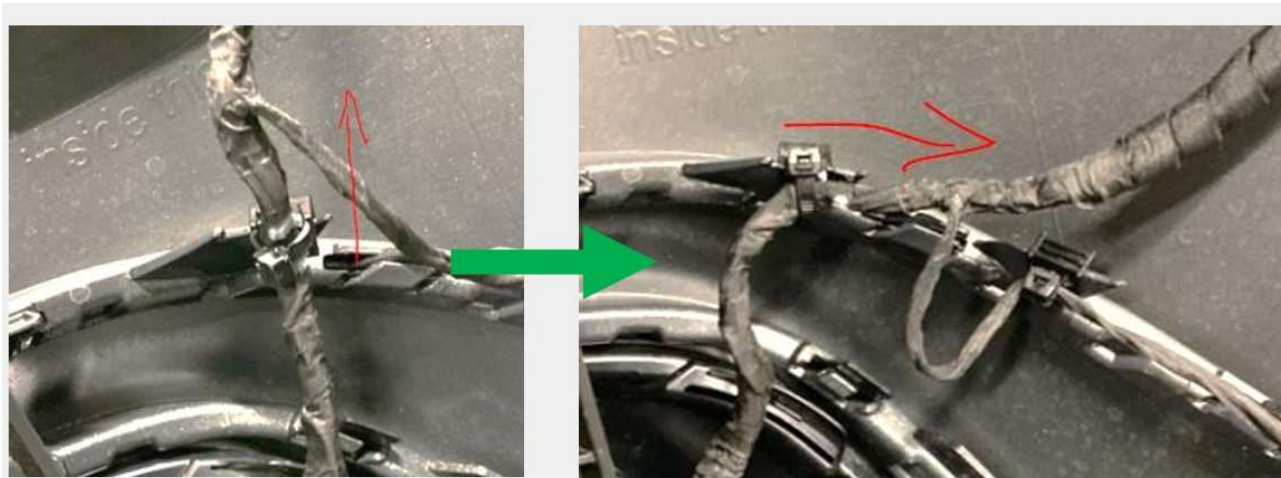
**Figure 3.** Left – previous cable routing. Right – new cable routing with cable tie with clamping base 3D0.971.838.L

The new cable tie enables the cable to be rotated 90° and makes it easier to route the cable (see Figure 3).

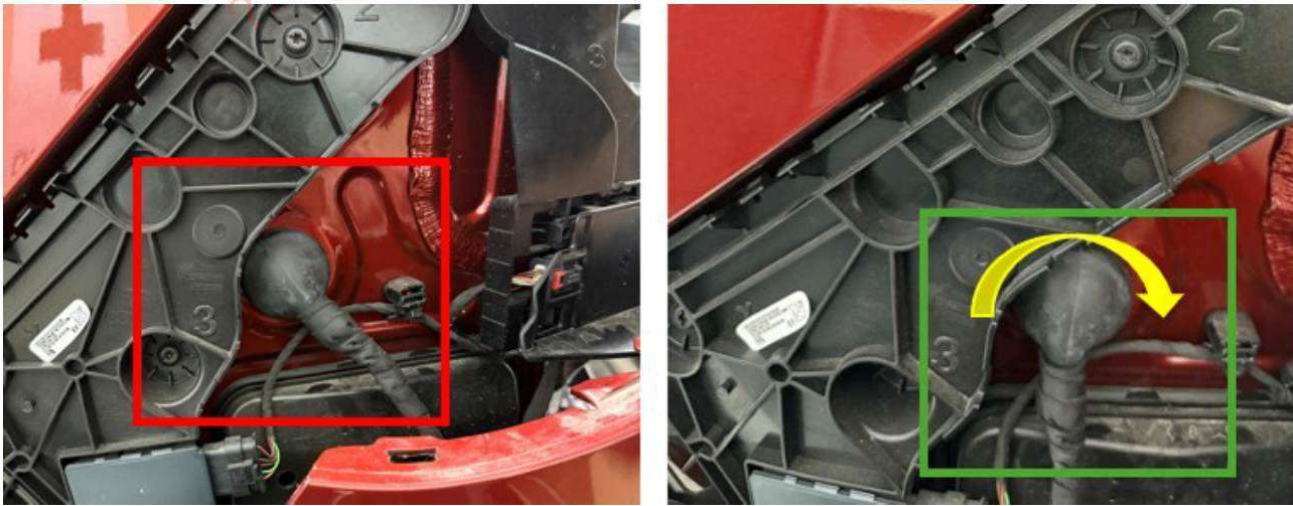
**Figure 4.** Left – factory grommet orientation. Right - bumper wiring harness grommet in 6 o'clock position.

Then turn the bumper wiring harness grommet downwards in the 6 o'clock position. Removal is generally not necessary (see Figure 4).
