Water enters the vehicle interior. The headliner and/or footwell is wet.

Water enters the dry area of the wind deflector storage compartment.

Modification(s) on panoramic sliding sunroof.

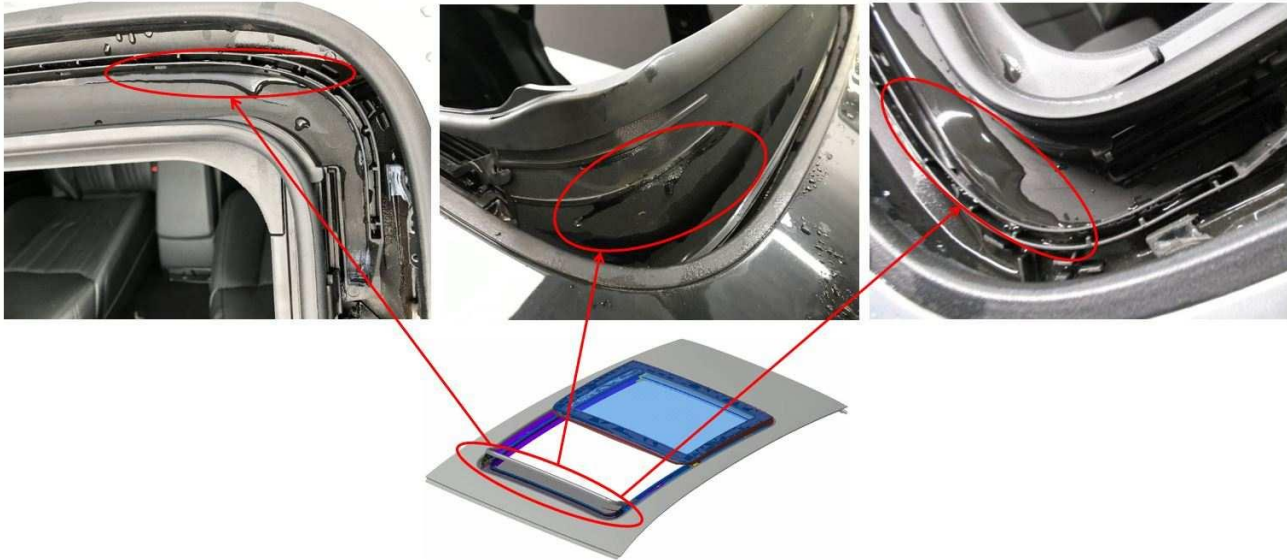
If there is standing water in the wind deflector area, as shown in Figure 1, work through the points in this TSB. Please note the production condition and compare the images with the components on the vehicles.

**Figure 1.** Examples of standing water in the wind deflector.

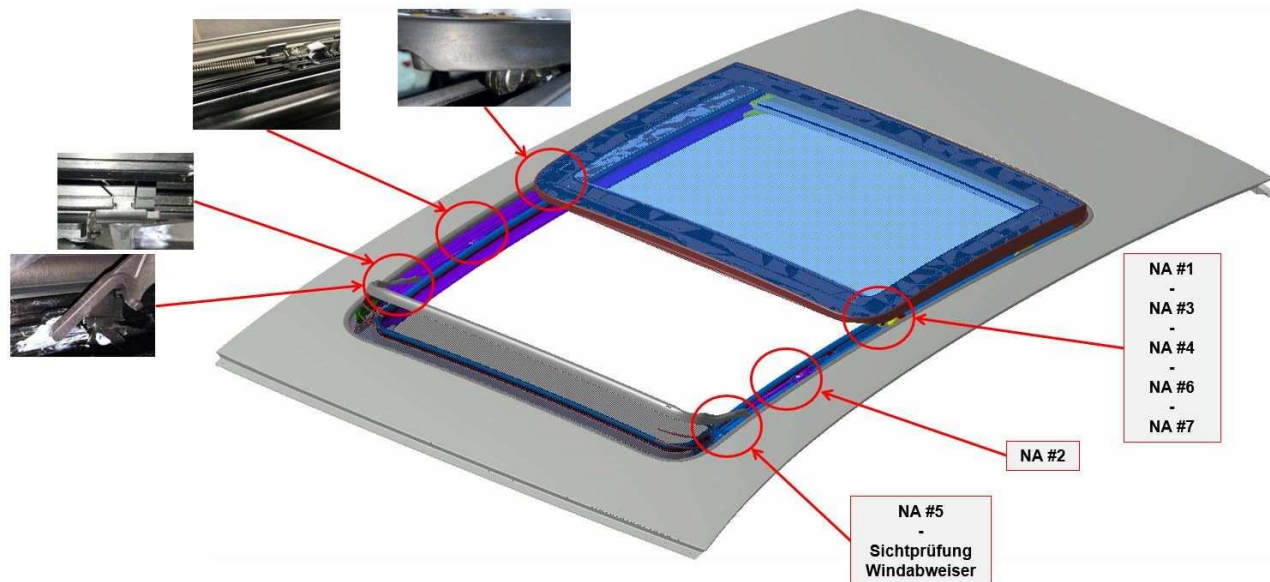
**Figure 2.** Modification areas.

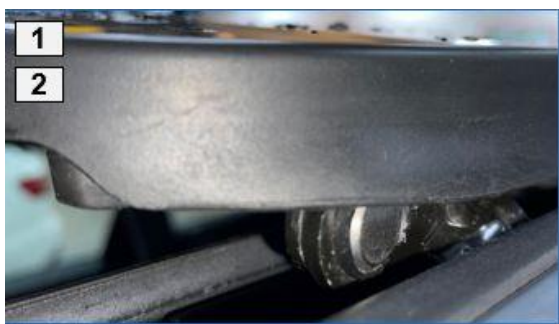
***Figure 3.***

1. "Short trim" glass panel **without** rubber buffers.
2. Mechanism **without** "flapper valve" (see Figure 3).

**Required modifications: no. 1, 2, 5**

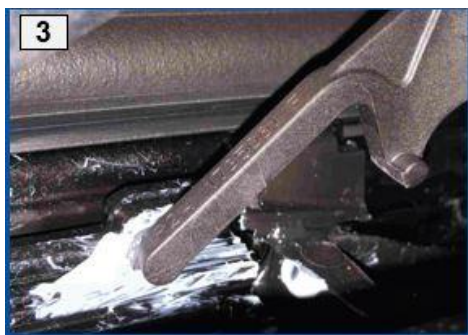
***Figure 4.***

3. Wind deflector tilt lever **without** "drip tab" (see Figure 4).

Replace wind deflector (if it does not have a water drip tab).

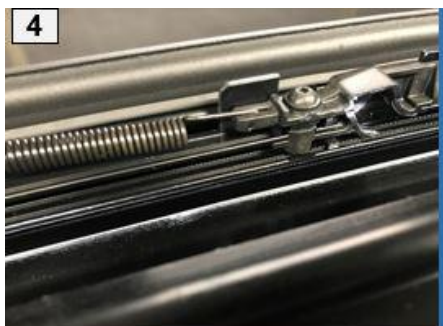
**Figure 5.**

4. Guide rail **without** "butyl barrier" (see Figure 5).

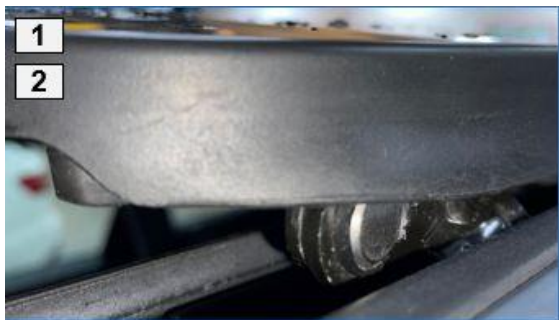
**Figure 6.**

1. "Short trim" glass panel **without** rubber buffers (see Figure 6).
2. Mechanism **without** "flapper valve" (see Figure 6).

**Required modifications: no. 1, 5**

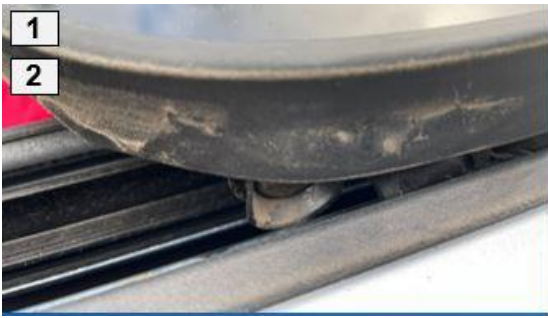
**Figure 9.**

1. "Short trim" glass panel **with** rubber buffers (see Figure 9).
2. Mechanism **with** "flapper valve" (see Figure 9).

**Required modifications: no. 3, 5**

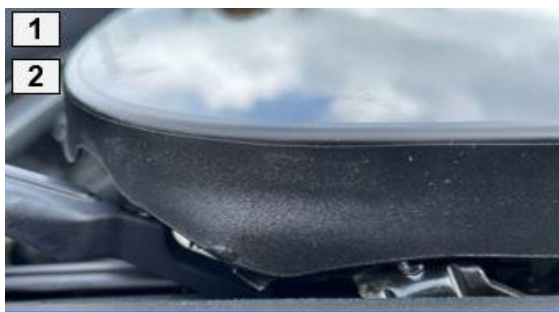
**Figure 12.**

1. "Long trim" glass panel **without** rubber buffers (see Figure 12).
2. Mechanism **without** "flapper valve" (see image 12).

**Required modifications: no. 4, 5**

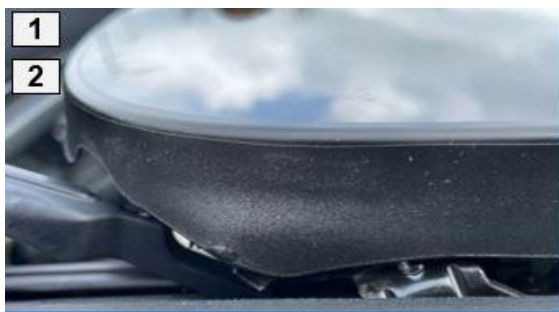
**Figure 15.**

1. "Long trim" glass panel without rubber buffers (see Figure 15).
2. Mechanism without "flapper valve" (see Figure 15).

**Required modifications: no. 4, 5**

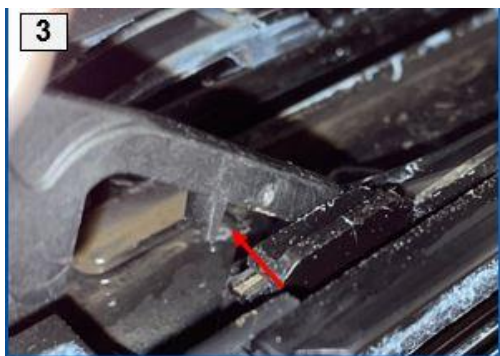
**Figure 16.**

3. Wind deflector tilt lever with "long drip tab" (see Figure 16).

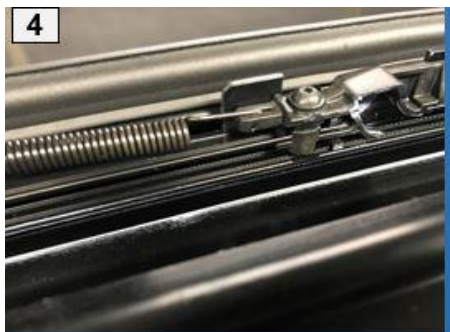
**Figure 17.**

4. Guide rail without "butyl barrier" (see Figure 17).

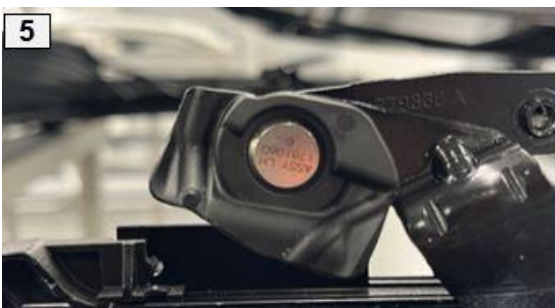
**Figure 21.**

5. Frame with new large “flapper valve” (see Figure 21).

**Required modifications: no. 6**

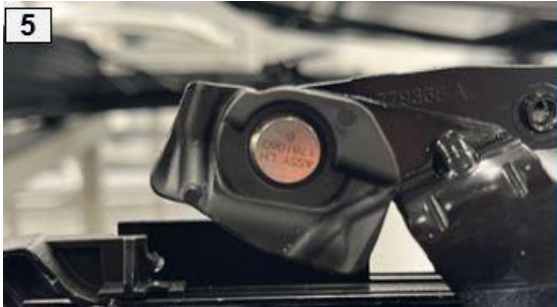
**Figure 22.**

5. Frame with new large "flapper valve" (see Figure 22).

**Required modifications: no. 7**

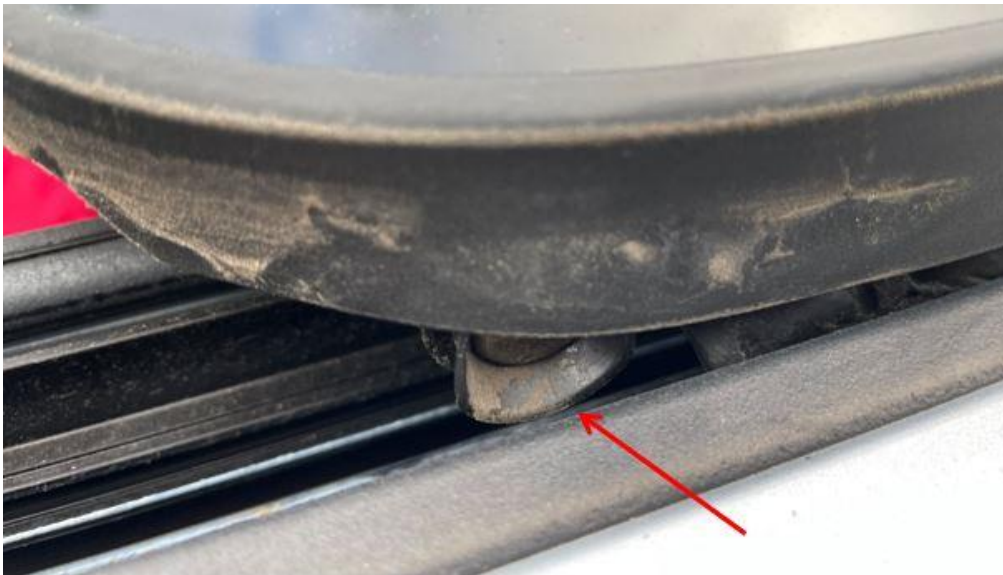
**Figure 35.**

Frame with flapper valve (see Figure 35)

Remove flapper valve from mechanism.

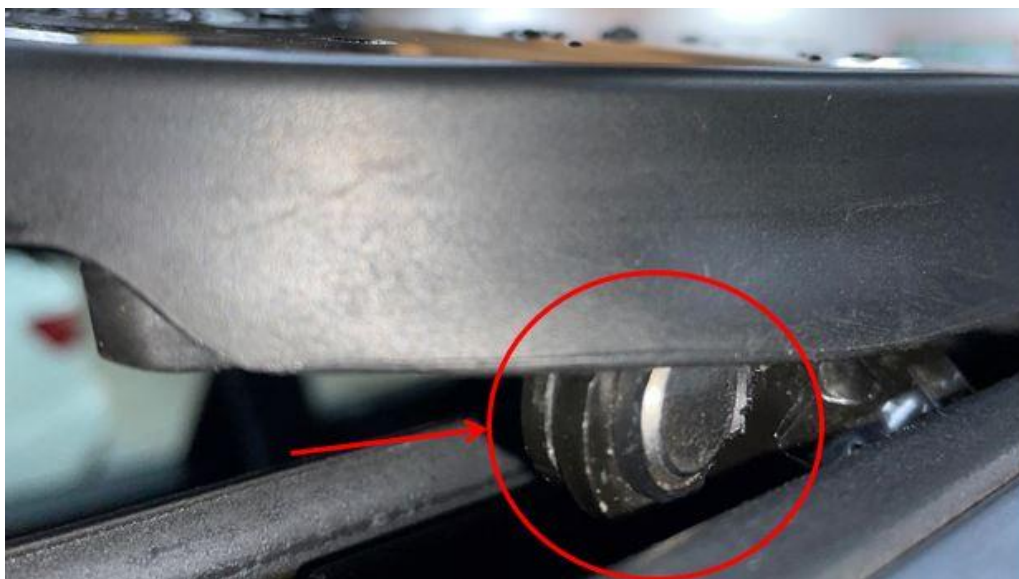
**Figure 36.**

Frame without flapper valve (see Figure 36).

Remove the water guiding washer using a diagonal cutter or cutter knife.

The plastic must be cut back so that it does not protrude from the silver pivot pin; it should be flush with the pivot pin.
