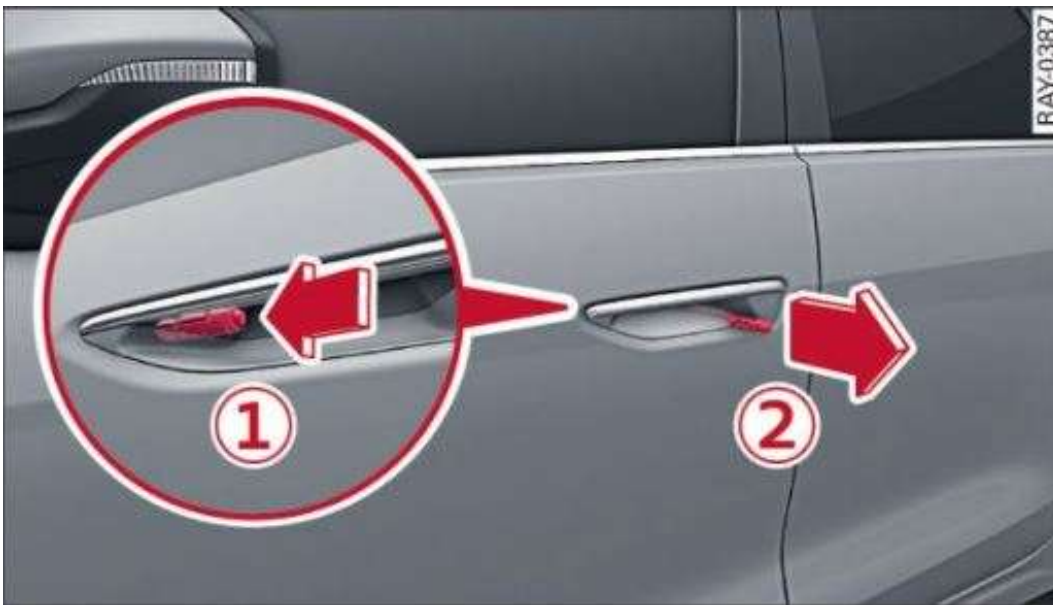
The manual release mechanism for the exterior door handles is ejected for no reason (refer to image taken from Owner's Manual).

**Figure 1.** Manual release mechanism for the door handles.

There is no apparent reason (e.g. an accident) why the manual release mechanism has been ejected.

The following event memory entry is logged in at least one door control unit (diagnostic addresses 0042, 0052, 00BB, 00BC):

- **B1908F0:** Crash response active.

There are further technical reasons why the manual release mechanism may be ejected in addition to the reasons stated in the Owner's Manual (an accident, manual release of the pin for the manual release mechanism)

- Vehicle battery is discharged/weak.
- Driver's door unlocked via emergency power supply at front bumper.
- Missing signals from airbag (fallback function relating to crash detection).
- Sudden interruption of a diagnostic session while terminal 15 is switched on.
- Unplugging of control units involved in signal transmission while terminal 15 is activated (e.g. airbag, J1312 control unit for drive system and running gear functions (HCP1), J1273 central control unit for data bus communication (HCP5), J519 onboard supply control unit (HCP4), door control unit, exterior door handle).
- Implausible signal chain of verified messages when programming the VKMS (vehicle key management system).

Please check whether one of the causes listed under *Technical Background* could have applied.

If the manual release mechanisms were triggered during the workshop visit, re-insert the pins for the manual release mechanism (refer to Owner's Manual). It is not necessary to perform further checks on the manual release mechanisms in this case.

If there are no further indications as to the cause, perform the combined software update described below

This complaint is solved in VR target state 03.11.00/C. Please check the column "VR target state 03.11.00/C" in the central service info 2081477. Here you can find information on whether the measure is already available via a combined software update TPI or whether the measure will be made available later. Please run the combined software update if available. Proceed according to the combined software update TSB which is specified for this vehicle in the central service info 2081477.
