## Condition

| Model(s) | Year(s) | VIN Range | Vehicle Specific Equipment |
|---|---|---|---|
| A5, S5 (FU), A6 Sportback e-tron, S6 Sportback e-tron (GH), Q5, Q5 Sportback e-tron, SQ5, SQ5 Sportback e-tron (GU), Q6 e-tron, Q6 Sportback e-tron, SQ6 e-tron, and SQ6 Sportback e-tron (GF) | 2025 | All | Software Version in 00A5:<br>0250<br>0295 |

All part and service references provided in this TSB (**2079690**) are subject to change and/or removal. Always check with your Parts Department and/or ETKA for the latest information and parts bulletins. Please check the Repair Manual for fasteners, bolts, nuts, and screws that require replacement during the repair.

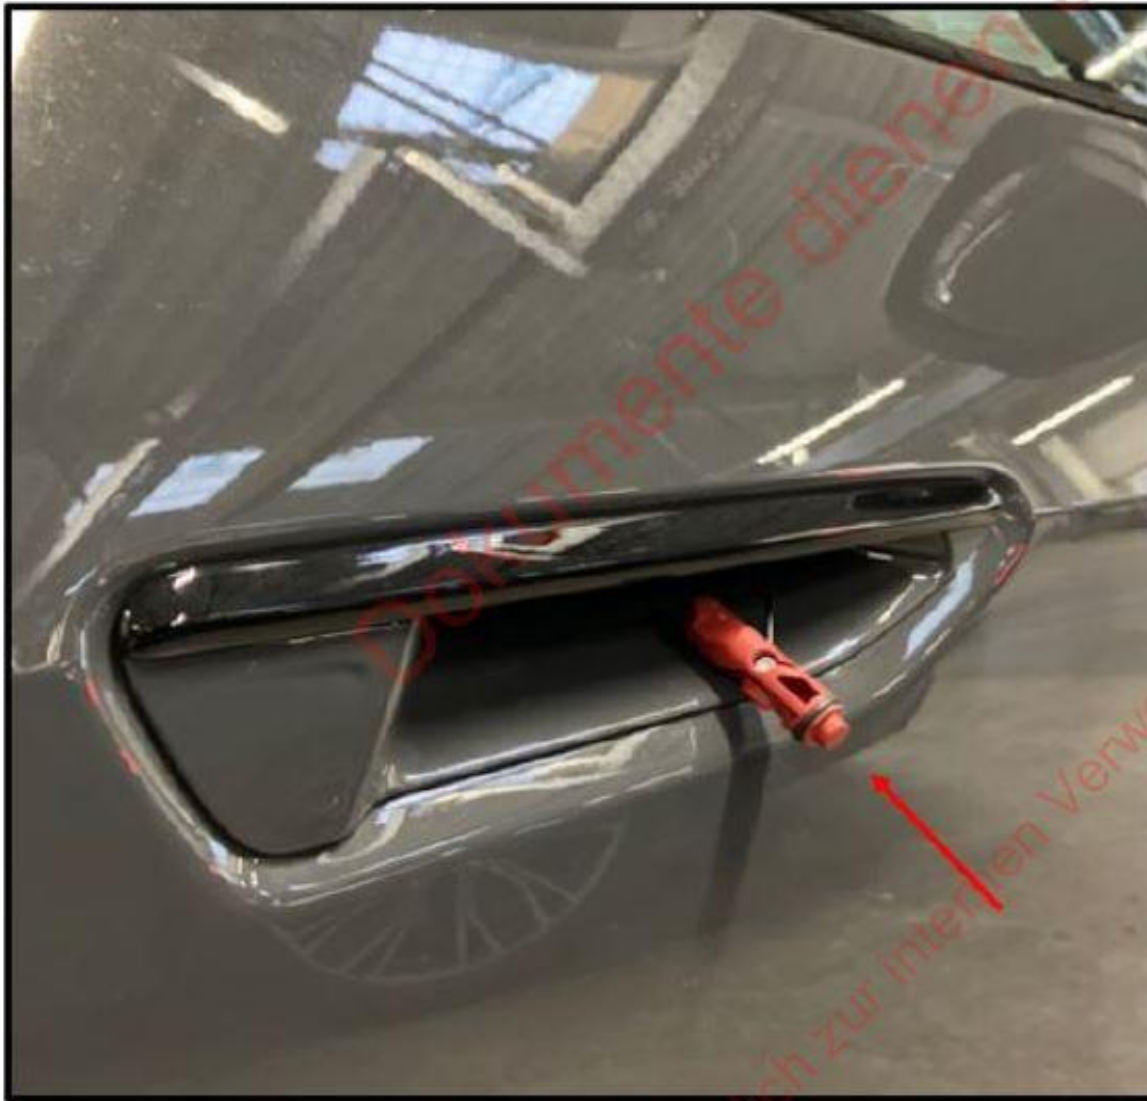
**Figure 1.** Triggered manual release mechanism.

- After the update, it is very important to open and close all vehicle doors and the rear lid (trunk) once (adaptive cruise assist initialization).
- If applicable, please press the triggered manual release mechanism back into its starting position (see figure 1 below).

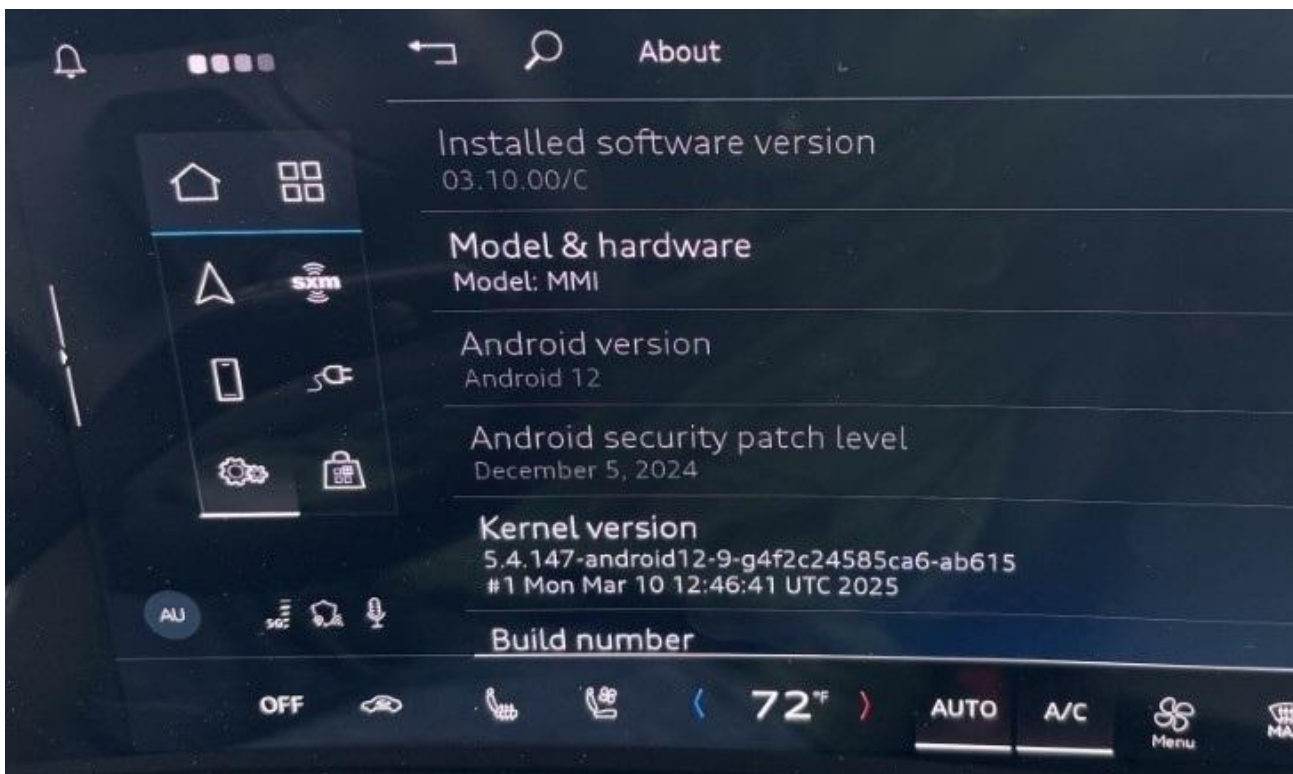
KD2 “installed software version” = **03.10.00/C**

**Figure 2.** MMI screenshot showing KD2 “installed software version”.
