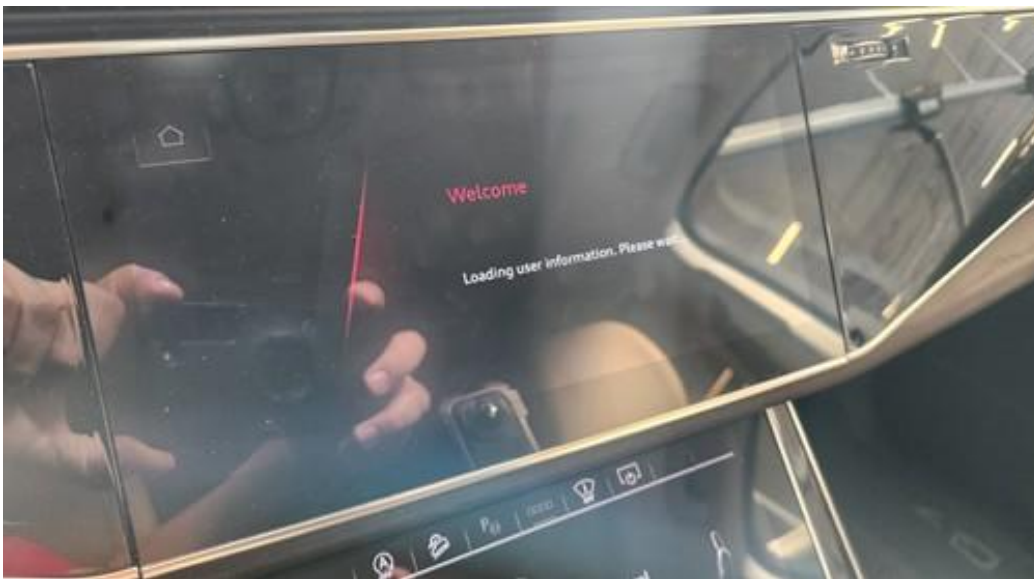
- The MMI screen sporadically gets stuck on the first welcome screen and shows: "Welcome. Loading user information. Please wait..."

**Figure 1.** MMI Screen is stuck.

Internal communication fault in gateway. Software-related functional impairment of DTC environment and history data in the diagnostic interface.

**Before creating a TAC case, check whether a software update for the MMI, connectivity box or gateway is available for the vehicle in the Elsa. Perform any available updates and then reassess the complaint. If this procedure does not fix the problem, follow the reporting obligation below.**

**Replacing the information electronics control unit (J794) DA005F does not correct the problem!**

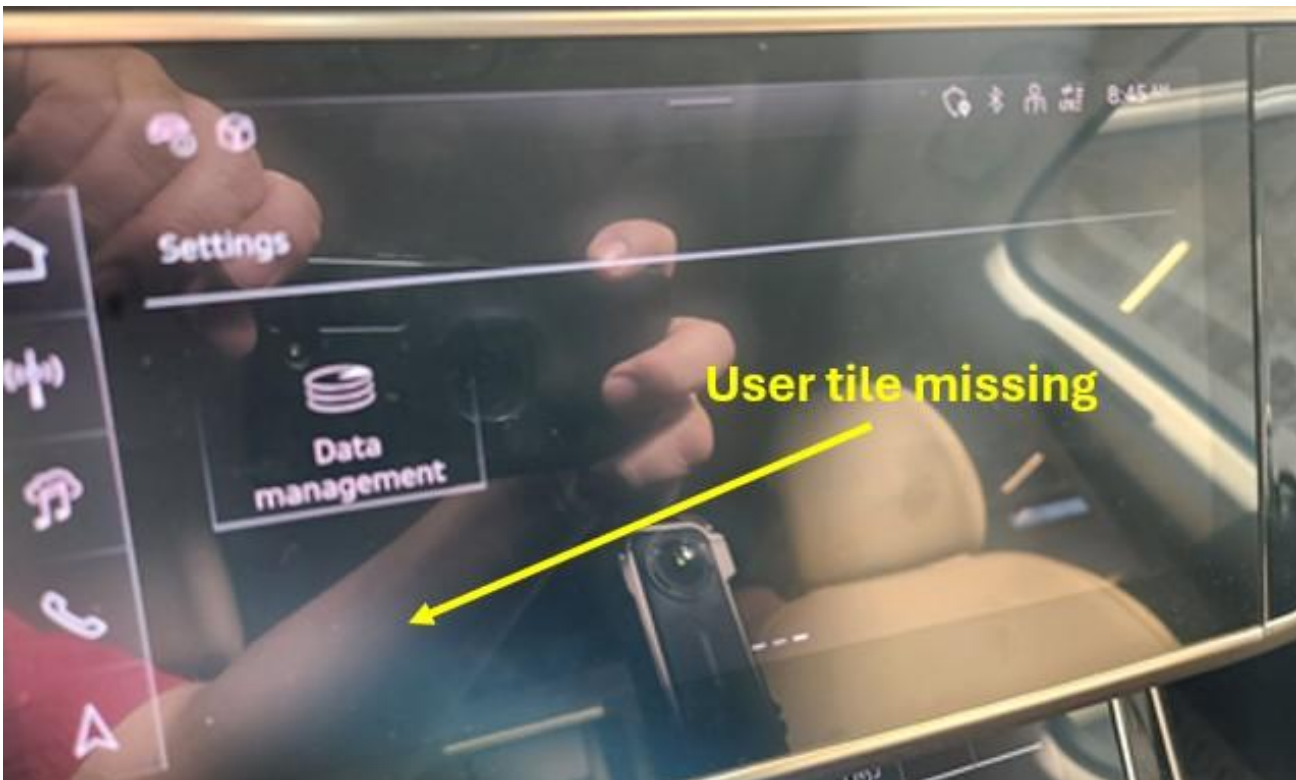
The "User" tile may also be missing as seen below:

**Figure 2.** The user tile is missing.

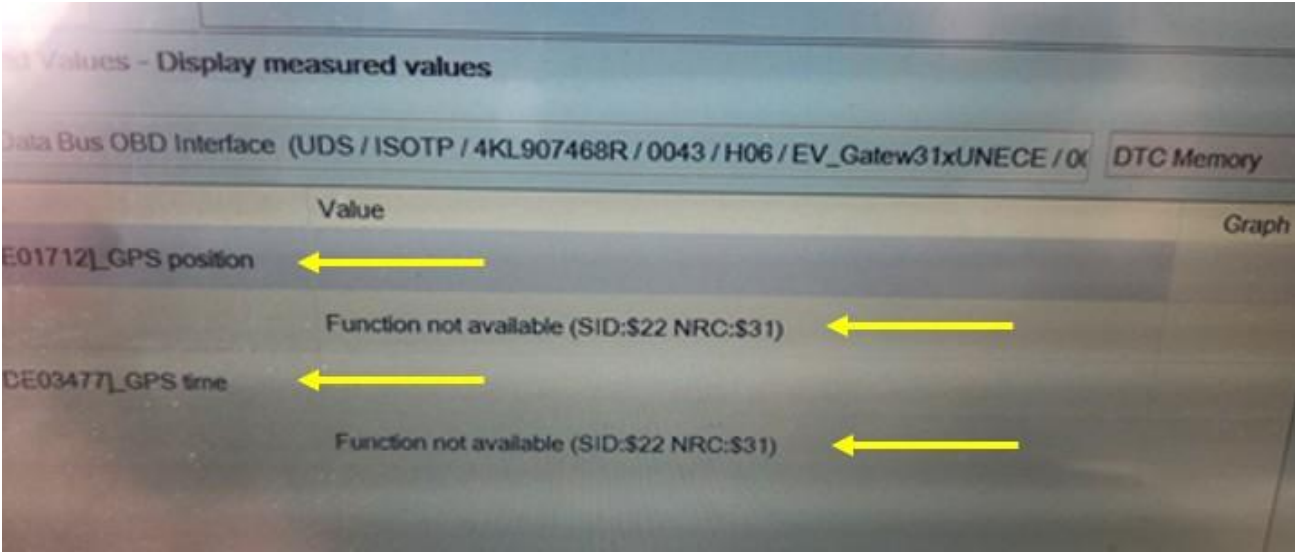
Figure 3.

If the concern is actively occurring, please read out all Measured Value Blocks (MVB) of the Gateway. If the two MVBs seen below provide the NRC error, this is a clear indicator that this belongs to this topic.

In the event of an error, create a current diagnostic log and read out all measured value blocks from the data bus diagnostic interface (J553) DA0019. Upload this log.
