| Model(s) | Year(s) | VIN Range | Vehicle Specific Equipment | |
| Q4 e-tron, and Q4 Sportback e-tron | 2024 – 2026 | All | PR codes:<br>V7A, V7B, or V7C, or V7E | |

The following TSB describes the specific flashing procedure that must be used on the vehicle.

All part and service references provided in this TSB (**2080398**) are subject to change and/or removal. Always check with your Parts Department and/or ETKA for the latest information and parts bulletins. Please check the Repair Manual for fasteners, bolts, nuts, and screws that require replacement during the repair.

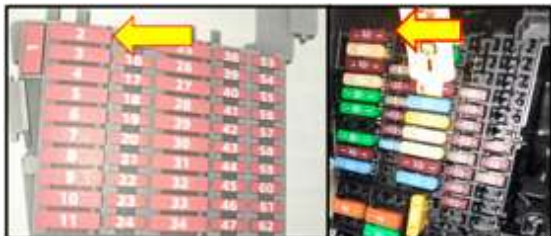
- If instructions to remove the fuse (7.5 A, brown) for airbag control unit J234 are shown, follow the instructions on the tester. Refer to the image to see the fuse location (-2-).
