**Condition**

The rear lid does not close and opens again.

## Technical Background

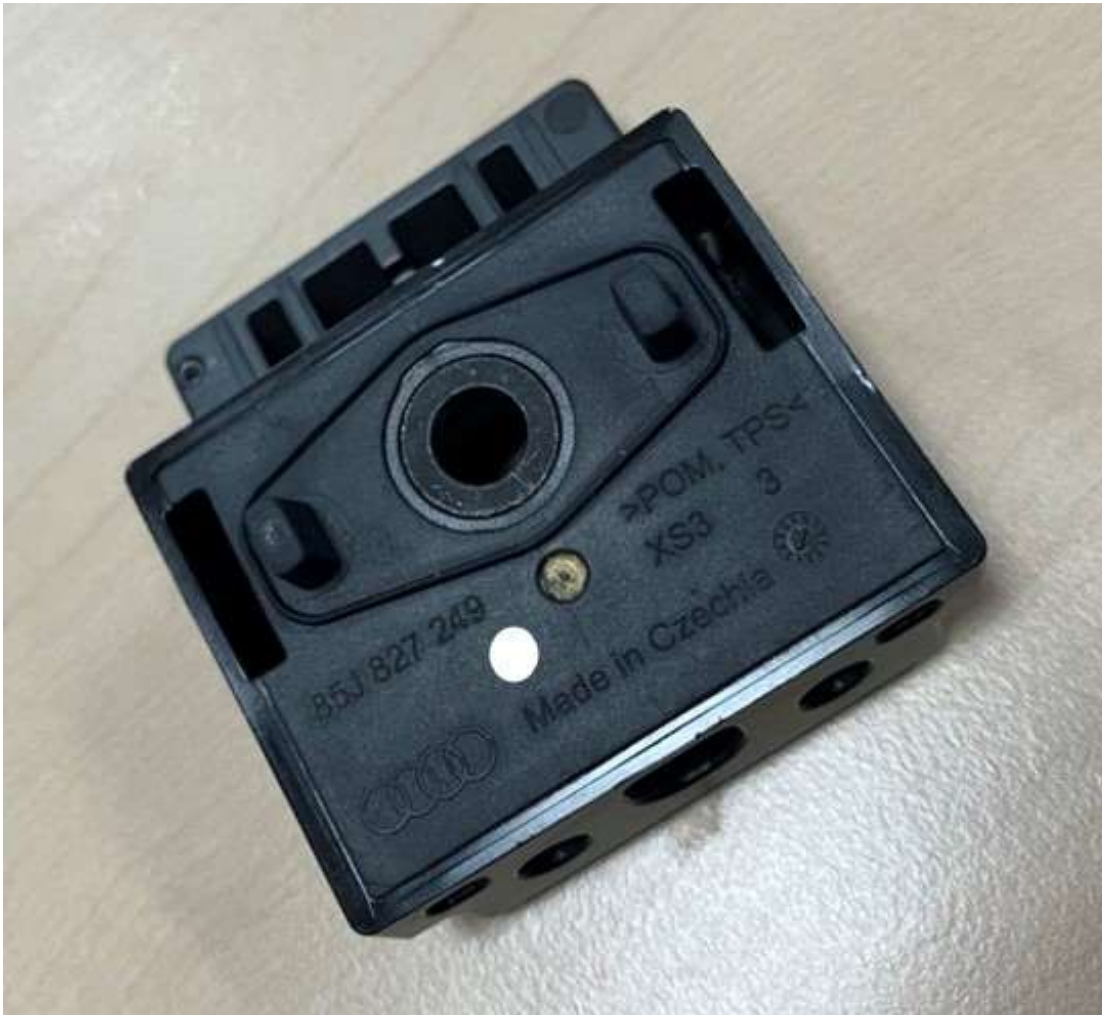
Make sure the new side bump stop (see Figure 1) with part number 85J 827 249 A is fitted on the vehicle. The spring preload is reduced on this part. If the old bump stop 85J 827 249 is fitted on the vehicle, replace it with the new bump stop with index A.

In autumn 2025, optimized buffers were already installed in vehicles that did not yet carry an index A. This buffer can be identified by a white dot on the back. These buffers can also remain fitted in the vehicle.

**Figure 1.** Example of an acoustic buffer with optimized spring without index A marked by a white dot.

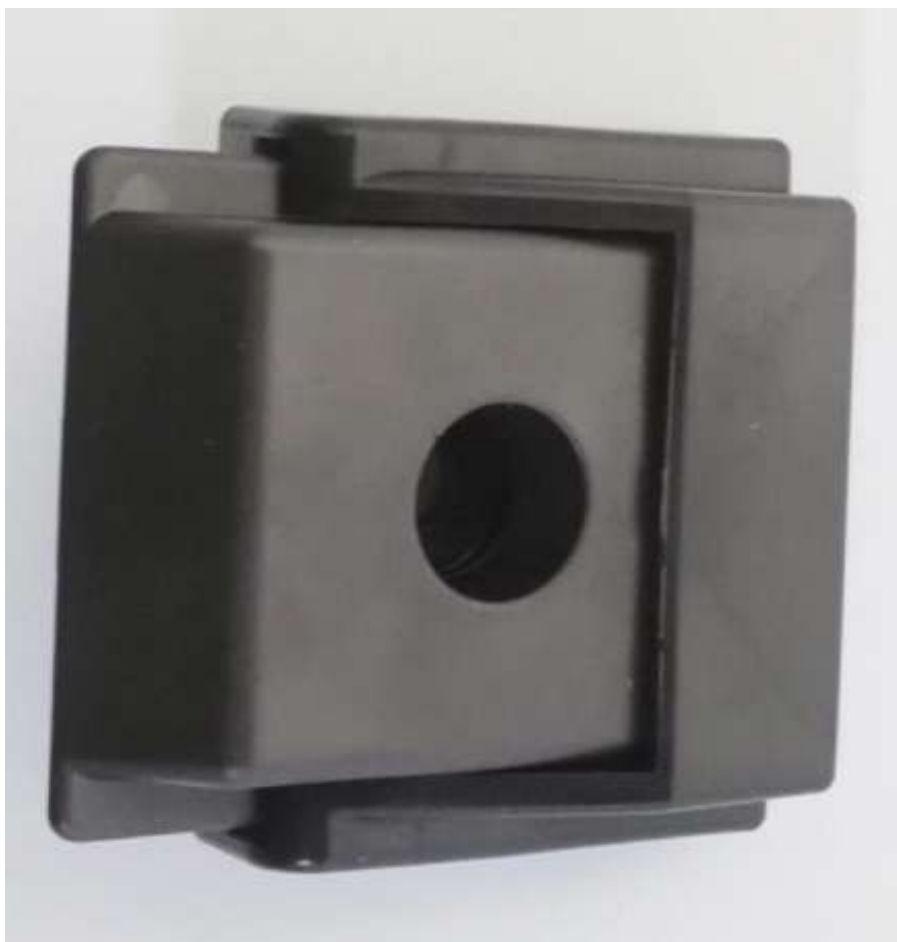
**Figure 2.** Pre-tensioned bump stop.

- Remove the side bump stops (pre-tensioned spring buffers, see image 2). Using the Workshop Manual, spring force gauge VAS 895 035 and measurement film VAS 895 037, adjust the buffer forces of the rear lid bump stops to between 40 N and 60 N and then refit the bump stops. Alternatively, you can leave the side bump stop installed and set the buffer forces to the lower limit of 40 N. Please also observe the Special Technical Service Training video on the spring force gauge VAS 895 035 in the Audi Knowledge Tank (AKT). In addition, make sure that the striker is positioned correctly and enters the lock in the center. Incorrect positioning can also

cause the rear lid to reverse direction. **NOTE:** If your vehicle is not equipped with side bump stops (see image 2), please start from the point: **“Adjusting buffer forces using spring force gauge VAS 895 035”**.
