**Condition**

**Customer States:**

## **Technical Background**

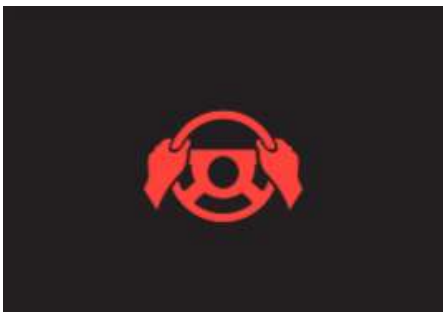
**Figure 1.** Take over steering warning light.

- Adaptive cruise assist: fault. You can continue driving
- Lane departure warning: fault. You can continue driving
- Active front assist / distance warning: fault. You can continue driving
- Traffic sign recognition: fault. You can continue driving
- Adaptive light: fault
- Main beam assist: fault
- Lane change assist: currently unavailable
- Proactive occupant protection: currently unavailable
- Driver assist systems currently restricted
- Emergency Assist: fault. You can continue driving (in combination with the red take over steering prompt (see Figure 1)).

**If the red warning lamp for the 'take over steering' prompt is not active, this TSB does NOT apply.**

The complaint relates to a software issue in the Data Bus Diagnostic Interface Control Unit, J1273 (diagnostic address 0019) which occurs shortly after switching the ignition on. The complaint occurs for one driving cycle and automatically fixes itself after a bus sleep cycle. A bus sleep cycle can be achieved by switching off the ignition, locking the vehicle and then waiting for approximately 3 minutes.

Please run the combined software update if available. Proceed according to the combined software update TSB which is specified for this vehicle in the central service info 2081477.

1. Run the test program **"SVM – Check vehicle configuration"** in ODIS (Figure 2). This step is required to use the SVM-code in step 2.
2. Select the "Flash" function, select "SVM code input" and enter the code **EGDHCP5DA0019**.
3. Flashing will be performed. Due to a system restriction, the procedure will end with the error 8113. Ignore this error. If a different error code appears, proceed as specified in the error message.
4. Run the **"SVM – Check vehicle configuration"** test program in ODIS again.
5. Put the vehicle in bus sleep mode.
6. End the diagnostic session, and send the diagnostic log online.
