## Condition

| Model(s) | Year(s) | VIN Range | Vehicle Specific Equipment |
|---|---|---|---|
| allroad, A4, A5, A5 Cabriolet, A6, A7, A8, and S8 | 2015 – 2016 | All | Not applicable |

| <b>Claim Comment:</b> | As per TSB 2082086/1 | | |

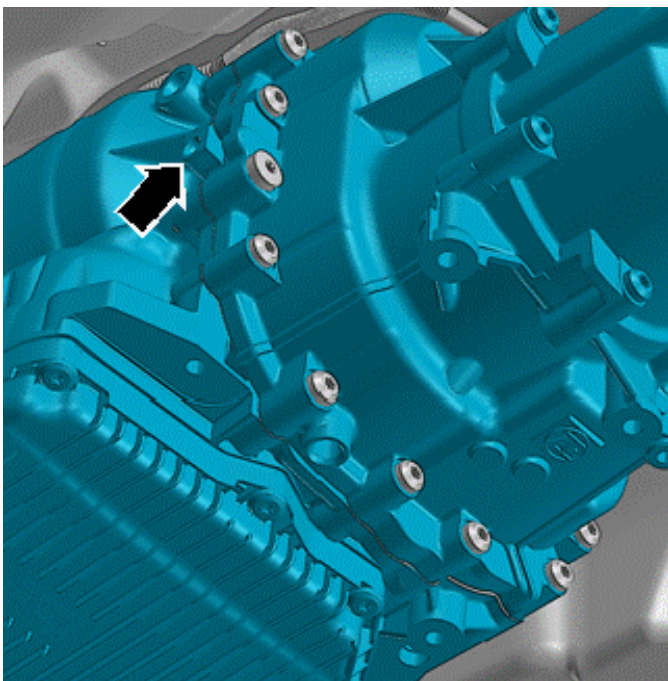
The detected leak can clearly be allocated to the fluid escape hole between the planetary gear and the transfer box on the left side of the gearbox.

**Figure 1.** The fluid escape hole is indicated with an arrow.

If oil is leaking from the fluid escape hole, the double oil seal between the automatic transmission fluid and manual transmission fluid reservoirs is damaged.

- If oil leaks from the fluid escape hole, the double oil seal is damaged.
- The fluid escape hole can only be checked reliably with a mirror.
- The fluid escape hole is dry and has no residue when the seal is undamaged.
- If the seal is damaged, oil residues or drops will be visible in/around the fluid escape hole.

- **Replace the double oil seal between the planetary gear and the transfer box according to the specifications in the Workshop Manual. Any subsequent disassembly and reassembly work must be performed as described in the Workshop Manual.**
- **You can find additional technical information and video support in the Audi Knowledge Tank (Audi Service TV) under *STV\_0491*.**
