## Condition

| Model(s) | Year(s) | VIN Range | Vehicle Specific Equipment |
|---|---|---|---|
| Q3 | 2026 | All | Not applicable |

Water is dripping into the luggage compartment.

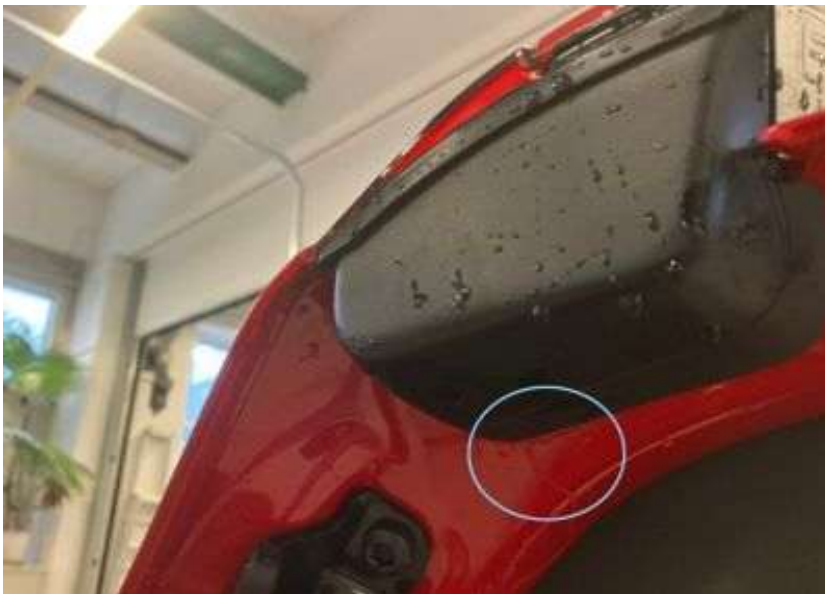
When the rear lid is opened, water from the area of the lights is collected on a piece of trim. The seal on this trim is sometimes not completely flush with the rear lid. In these situations, water can escape from inside the trim, run along the rear lid and drip into the luggage compartment (refer to circle in Figure 1).

**Figure 1.** Water escaping the trim.

Apply two small self-adhesive felt strips with a thickness of 0.5 – 1.0 mm (e.g. part number 533867910x) to the locking pins of the trim so that the trim is pressed more firmly onto the rear lid (refer to circles in Figure 2).

Modify the trim in the white area marked in Figure 3.

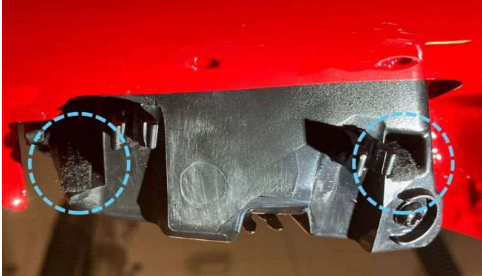
**Figure 2.** Felt strips applied to locking pins.

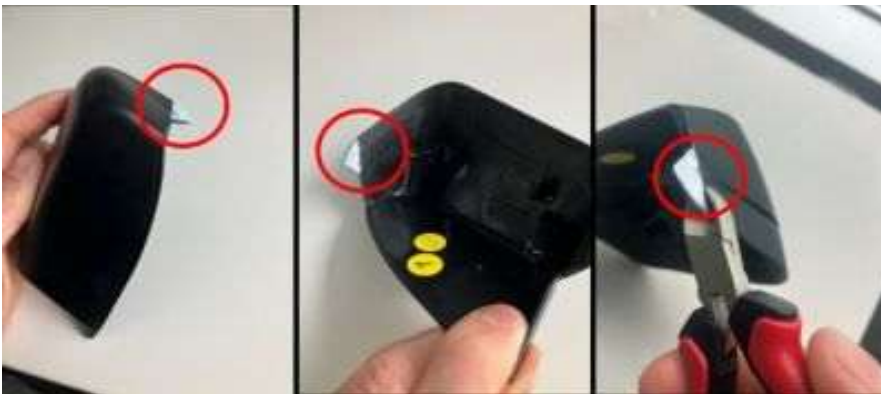
**Figure 3.** Area of trim to be modified.
