Condition

Customer states:

When the MMI is started, the Audi rings animation is shown for an extended period in the center display.

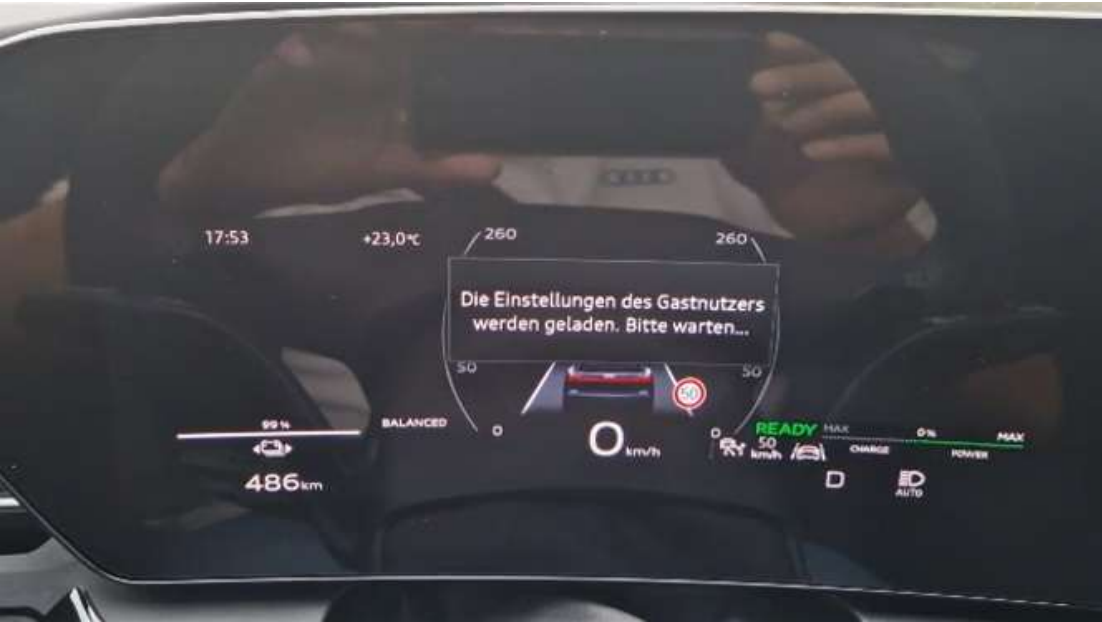
Software issue.

This complaint is solved in **VR target state 03.11.00/C**. Please check the column **VR target state 03.11.00/C** in the central service info **TSB 2081477, 00 Service info: central overview of combined software update 03.11.00/C PPE/PPC - KD2\***.

Please run the combined software update if available. Proceed according to the combined software update TSB which is specified for this vehicle in the central service info **TSB 2081477**.

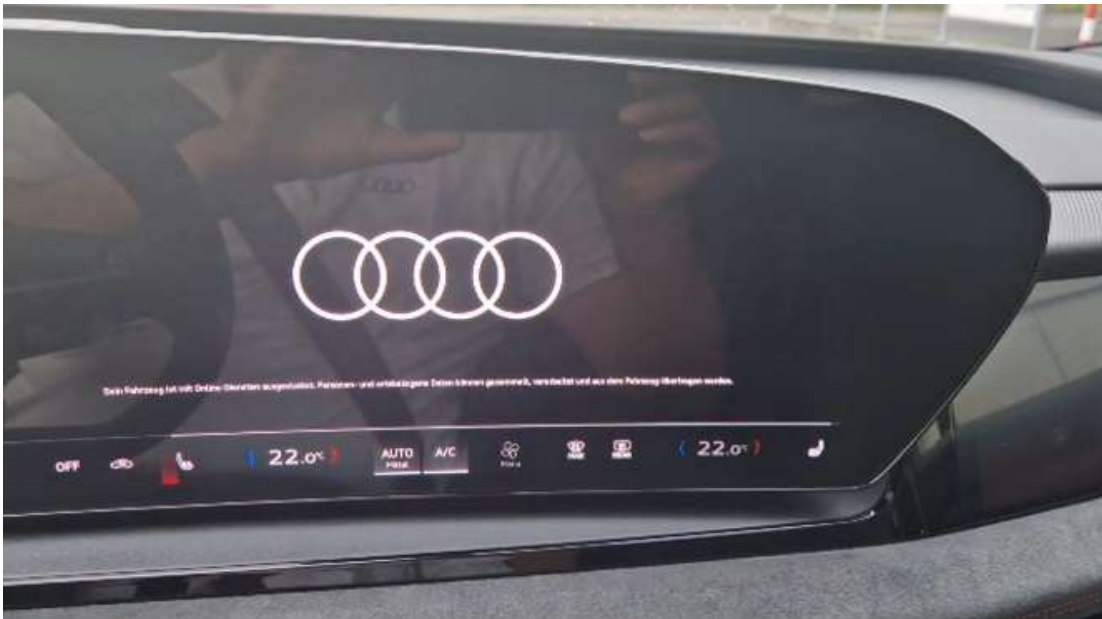
At the same time, a message stating that user settings are loading appears in the driver display.

Loading continues for several minutes. It is not possible to operate the MMI during this time.
