## Condition

## Technical Background

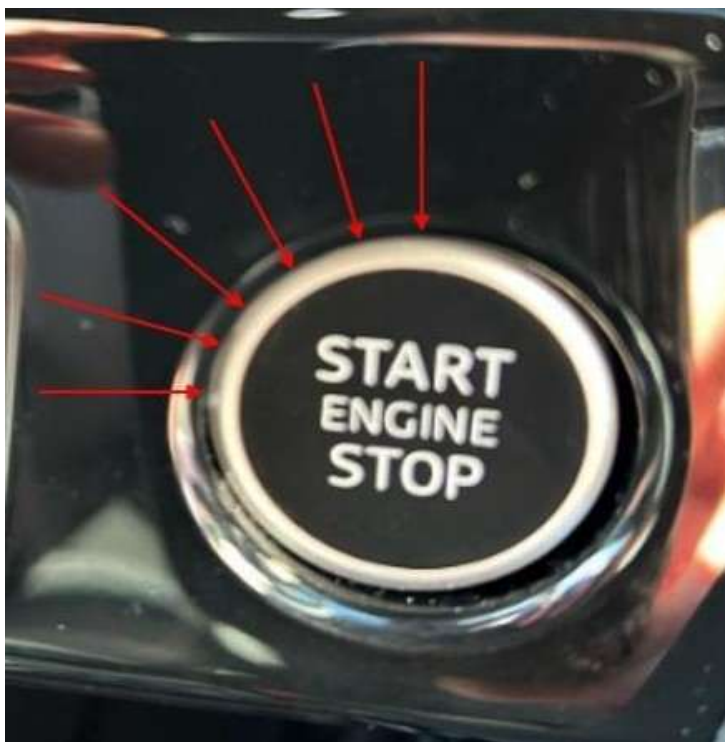
The start/stop button is not aligned correctly in the trim (refer to Figure 1).

**Figure 1.** The start/stop button is not aligned correctly.

Remove the button trim as described in the Workshop Manual and clip the button correctly into all tabs. Then test that the button is engaged correctly by pressing it. Install the button trim again and delete the event memory entries if any are logged.

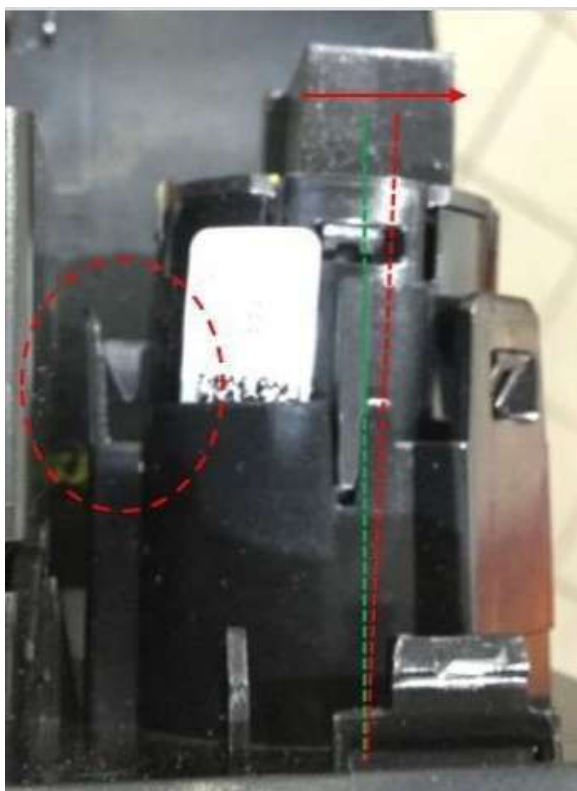
The retaining hook is not engaged in the tab (refer to Figure 2).

**Figure 2.** The retaining hook is not engaged in the tab.
