## Technical product information

| <b>Topic</b> | Sporadic All-Wheel Drive Warning Continental GT/GTC/Flying Spur 25-26MY |
| <b>Transaction No.</b> | 2077545/8 |

Sporadic All-Wheel Drive Warning | Continental GT/GTC/Flying Spur | 25-26MY

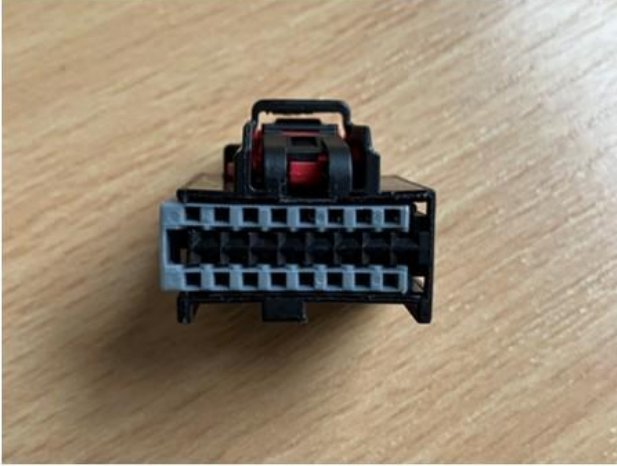
Potential issue with the T16-way connector at J647, causing intermittent faults in the differential lock system due to:

- Poor electrical contact
- Corroded or loose terminals
- Defective terminals.

2077545/8 – Figure 1 revised to show the applicable 16-way (T16) connector to be inspected.

1. Inspect the T16-way connector at J647 for any defective terminals.

2. Perform a detailed check of the terminals within the T16-way connector at J647.
  3. If any terminals are found to be defective.
    - Replace all the defective individual terminals (part number P00427711).
- and/or*
- If required replace the entire 16-way connector at the J647 unit (part number P00293586).
