# Service Bulletin

Bulletin No.: PIT5966F

**Subject: OTA Failure or Download Will Not Complete**

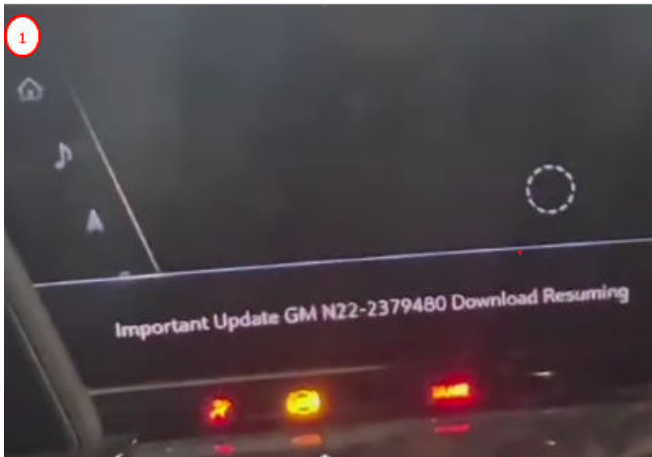
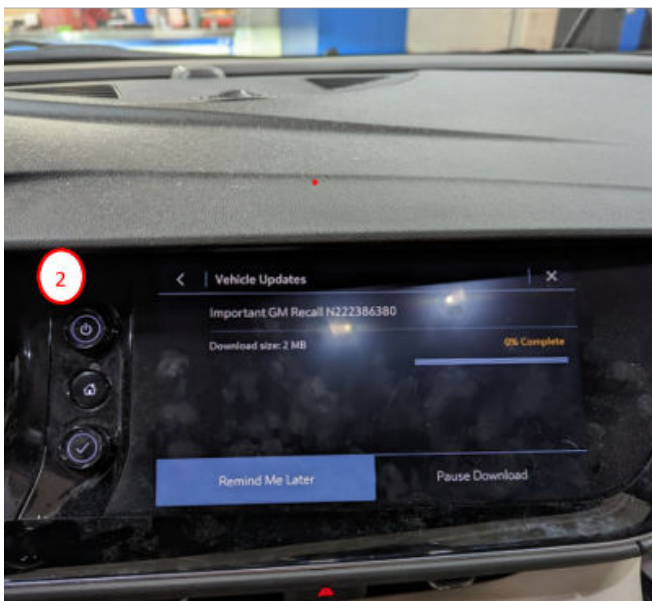
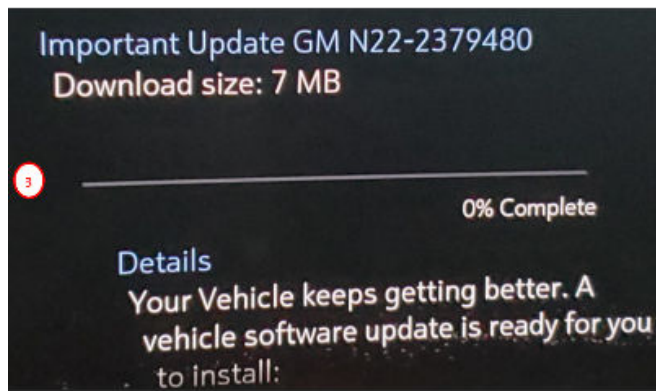
| <b>Condition</b> | <p>Some customers may comment on any of the following complaints after an Over The Air (OTA) update:</p> <ul style="list-style-type: none"><li>- The radio will remain on for up to 11 minutes after RAP is canceled.</li><li>- Loss of super cruise, "Super Cruise Unavailable", message.</li><li>- No Crank due to a dead battery. Vehicle will start and run after the battery is charged</li><li>- Intermittently at start up the radio display may momentarily display "Important Update ..... Download Resuming". Example shown below (1).</li><li>- When checking the Vehicle Update screen, it will show OTA failure, or an OTA available that will not complete. Examples shown below (2 and 3).</li></ul> <p><b>Note:</b> These messages will indicate which OTA is being downloaded examples: N222379480, N22236683, N222386380, N22236410, N22236365, N222382220. Not all OTA campaign numbers will show up in Global Warranty under Required Field Actions.</p> |
| <b>Cause</b> | The cause of these concerns could be an OTA is stuck in a pending or download state. |
