**Complaint Regarding the Camera View (Real Top View) in the PCM Central Display (03/26)**

Model Line: **Taycan (Y1A / Y1B / Y1C)**

Equipment: **ParkAssist incl. Surround View (M-no. KA6)**

Information: **The customer complains that the Real Top View in the central display fails sporadically, partially or completely.**

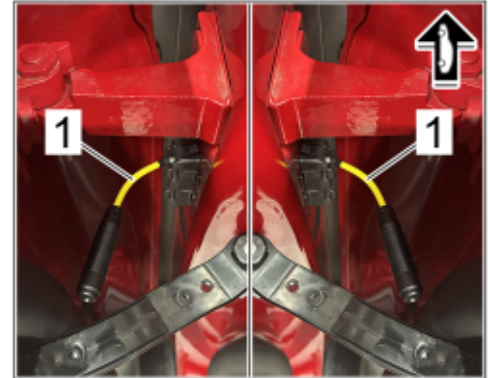
*Resistance measurement on vehicle-side door connection points*

| Assessment | Action |
|---|---|
| Resistance is <b>200 mΩ</b> or <b>less</b> . | <p>The resistance of the signal lines is <b>OK</b>.</p> <p>Plug in and lock electric plug connection on door connection point.</p> <p>Install front door panel loudspeakers and door trim panels.<br/> ⇒ <i>Workshop Manual '914119 Removing and installing front loudspeaker, door trim panel'</i></p> <p>Then connect earth strap for battery.<br/> ⇒ <i>Workshop Manual '978519A1 Removing and installing earth strap for battery'</i></p> <p><b>End of action.</b></p> |
| The resistance value is <b>greater than 200 mΩ</b> . | <p>The resistance of the signal lines is <b>not OK</b>.</p> <p>Replace the plug contact of a signal line at the vehicle-side door connection points.</p> <p>Continue with Step ⇒ 2.</p> |

- Work Procedure: 1 Secure the **measuring adapter** to the signal lines  
 ⇒ *Resistance measurement on vehicle-side door connection points -1-* of the vehicle-side door connection points on the left and right and perform a resistance measurement through the vehicle using the **P90999 - Porsche Tester 4**.

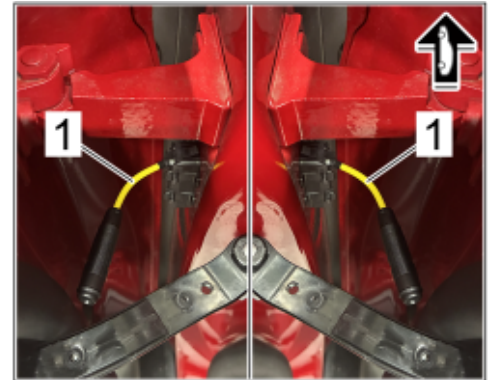
*Resistance measurement on vehicle-side door connection points*

| Assessment | Action |
|---|---|
| Resistance is <b>200 mΩ</b> or less. | <p>The resistance of the signal lines is <b>OK</b>.</p> <p>Plug in and lock electric plug connection on door connection point.</p> <p>Install front door panel loudspeakers and door trim panels.<br/> ⇒ <i>Workshop Manual '914119 Removing and installing front loudspeaker, door trim panel'</i></p> <p>Then connect earth strap for battery.<br/> ⇒ <i>Workshop Manual '978519A1 Removing and installing earth strap for battery'</i></p> <p><b>End of action.</b></p> |
| The resistance value is still <b>greater than 200 mΩ</b> . | <p>The resistance of the signal lines is <b>not OK</b>.</p> <p>Replace the plug contact of the signal line at the vehicle-side <b>front left</b> door connection point.</p> <p><b>Repeat steps ⇒ 2 to ⇒ 5 on the left-hand side and then perform another resistance measurement.</b></p> <p>Install front door panel loudspeakers and door trim panels.<br/> ⇒ <i>Workshop Manual '914119 Removing and installing front loudspeaker, door trim panel'</i></p> <p>Then connect earth strap for battery.<br/> ⇒ <i>Workshop Manual '978519A1 Removing and installing earth strap for battery'</i></p> <p><b>End of action.</b></p> |

- 6 Secure the **measuring adapter** to the signal lines  
 ⇒ *Resistance measurement on vehicle-side door connection points -1-* of the vehicle-side door connection points on the left and right and perform another resistance measurement using the **P90999 - Porsche Tester 4**.
