**Complaint Regarding the Camera View (Real Top View) in the PCM Central Display (03/26)**

Model Line: **911 (992 I)**

Concerns: **Signal lines and plug contacts for the Real Top View cameras**

Information: **The customer complains that the Real Top View in the central display fails sporadically, partially or completely.**

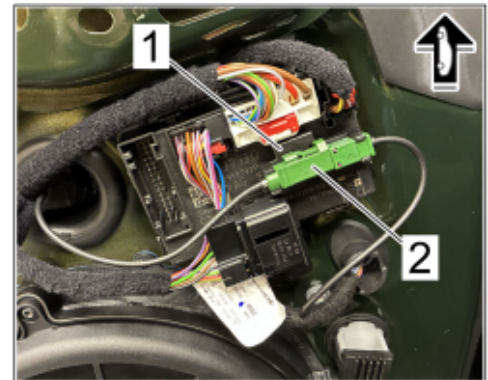
*Front door signal line connection point*

- Work Procedure:
- 1 Loosen the earth strap for the vehicle electrical system battery.  
⇒ *Workshop Manual '978509A1 Loosen and secure earth strap for battery'*
  - 2 Remove front left door trim panel.  
⇒ *Workshop Manual '705919A3 Removing and installing the front door trim panel'*
  - 3 Loosen, release and disconnect signal line on door control unit ⇒ *Front door signal line connection point -1-* and electric plug connection ⇒ *Front door signal line connection point -2-*.

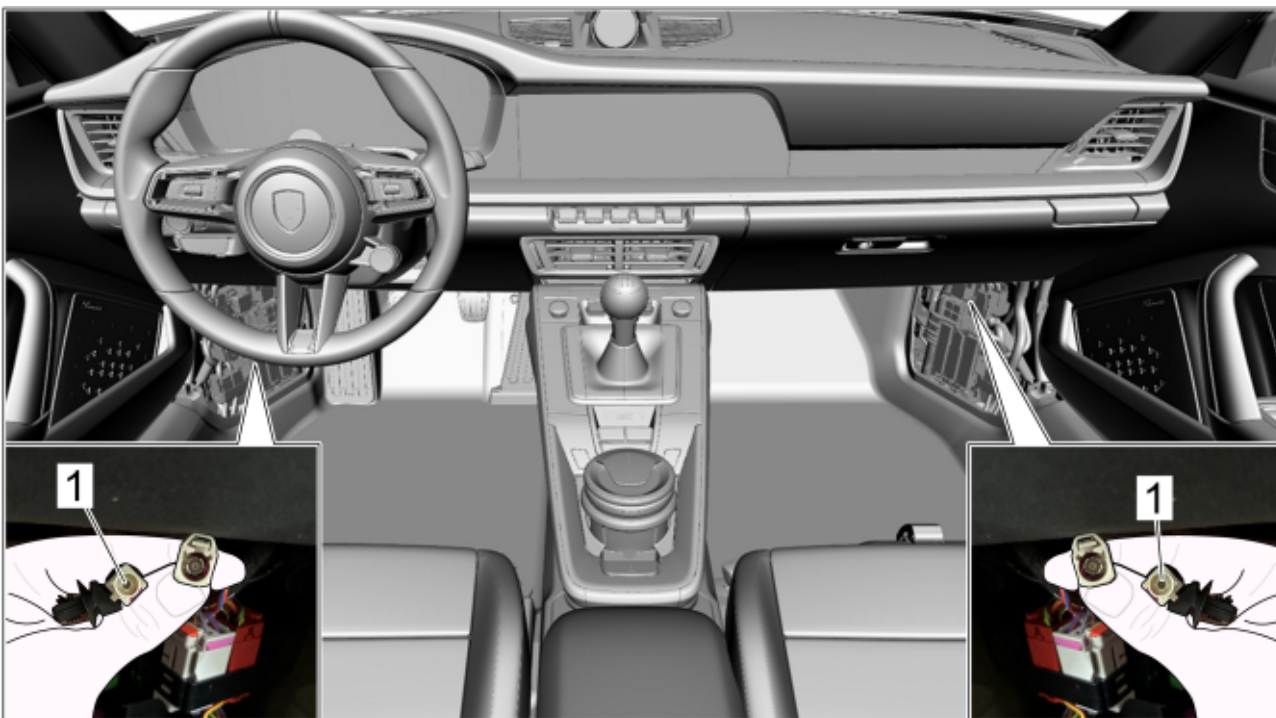
Work Procedure: 1 Fasten the **measuring adapter** to the signal lines  $\Rightarrow$  Resistance measurement of the signal lines in the passenger compartment -1- in the passenger compartment on the left and right and perform a resistance measurement through the vehicle using the **P90999 - Porsche Tester 4**.

The measurement is performed from the left door connection point **through the vehicle** to the right door connection point. This means that one measuring cable must be connected to the **left door connection point** and the other to the **right door connection point**.

| Assessment | Action |
|---|---|
| Resistance is <b>335 mΩ</b> or <b>less</b> . | <p>The resistance of the signal lines is <b>OK</b>.</p> <p>Connect electric plug connections until connector locks perceptibly.</p> <p>Install front side section and door trim panel<br/> ⇒ Workshop Manual '702419A1 Removing and installing front side section trim panel'<br/> ⇒ Workshop Manual '705919A3 Removing and installing the front door trim panel'</p> <p>Install front luggage compartment trim panel.<br/> ⇒ Workshop Manual '700519A1 Removing and installing front luggage compartment trim panel'</p> <p>Then connect earth strap for battery.<br/> ⇒ Workshop Manual '978509A1 Loosen and secure earth strap for battery'</p> <p><b>End of action.</b></p> |
| The resistance value is <b>greater than 335 mΩ</b> . | <p>The resistance of the signal lines is <b>not OK</b>.</p> <p>Replace plug contact of a signal line in the passenger compartment.</p> <p>Continue with Step ⇒ 2.</p> |

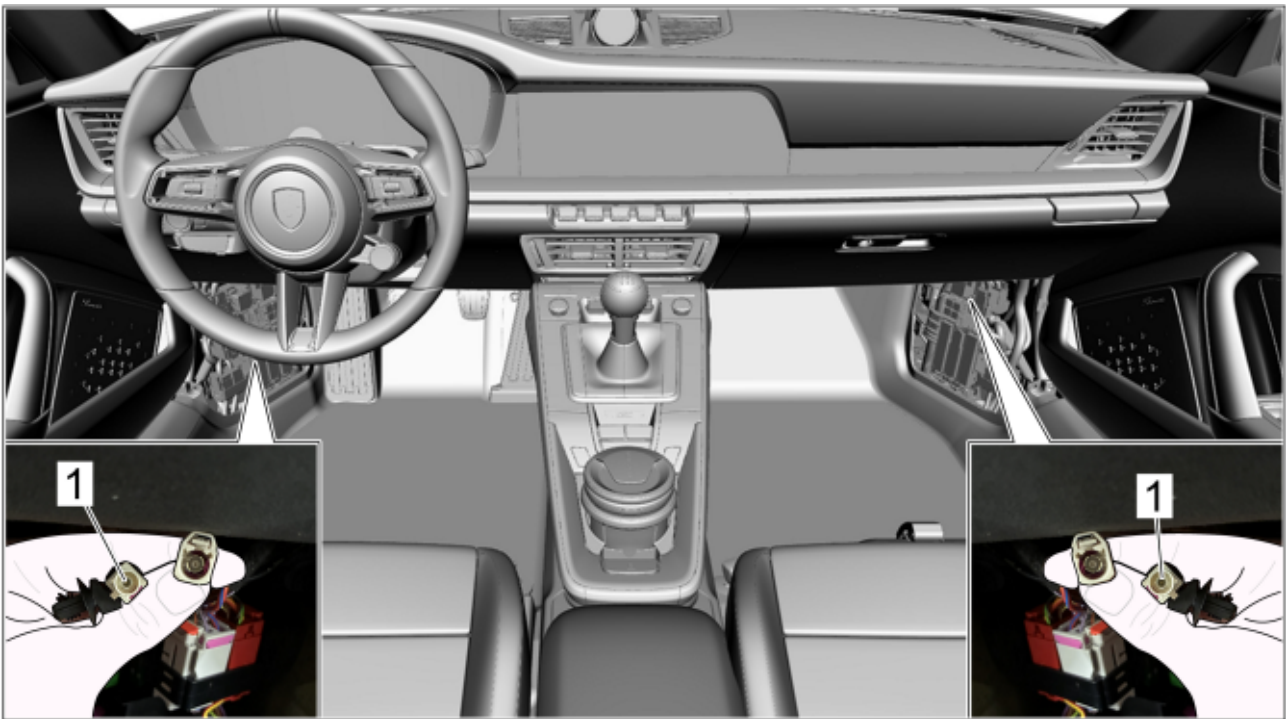
Resistance measurement of the signal lines in the passenger compartment

- 2 Replace plug contact ⇒ *Plug contact for signal line in passenger compartment -1-* of the signal line in the passenger compartment on the left.  
For work procedure, see: ⇒ Workshop Manual '912841 Repairing antenna line'
- 3 Fasten the **measuring adapter** to the signal lines  
⇒ *Resistance measurement of the signal lines in the passenger compartment -1-* in the passenger compartment on the left and right and perform another resistance measurement using the **P90999 - Porsche Tester 4**.

| Assessment | Action |
|---|---|
| Resistance is <b>335 mΩ</b> or less. | <p>The resistance of the signal lines is <b>OK</b>.</p> <p>Connect electric plug connections until connector locks perceptibly.</p> <p>Install front side section and door trim panel<br/>⇒ Workshop Manual '702419A1 Removing and installing front side section trim panel'<br/>⇒ Workshop Manual '705919A3 Removing and installing the front door trim panel'</p> <p>Install front luggage compartment trim panel.<br/>⇒ Workshop Manual '700519A1 Removing and installing front luggage compartment trim panel'</p> <p>Then connect earth strap for battery.<br/>⇒ Workshop Manual '978509A1 Loosen and secure earth strap for battery'</p> |

| | End of action. |
|---|---|
| The resistance value is still <b>greater than 335 mΩ</b> . | <p>The resistance of the signal lines is <b>not OK</b>.</p> <p>Replace plug contact of the signal line in the passenger compartment on the <b>right</b>.</p> <p><b>Repeat step ⇒ 2 on the right-hand side and then perform another resistance measurement.</b></p> <p>Install front side section and door trim panel<br/> ⇒ Workshop Manual '702419A1 Removing and installing front side section trim panel'<br/> ⇒ Workshop Manual '705919A3 Removing and installing the front door trim panel'</p> <p>Install front luggage compartment trim panel.<br/> ⇒ Workshop Manual '700519A1 Removing and installing front luggage compartment trim panel'</p> <p>Then connect earth strap for battery.<br/> ⇒ Workshop Manual '978509A1 Loosen and secure earth strap for battery'</p> <p><b>End of action.</b></p> |

If the resistance reading is still too high after replacing **both plug contacts** in the passenger compartment, create a **Warranty / Campaigns PRMS ticket** with priority "B" and the title (brief description) "**TI 03/26 - Support**", attach the measurement results of the individual measurements and a brief description of the work performed.
