# Rotational Clicking Noise From Front Drive Shaft Assembly on Acceleration

Service  
Category    Drivetrain

Section     Drive Shaft/Propeller Shaft

Applicability

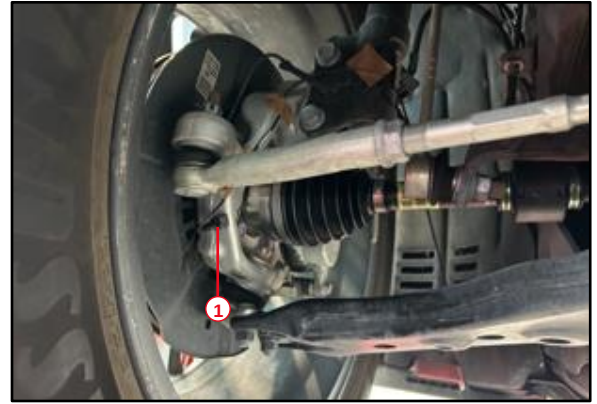
Figure 1.

| <b>1</b> | <b>ChassisEAR™ on the Front Knuckle Assembly</b> |

2. Place the vehicle on a lift and install the ChassisEAR™ (or equivalent) on the front knuckle assembly, as shown in Figure 1, to help isolate the source of the noise.
