# Water Leaking Through Roof Rack Attachment Clips Due to Sealer Interference

| YEAR(S) | MODEL(S) | ADDITIONAL INFORMATION |
|---|---|---|
| 2020 - 2026 | Highlander, Highlander HV | |

Some 2020 – 2026 model year Highlander and Highlander Hybrid vehicles may exhibit a water leak from the roof rack attachment clips. This may be caused by the sealant in the roof channel obstructing the proper seating position for the clip gasket. Follow the Repair Procedure in this bulletin to address this condition.

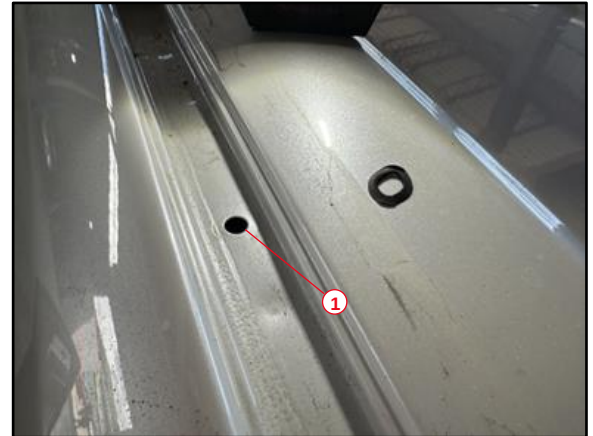
**Figure 1.**

3. Inspect the roof channel.  
Is there any sealant within 3 mm of the outside radius of the clip hole that may interfere with flush condition of the clip gasket, as shown in Figure 1?
  - **YES** — Continue to step 4.
  - **NO** — Replace the clip, ensure full seating of the clip, and go to step 7.

| <b>1</b> | <b>Clip Hole</b> |

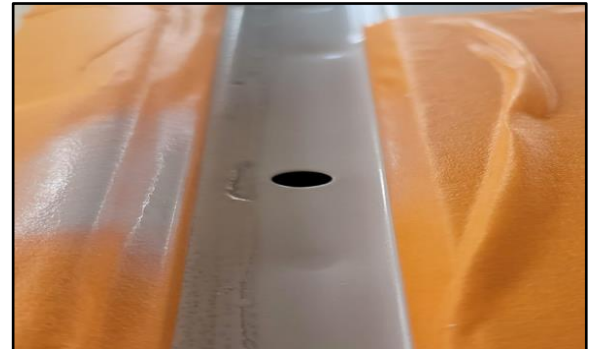
**Figure 3. Clip Hole After Sanding and Painting.**

5. Sand the area down to primer or ED coating (until it is uniformly flat).

6. Paint the affected area using a light coat of color matched touch up paint, as shown in Figure 3.

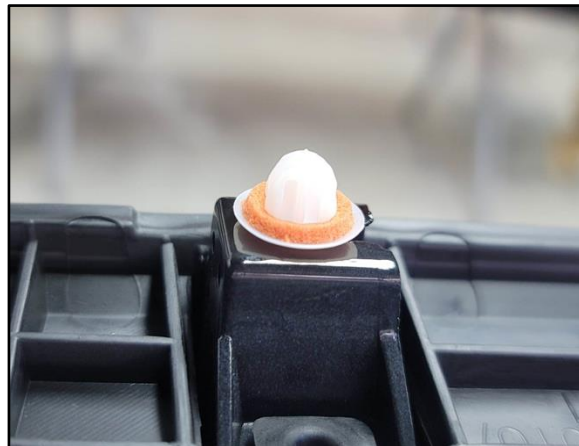
7. Ensure the countermeasure clips and pad are NOT damaged. The NEW clip gasket will be orange (the old clip may have a black gasket).

**Figure 4. New Roof Rail Garnish Clip**

8. Carefully install the six NEW roof rail garnish clips and reinstall the roof rail garnish. Refer to TIS, Applicable model and model year Repair Manual:
  - [2020 – 2026](#) Highlander and Highlander HV:  
*Vehicle Exterior – Exterior Panels / Trim – Roof Rack – Installation*
9. Confirm the condition no longer exists.
