# Service Alert

**CLICKING OR KNOCKING NOISE FROM EITHER FRONT DRIVE  
SHAFT OUTER CV JOINT WHEN TURNING AND ACCELERATING**

**Service Alert No.: SA-028/26**

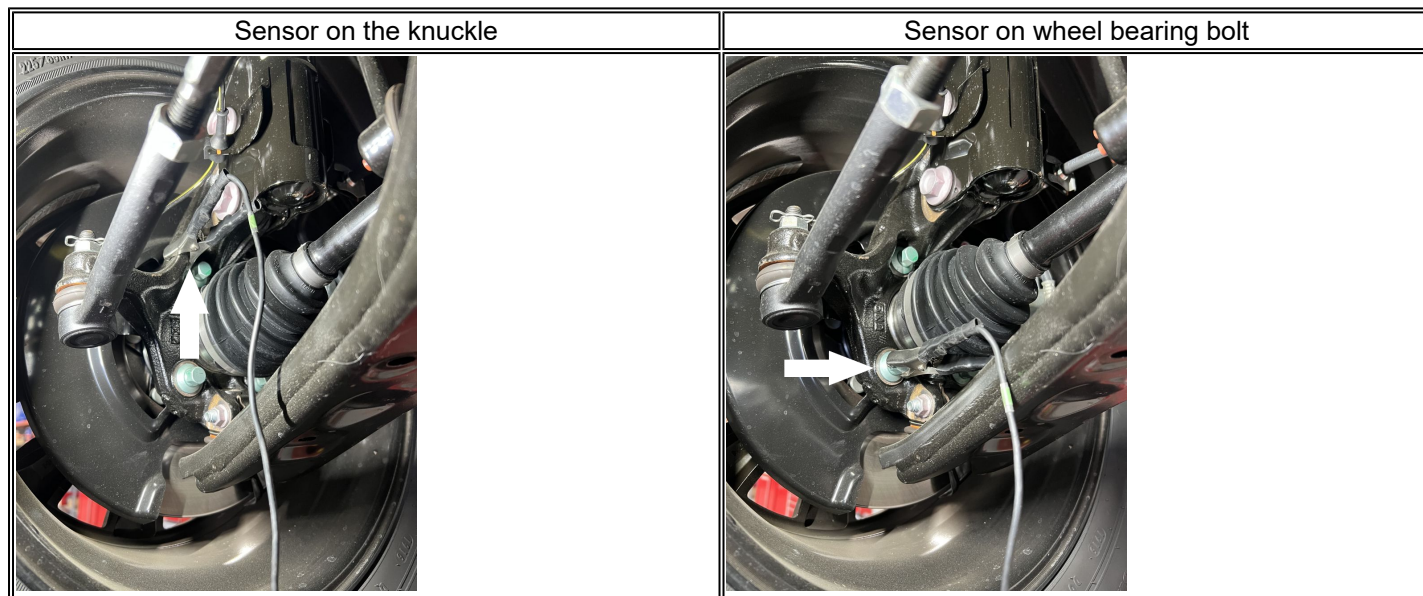
## 2. Sensor placement:

- Attach chassis ears to the steering knuckle as close to the front wheel bearing as possible.
- DO NOT attach sensors to the driveshaft.
