**HYUNDAI**  
**Technical Service Bulletin**

| GROUP<br><b>CAMPAIGN</b> | NUMBER<br><b>26-01-055H</b> |
| DATE<br><b>JULY 2026</b> | MODEL(S)<br><b>PALISADE HYBRID (LX3 HEV)</b> |

**SUBJECT:** VPC SOFTWARE UPDATE  
(LIMITED COVERAGE CAMPAIGN LA28)

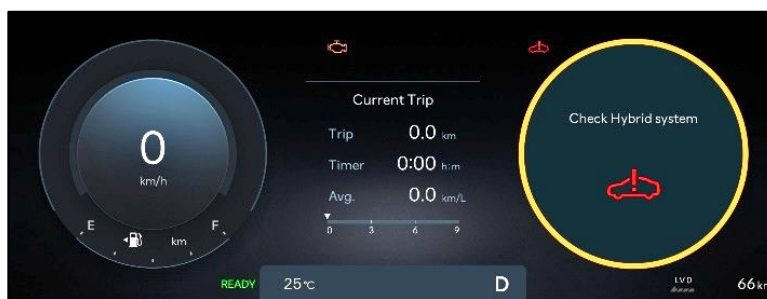
**Description:** Certain Palisade Hybrid (LX3 HEV) vehicles may illuminate the Malfunction Indicator Lamp (MIL) and display a false “Check Hybrid System” warning message after use of Bluelink Remote Start following extended parking periods. This bulletin provides instructions to perform a Vehicle Platform Controller (VPC) software update to prevent these conditions.

Related DTCs associated with MIL illumination may include:

- U116087
- U012987
- U100287
- U016487
- U010087
- U010187
- U100787
- U100387
- U015587
