| REFERENCE: | TSB: 08-255-26<br>GROUP: 08 - Electrical | Date: | July 1, 2026 | REVISION: | — |
| VEHICLES AFFECTED: | 2026 - 2027 (DT) RAM 1500 Pickup<br>2026 - 2027 (LB) Dodge Charger<br>2026 - 2027 (WS) Jeep Grand Wagoneer / Wagoneer<br>2026 - 2027 (RU) Chrysler Pacifica / Voyager<br>2026 (EJ) Jeep Recon<br>2026 (WL) Jeep Grand Cherokee / Grand Cherokee L<br>2026 - 2027 (DJ) RAM 2500 Pickup<br>2026 - 2027 (D2) RAM 3500 Pickup<br>2026 - 2027 (DD) RAM 3500 Cab Chassis<br>2026 - 2027 (DP) RAM 4500/5500 Cab Chassis<br>This bulletin applies to vehicles equipped with one of the following: <ul style="list-style-type: none"><li>Uconnect 5 Nav W 12.0" Display (Sales Codes UBQ, UEQ and UFQ).</li><li>Uconnect 5 Nav W 12.3" Display (Sales Codes UBX, UEP, UFP and UEX).</li><li>Uconnect 5 Nav W 14.4" Display (Sales Codes UBW, UEW and UFW).</li></ul> | | | MARKET APPLICABILITY:<br><div><input checked="" type="checkbox"/> NA<input type="checkbox"/> MEA</div> <div><input type="checkbox"/> SA<input type="checkbox"/> IAP</div> <div><input type="checkbox"/> EE<input type="checkbox"/> CH</div><br>NOTE: This bulletin applies to the North America markets. | |

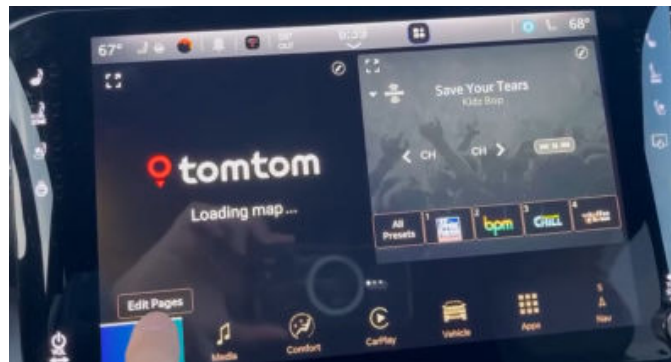
**Fig. 1**  
Factory Navigation Screen

| CUSTOMER SYMPTOM: | Customers may experience the following: <ul style="list-style-type: none"><li>Factory navigation won't load on the Home/Split screen <a href="#">Fig. 1</a>.</li></ul> | | | | |
| CAUSE: | Software issue | | | | |

This is a known issue that engineering is investigating. When switching to full navigation page the issue doesn't appear.

**IMPORTANT!** Radio replacement will not resolve this issue. A radio software update is scheduled for release during Q4 2026.
