| <br>PARTS & SERVICES | | <b>Technical Service Bulletin (TSB)</b><br><b>Global Telematics Box (TBM) Firmware Over</b><br><b>The Air (FOTA) Update To SW 4.39</b> | | | |
| <b>REFERENCE:</b> | <b>TSB:</b> 08-265-26<br><b>GROUP:</b> 08 - Electrical | <b>Date:</b> | July 3, 2026 | <b>REVISION:</b> | — |
| <b>VEHICLES AFFECTED:</b> | <b>2026 (WD) Dodge Durango</b><br>This bulletin applies to vehicles built on or before July 20, 2026 (MDH 0720XX) equipped with Global Telematics Box Module (Sales Code RDG). | | | <b>MARKET APPLICABILITY:</b><br><div><input checked="" type="checkbox"/> NA<input type="checkbox"/> MEA</div> <div><input type="checkbox"/> SA<input type="checkbox"/> IAP</div> <div><input type="checkbox"/> EE<input type="checkbox"/> CH</div><br><b>NOTE:</b> This bulletin applies to the North America market. | |

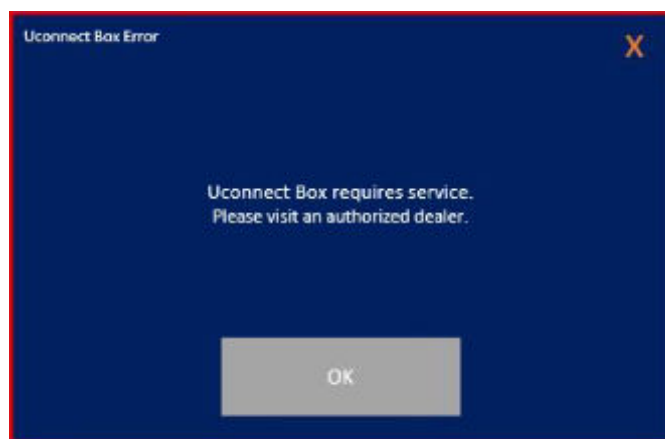
**Fig. 1**

| <b>CUSTOMER SYMPTOM:</b> | <b>Customers must experience a Malfunction Indicator Lamp (MIL) illumination and one or more of the following Diagnostic Trouble Codes (DTCs):</b> <ul style="list-style-type: none"><li>• B22A9-96 - ECU Internal Performance-Component Internal Failure.</li><li>• B1560-11 - Cellular Antenna 1-Circuit Short To Ground.</li><li>• B1560-13 - Cellular Antenna 1-Circuit Open.</li><li>• B1561-11 - Cellular Antenna 2-Circuit Short To Ground.</li><li>• B1561-13 - Cellular Antenna 2-Circuit Open.</li><li>• B1562-14 - GPS Antenna-Circuit Short To Ground Or Open.</li></ul> <b>Customers may also experience the following:</b> <ul style="list-style-type: none"><li>• "UConnect Box Requires Service" Message in Radio Display.</li></ul> | | | | |
| <b>CAUSE:</b> | <b>TBM Software</b> | | | | |

Uconnect Box Error Message

Message display on the radio screen "Uconnect Box requires service. Please visit an authorized dealer." [Fig. 1.](#)

This bulletin provides information regarding the latest Firmware Over The Air (FOTA) update and provides the service technician an overview of the steps a customer will need to take to complete the update. The TBM software will be updated from 4.38 to 4.39 (243187 SW PN number).
