**Technical Service Bulletin (TSB)**  
**Lower Left Door Pocket Contacting**  
**Lower Door Hinge Causing Paint Loss**

| REFERENCE: | TSB: 23-024-26<br>GROUP: 23 - Body | Date: | July 3, 2026 | REVISION: | — |
| VEHICLES AFFECTED: | 2026 (JL) Jeep Wrangler<br>This bulletin applies to vehicles built on or after January 22, 2026 (MDH 0122XX) and built on or before January 28, 2026 (MDH 0128XX) equipped as Two Door (Sales Code 5ZS). | | | MARKET APPLICABILITY:<br><div><input checked="" type="checkbox"/> NA<input type="checkbox"/> MEA</div> <div><input type="checkbox"/> SA<input type="checkbox"/> IAP</div> <div><input type="checkbox"/> EE<input type="checkbox"/> CH</div><br><b>NOTE:</b> This bulletin applies to the North American market. | |

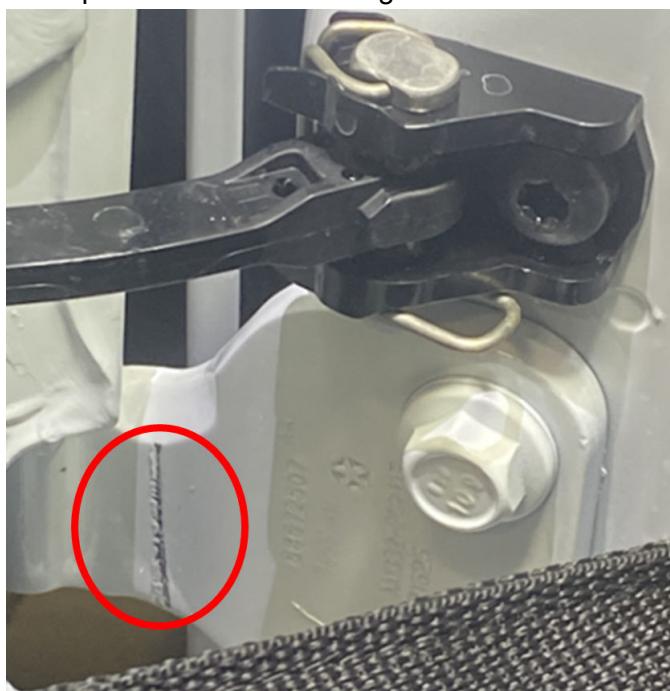
**Fig. 1**  
Lower Driver Door Hinge Contact Area To Inspect

2. Was there chipped, cracked or missing paint on the driver lower door hinge [Fig. 1](#)?
  - YES >>> Proceed to [Step 3](#).
  - NO >>> This bulletin has been completed, Use Inspect LOP (23-40-20-9J) to close the active RSU.
3. Open the door to a 90 degree angle.

8. Apply primer and touch up paint as required to the lower hinge [Fig. 1](#) and door pocket trim edge [Fig. 2](#). Refer to the detailed service procedures available in DealerCONNECT/Service Library under: 31 - Collision Information / Standard Procedures (PAINT TOUCH-UP).

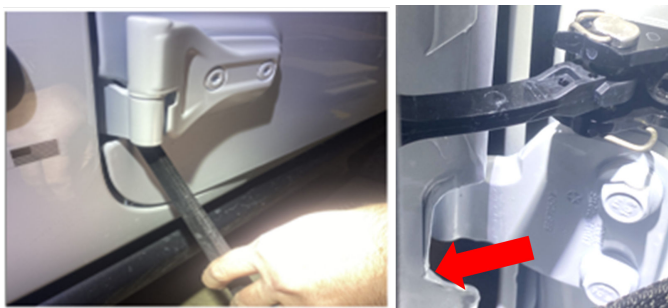
**Fig. 2**

**NOTE: The next step involves modifying the trim edge of the door pocket [Fig. 2](#) as required to prevent it from contacting the door hinge.**

Trim Stick In Door Hinge And Door Pocket Trim To Be Modified

4. Using the end of the trim stick, insert the trim stick between the door and the hinge in 1 mm (0.039 in.) increments [Fig. 2](#). Gently close the door as required, until resistance can be felt from the door contacting the trim stick.

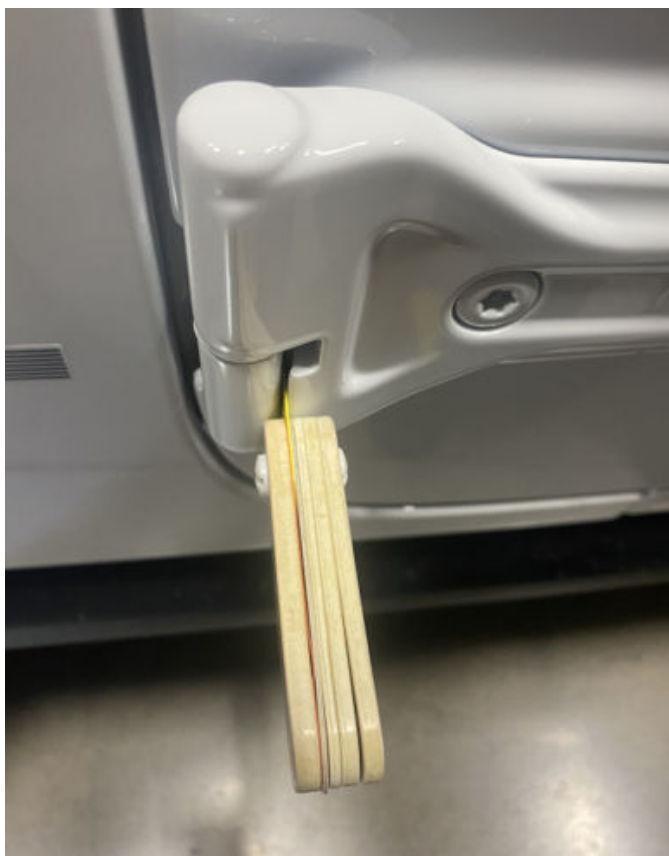
**Fig. 3**

Checking Hinge Gap With Feeler Gauge

5. Fully close the door.
6. Using a feeler gauge, insert the gauge between the lower hinge and door pocket to verify the gap is .25 mm (.025 cm) or larger [Fig. 3](#).

7. Was the lower hinge to door pocket gap .25 mm (.025 cm) or larger [Fig. 3](#)?
- YES >>> Proceed to [Step 8](#).
  - NO >>> Repeat [Steps 3](#) through [Step 6](#) until the lower hinge to door pocket gap is .25 mm (.025 cm) or larger [Fig. 3](#).
