TECHNICAL SERVICE BULLETIN  
Distorted Or Corrupted 360-Degree Camera View

Model:  
Ford  
2024-2025 F-150

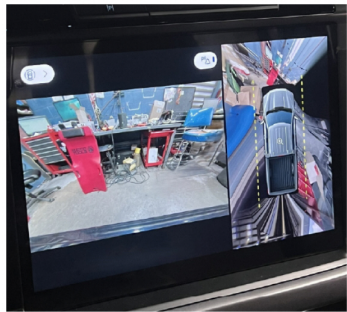
**Service Procedure**  
**NOTE:** Make sure all doors are closed, exterior mirrors are in the normal driving position (not folded in) and the front, rear, left hand and right-hand parking aid camera lenses are clear of any debris or scratches.  
1. Test the parking aid camera system while observing the video camera image. Does the vehicle exhibit a distorted or corrupted 360-degree camera image as shown in the example images below?  
**NOTE:** Some rounding or stretching of the image is considered a normal characteristic of the fisheye lens on each camera.  
Figure 1

- (1). Yes - proceed to Step 2.  
(2). No - this article does not apply. Refer to WSM, Section 413-136 for normal diagnostics.  
2. For 2024 vehicles, download and run the "IPMA - Image Processing Module A (IPMA) Software Update" and "PSCM - Power Steering Control Module Software Update" applications using the latest software version of the FDRS scan tool.  
**NOTE:** It is highly recommended to use a XCM 3 when updating the IPMA. Using a XCM 3 reduces the chances of programming failures on modules when very large files are being transferred.  
3. For 2025 vehicles, download and run the "IPMA - Image Processing Module A (IPMA) Software Update" application using the latest software version of the FDRS scan tool.  
4. For all vehicles, perform the "360 Degree View Camera Alignment" procedure in WSM, Section 413-136.
