# Service Bulletin

Bulletin No.: PIC6628E

**Subject: Windshield to Dash Valence Foam Seal Mis-positioned**

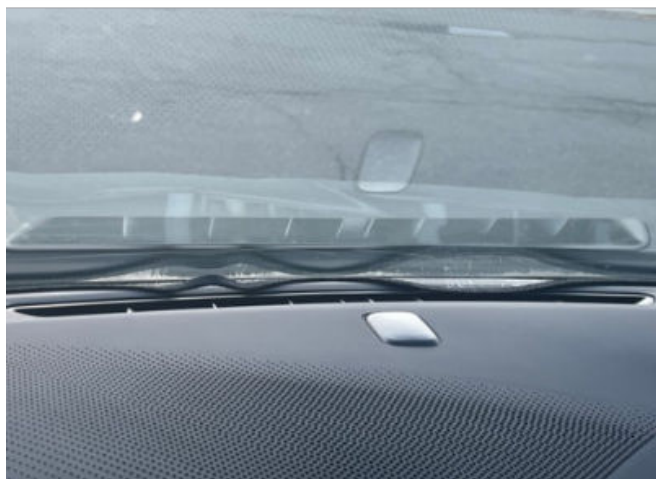
7012512

The foam windshield seal will be visible from either the windshield OR from inside the interior when looking at the front of the instrument panel.
